**REFURBISHMENT / DEMOLITION**  
**ASBESTOS SURVEY REPORT**

**Middlesex Hospital  
Cleveland Street  
London  
W1T4DR**

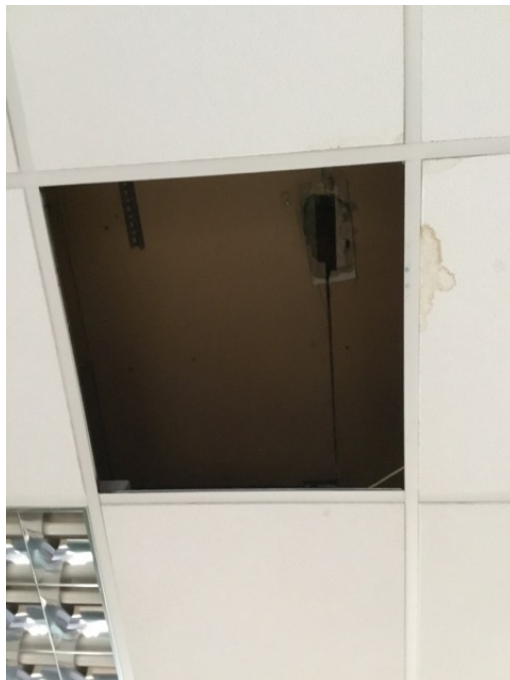
Lead Surveyor	Colin Bliss
Date of Survey	20/09/2017
Date of Next Re-inspection	
Item Description	Visual inspection of reception
Level of Identification	
Location Name	1 / Main reception / Ground
Sample No	
Product Type	
Extent of Damage	
Surface Treatment	
Asbestos Type	Not Applicable
Amount / Extent	
Accessibility	
Algorithm Score	0
<b>RECOMMENDATION</b>	Negative Sample - No Recommendation Required

MMMF suspended ceiling with plasterboard false ceiling above and a secondary timber ceiling.

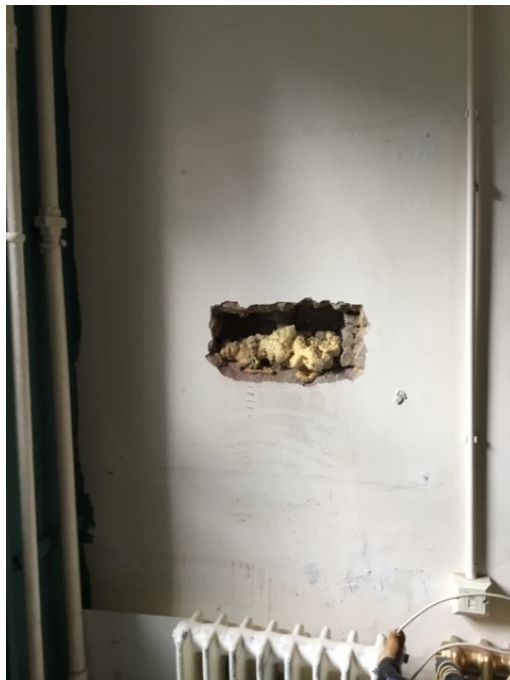
Lead Surveyor	Colin Bliss
Date of Survey	20/09/2017
Date of Next Re-inspection	
Item Description	Visual inspection of wall
Level of Identification	
Location Name	1 / Main reception / Ground
Sample No	
Product Type	
Extent of Damage	
Surface Treatment	
Asbestos Type	Not Applicable
Amount / Extent	
Accessibility	
Algorithm Score	0
<b>RECOMMENDATION</b>	Negative Sample - No Recommendation Required

Plaster onto masonry walls

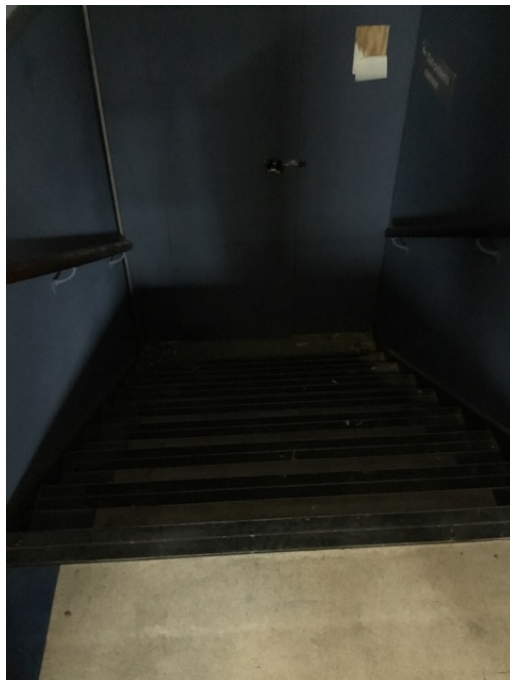
Lead Surveyor	Colin Bliss
Date of Survey	20/09/2017
Date of Next Re-inspection	
Item Description	Rubber stair nosing
Level of Identification	
Location Name	1 / Main reception / Ground
Sample No	
Product Type	
Extent of Damage	
Surface Treatment	
Asbestos Type	Not Applicable
Amount / Extent	
Accessibility	
Algorithm Score	0
<b>RECOMMENDATION</b>	Negative Sample - No Recommendation Required

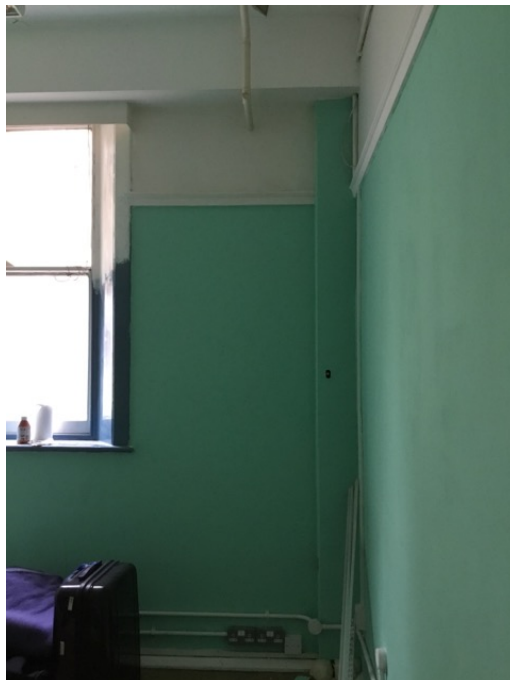
Lead Surveyor	Colin Bliss
Date of Survey	20/09/2017
Date of Next Re-inspection	
Item Description	Boxing
Level of Identification	
Location Name	2 / Offices / Ground
Sample No	
Product Type	
Extent of Damage	
Surface Treatment	
Asbestos Type	Not Applicable
Amount / Extent	
Accessibility	
Algorithm Score	0
<b>RECOMMENDATION</b>	Negative Sample - No Recommendation Required

Plyboard boxing housing metal pipework

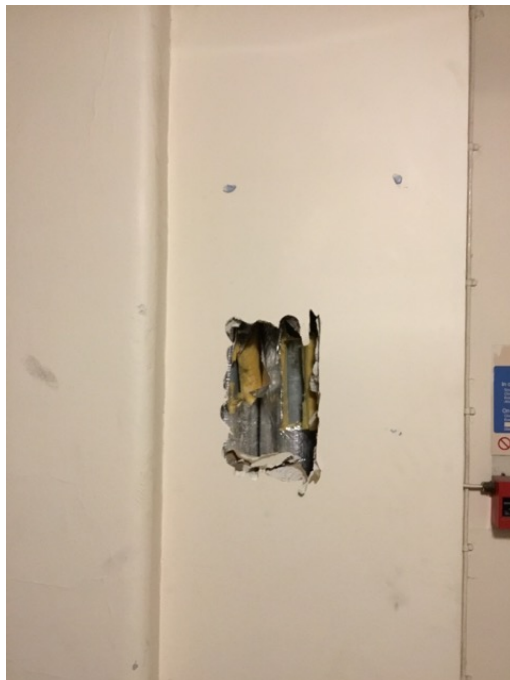
Lead Surveyor	Colin Bliss
Date of Survey	20/09/2017
Date of Next Re-inspection	
Item Description	Boxing
Level of Identification	
Location Name	4 / Corridor / Ground
Sample No	
Product Type	
Extent of Damage	
Surface Treatment	
Asbestos Type	Not Applicable
Amount / Extent	
Accessibility	
Algorithm Score	0
<b>RECOMMENDATION</b>	Negative Sample - No Recommendation Required

Plasterboard boxing with fibreglass lagged pipework

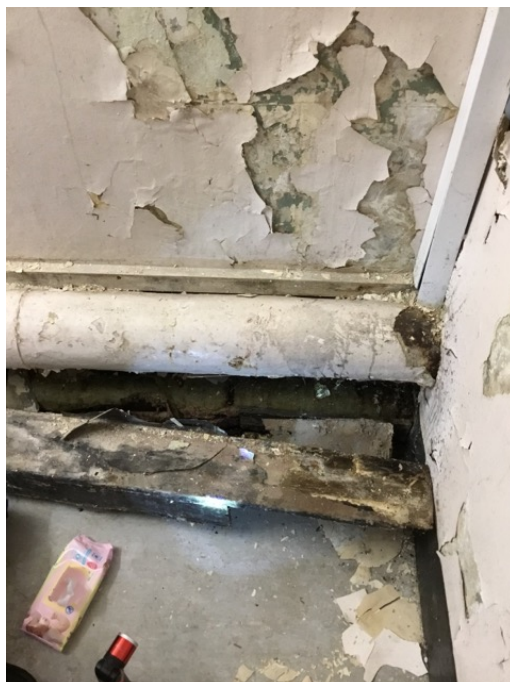
Lead Surveyor	Colin Bliss
Date of Survey	20/09/2017
Date of Next Re-inspection	20/09/2018
Item Description	Lagging to low level pipework
Level of Identification	Sampled
Location Name	4 / Corridor / Ground
Sample No	04
Product Type	Lagging
Extent of Damage	High Damage
Surface Treatment	Unsealed Lagging & Spray
Asbestos Type	Crocidolite / Chrysotile
Amount / Extent	4 LM
Accessibility	Occasional Disturbance
Algorithm Score	9
<b>RECOMMENDATION</b>	Remove by Licensed Asbestos Contractor

Unclear where this lagging is going through to. It is located on the stairwell B.

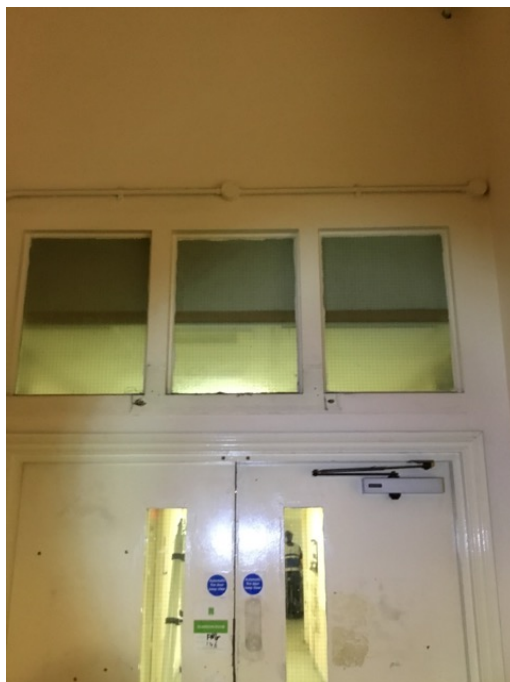
Lead Surveyor	Colin Bliss
Date of Survey	20/09/2017
Date of Next Re-inspection	
Item Description	Insulating board to door header
Level of Identification	Sampled
Location Name	4 / Corridor / Ground
Sample No	03
Product Type	Insulating board
Extent of Damage	
Surface Treatment	
Asbestos Type	NADIS - No Asbestos Detected in Sample
Amount / Extent	
Accessibility	
Algorithm Score	0
<b>RECOMMENDATION</b>	Negative Sample - No Recommendation Required

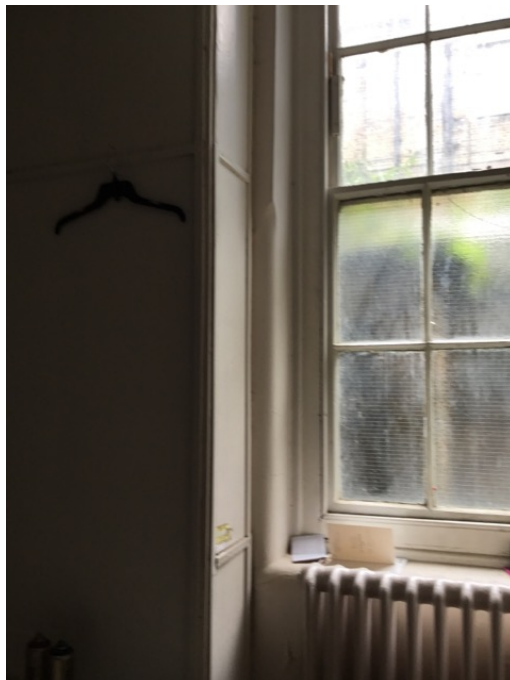
Lead Surveyor	Colin Bliss
Date of Survey	20/09/2017
Date of Next Re-inspection	20/09/2018
Item Description	Cement side panels
Level of Identification	Presumed
Location Name	5 / Section 1 / Ground
Sample No	
Product Type	Cement
Extent of Damage	Good Condition
Surface Treatment	Unsealed Cement
Asbestos Type	Chrysotile
Amount / Extent	2 LM
Accessibility	Unlikely Disturbance/Usually Inaccessible
Algorithm Score	12
<b>RECOMMENDATION</b>	Remove by Approved Asbestos Contractor

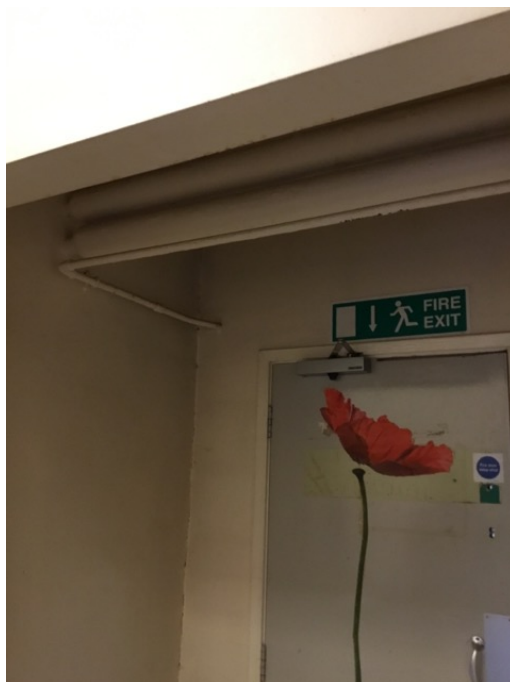
Lead Surveyor	Colin Bliss
Date of Survey	20/09/2017
Date of Next Re-inspection	20/09/2018
Item Description	Thermal lagging to pipework
Level of Identification	Strongly Presumed
Location Name	5 / Section 1 / Ground
Sample No	05
Product Type	Thermal Insulation
Extent of Damage	Good Condition
Surface Treatment	Sealed lagging
Asbestos Type	Amosite / Chrysotile
Amount / Extent	50 LM
Accessibility	Unlikely Disturbance/Usually Inaccessible
Algorithm Score	5
<b>RECOMMENDATION</b>	Remove by Licensed Asbestos Contractor

This is located within the kitchen, bathrooms, Room G92

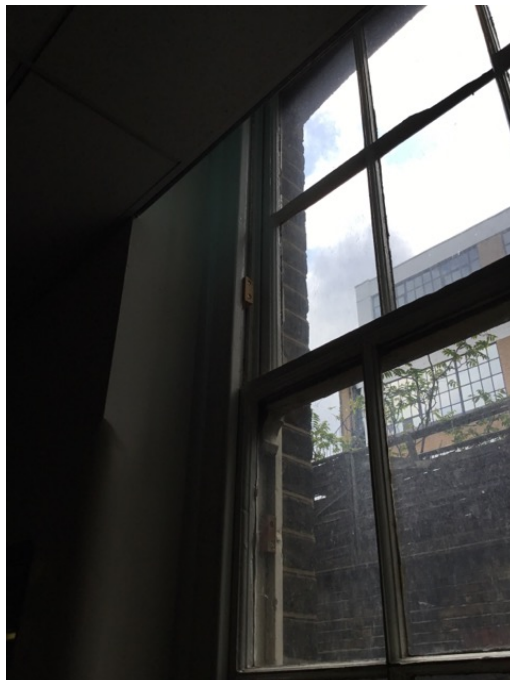
To all sash windows throughout.

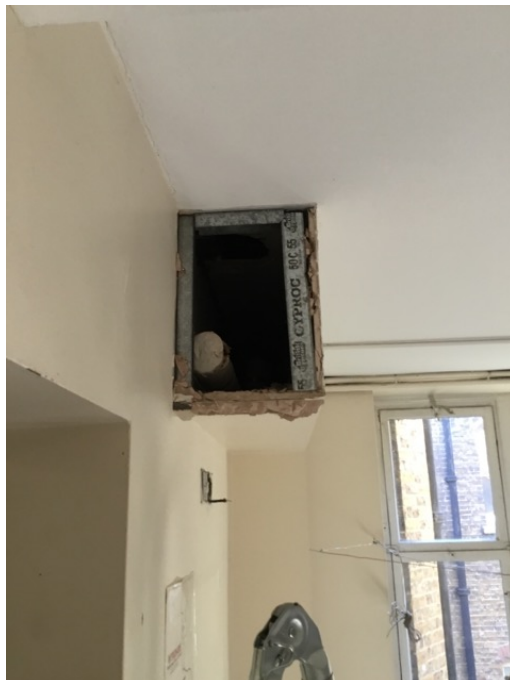
Lead Surveyor	Colin Bliss
Date of Survey	20/09/2017
Date of Next Re-inspection	
Item Description	Fibreglass lagged pipework within boxing
Level of Identification	
Location Name	9 / Section 5 / Second
Sample No	
Product Type	
Extent of Damage	
Surface Treatment	
Asbestos Type	Not Applicable
Amount / Extent	
Accessibility	
Algorithm Score	0
<b>RECOMMENDATION</b>	Negative Sample - No Recommendation Required

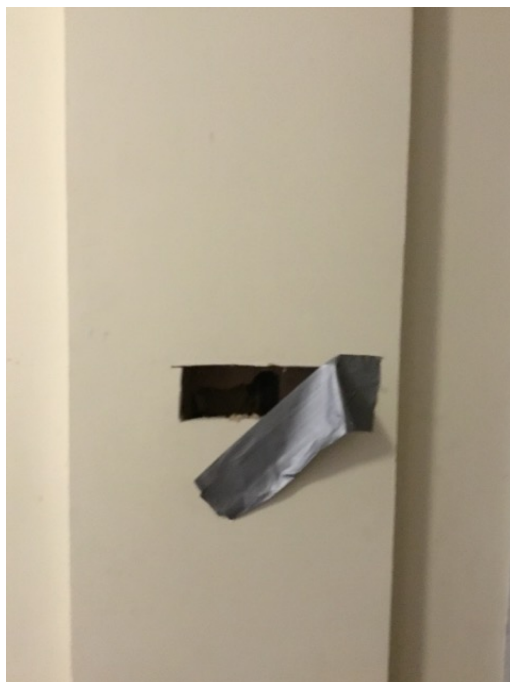
Lead Surveyor	Colin Bliss
Date of Survey	20/09/2017
Date of Next Re-inspection	
Item Description	Plasterboard boxing in main corridor
Level of Identification	
Location Name	9 / Section 5 / Second
Sample No	
Product Type	
Extent of Damage	
Surface Treatment	
Asbestos Type	Not Applicable
Amount / Extent	
Accessibility	
Algorithm Score	0
<b>RECOMMENDATION</b>	Negative Sample - No Recommendation Required

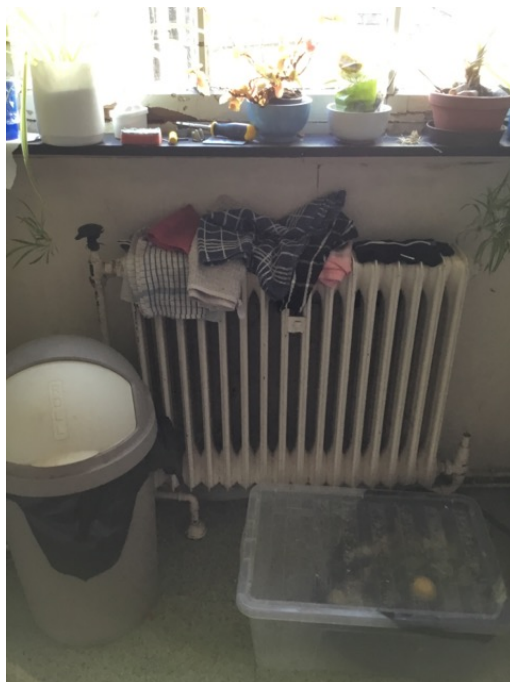
Lead Surveyor	Colin Bliss
Date of Survey	20/09/2017
Date of Next Re-inspection	20/09/2018
Item Description	Radiator nob
Level of Identification	Presumed
Location Name	9 / Section 5 / Second
Sample No	
Product Type	Asbestos Reinforced Composite
Extent of Damage	Good Condition
Surface Treatment	Sealed Cement
Asbestos Type	Chrysotile
Amount / Extent	1 No
Accessibility	Unlikely Disturbance/Usually Inaccessible
Algorithm Score	12
<b>RECOMMENDATION</b>	Remove by Licensed Asbestos Contractor

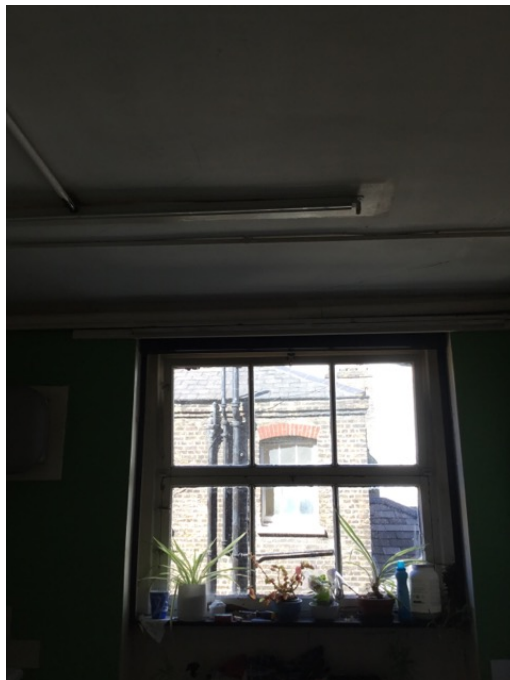
Lead Surveyor	Colin Bliss
Date of Survey	20/09/2017
Date of Next Re-inspection	
Item Description	Foam lagged high level pipework in kitchen
Level of Identification	
Location Name	9 / Section 5 / Second
Sample No	
Product Type	
Extent of Damage	
Surface Treatment	
Asbestos Type	Not Applicable
Amount / Extent	
Accessibility	
Algorithm Score	0
<b>RECOMMENDATION</b>	Negative Sample - No Recommendation Required

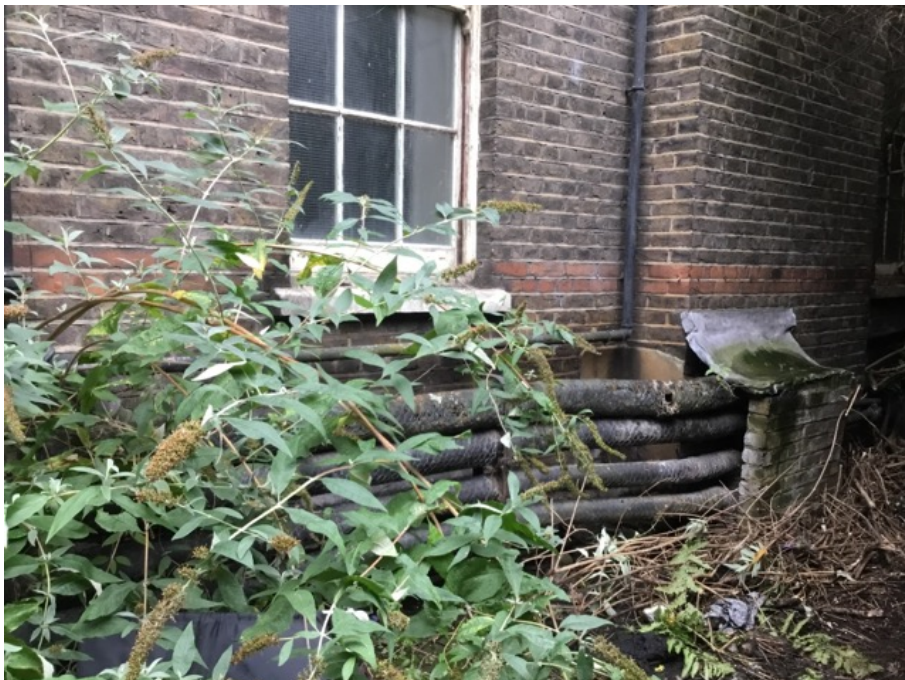
Lagging is in very poor condition. There may be lagging debris with the over grown vegetation. Lagging is to all pipes

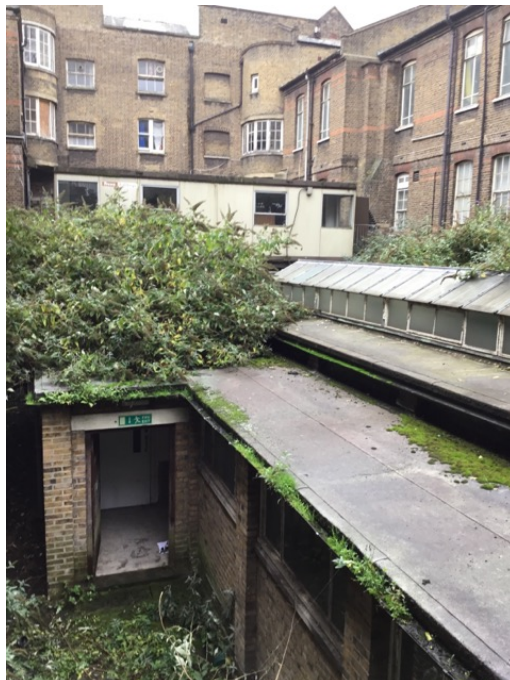
Lead Surveyor	Colin Bliss
Date of Survey	20/09/2017
Date of Next Re-inspection	
Item Description	Bitumen felt to roof
Level of Identification	Sampled
Location Name	/ External /
Sample No	08
Product Type	Asbestos Reinforced Composite
Extent of Damage	
Surface Treatment	
Asbestos Type	NADIS - No Asbestos Detected in Sample
Amount / Extent	
Accessibility	
Algorithm Score	0
<b>RECOMMENDATION</b>	Negative Sample - No Recommendation Required

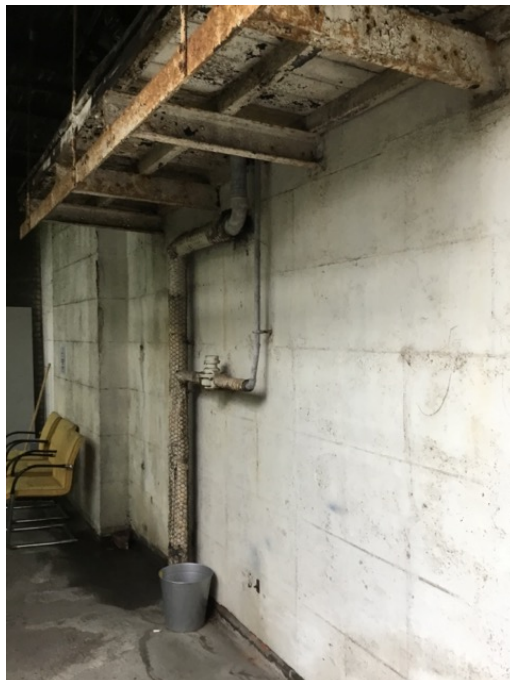
Lead Surveyor	Colin Bliss
Date of Survey	20/09/2017
Date of Next Re-inspection	
Item Description	Fibreglass lagged pipework
Level of Identification	
Location Name	/ External /
Sample No	
Product Type	
Extent of Damage	
Surface Treatment	
Asbestos Type	Not Applicable
Amount / Extent	
Accessibility	
Algorithm Score	0
<b>RECOMMENDATION</b>	Negative Sample - No Recommendation Required

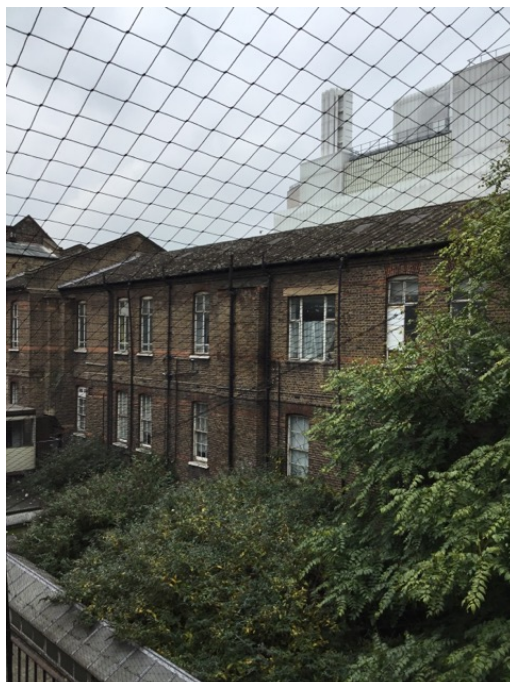
Lead Surveyor	Colin Bliss
Date of Survey	20/09/2017
Date of Next Re-inspection	20/09/2018
Item Description	Cement sheeting to roof
Level of Identification	Sampled
Location Name	/ External /
Sample No	09
Product Type	Asbestos Cement
Extent of Damage	Low Damage
Surface Treatment	Unsealed Cement
Asbestos Type	Chrysotile
Amount / Extent	1300 M2
Accessibility	Unlikely Disturbance/Usually Inaccessible
Algorithm Score	4
<b>RECOMMENDATION</b>	Remove by Approved Asbestos Contractor

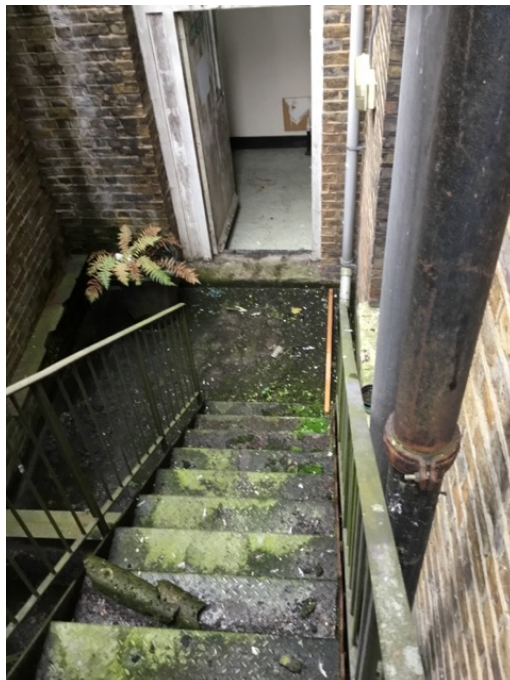
Cement debris to floor throughout external area.

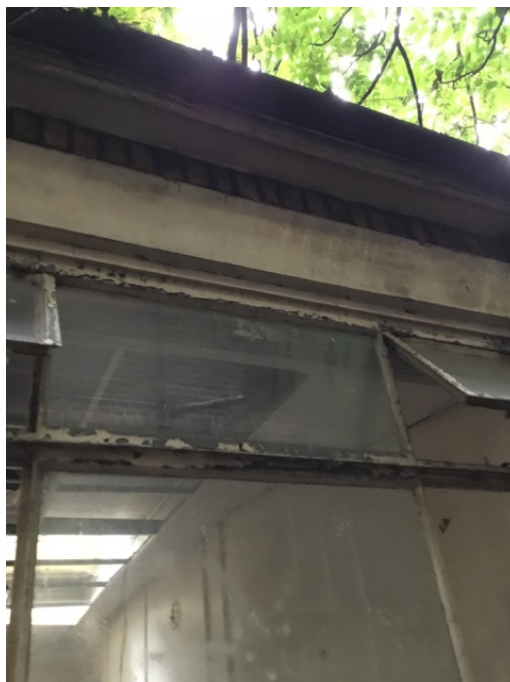
Lead Surveyor	Colin Bliss
Date of Survey	20/09/2017
Date of Next Re-inspection	20/09/2018
Item Description	Cement soffits from ceiling in room
Level of Identification	Crossed Referenced
Location Name	/ External /
Sample No	11
Product Type	Cement soffit
Extent of Damage	Good Condition
Surface Treatment	Sealed Cement
Asbestos Type	Chrysotile
Amount / Extent	200 LM
Accessibility	Unlikely Disturbance/Usually Inaccessible
Algorithm Score	1
<b>RECOMMENDATION</b>	Remove by Approved Asbestos Contractor

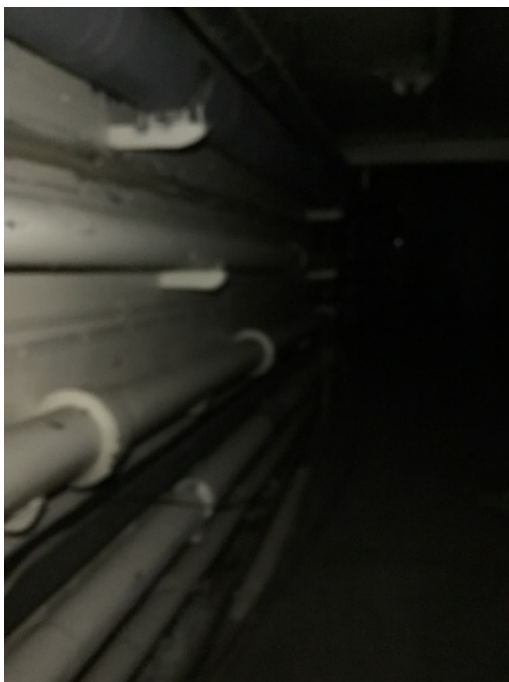
There is associated debris to walls. Will need to be removed as part of abatement works. Lagging to 5 pipes.

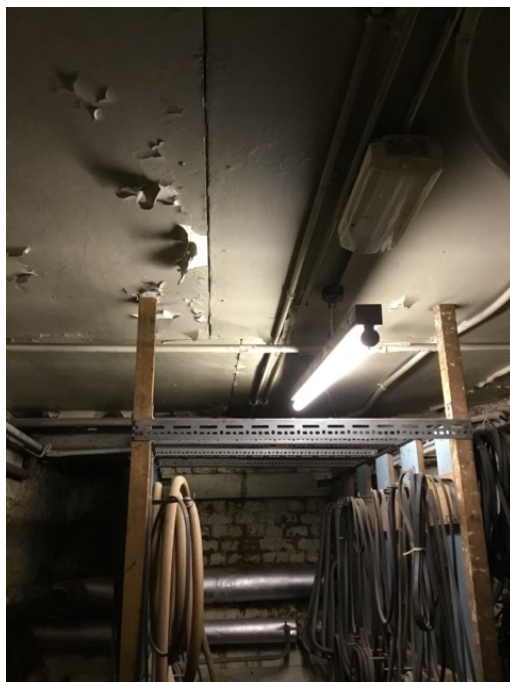
Cement panels to ceiling, gaskets visually identified to floor

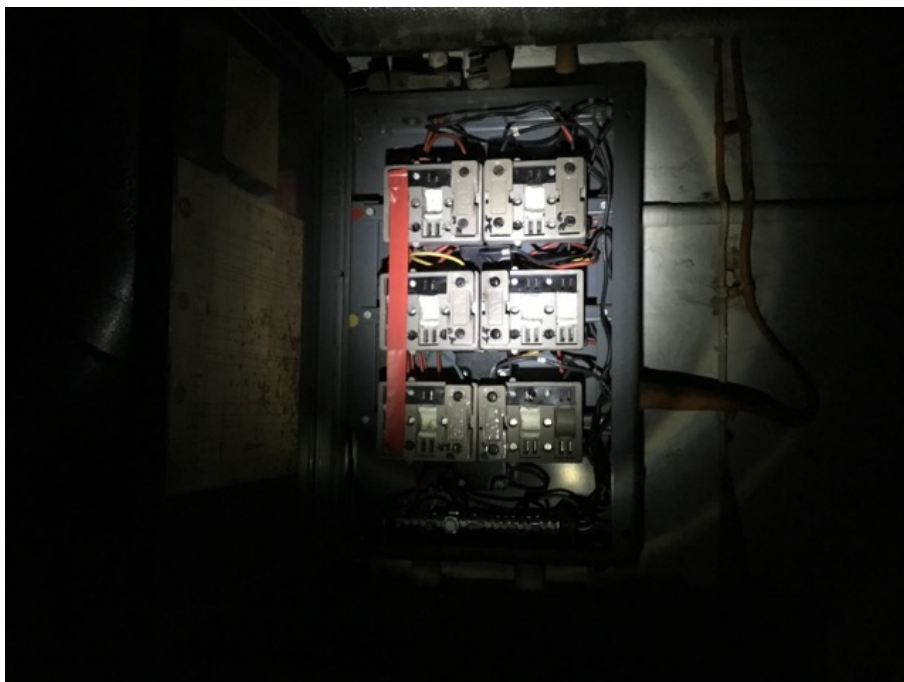
Presumed to all fuse boxes throughout basement.

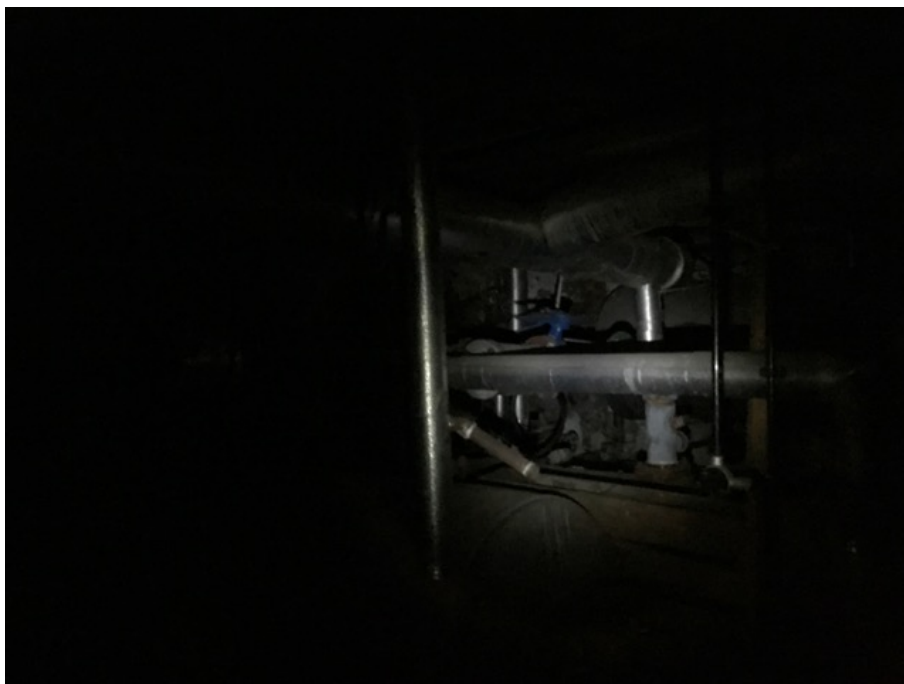
Presume gaskets to all pipework throughout building.

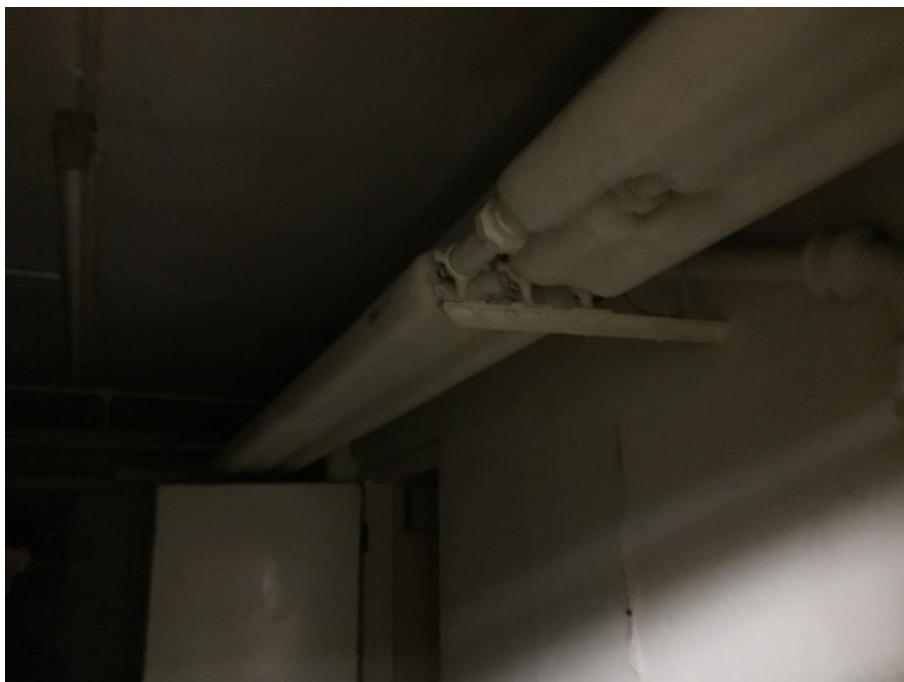
Pipework is located in all rooms in this section.

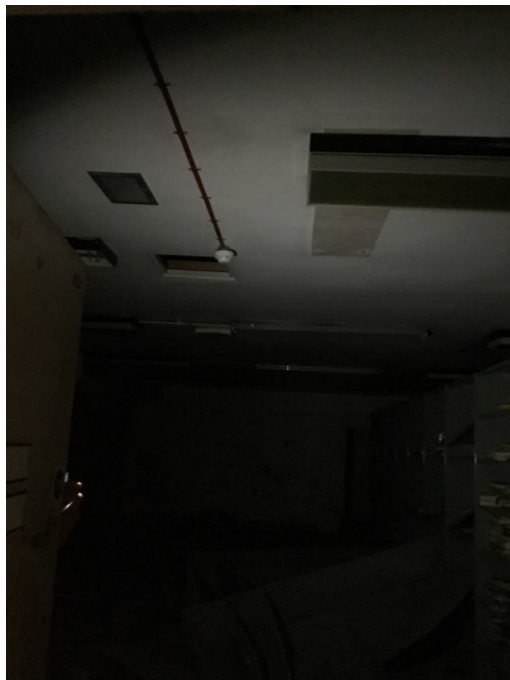
Lead Surveyor	Colin Bliss
Date of Survey	20/09/2017
Date of Next Re-inspection	
Item Description	Plasterboard ceiling opening to concrete ceiling
Level of Identification	
Location Name	15 / Room / Basement
Sample No	
Product Type	
Extent of Damage	
Surface Treatment	
Asbestos Type	Not Applicable
Amount / Extent	
Accessibility	
Algorithm Score	0
<b>RECOMMENDATION</b>	Negative Sample - No Recommendation Required

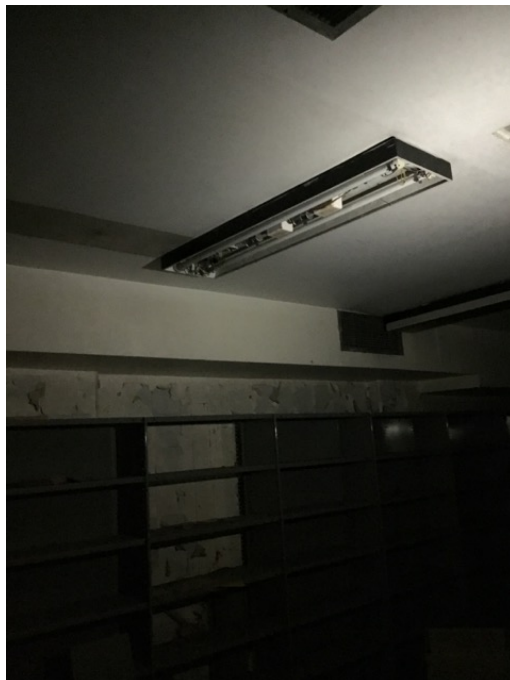
Lead Surveyor	Colin Bliss
Date of Survey	20/09/2017
Date of Next Re-inspection	
Item Description	Metal ducting
Level of Identification	
Location Name	15 / Room / Basement
Sample No	
Product Type	
Extent of Damage	
Surface Treatment	
Asbestos Type	Not Applicable
Amount / Extent	
Accessibility	
Algorithm Score	0
<b>RECOMMENDATION</b>	Negative Sample - No Recommendation Required

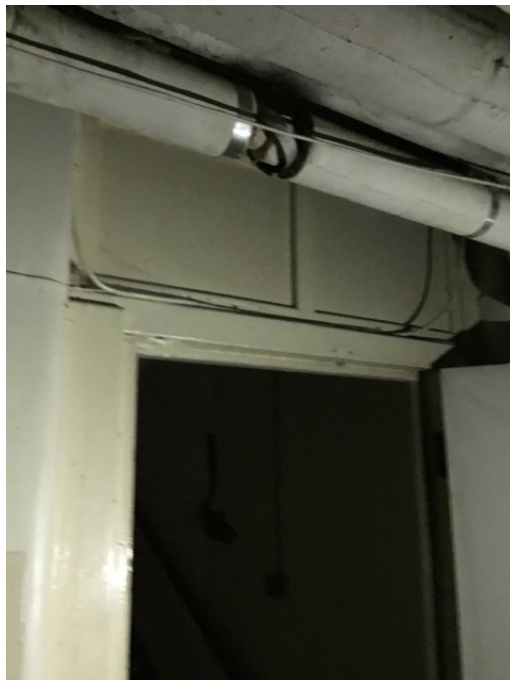
Lead Surveyor	Colin Bliss
Date of Survey	20/09/2017
Date of Next Re-inspection	
Item Description	Painted glass headers to doors
Level of Identification	
Location Name	15 / Room / Basement
Sample No	
Product Type	
Extent of Damage	
Surface Treatment	
Asbestos Type	Not Applicable
Amount / Extent	
Accessibility	
Algorithm Score	0
<b>RECOMMENDATION</b>	Negative Sample - No Recommendation Required

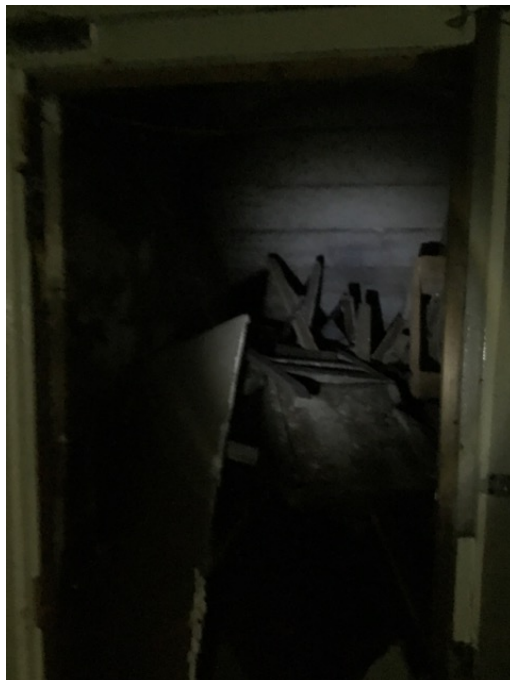
Limited access.

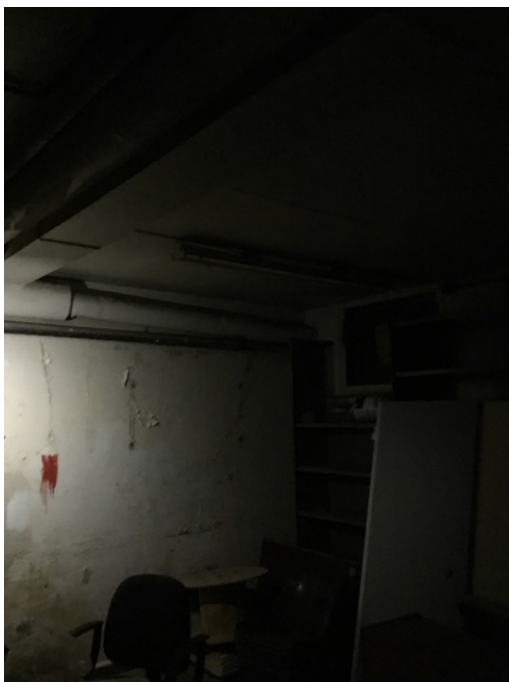
Fibreglass lagged pipework.

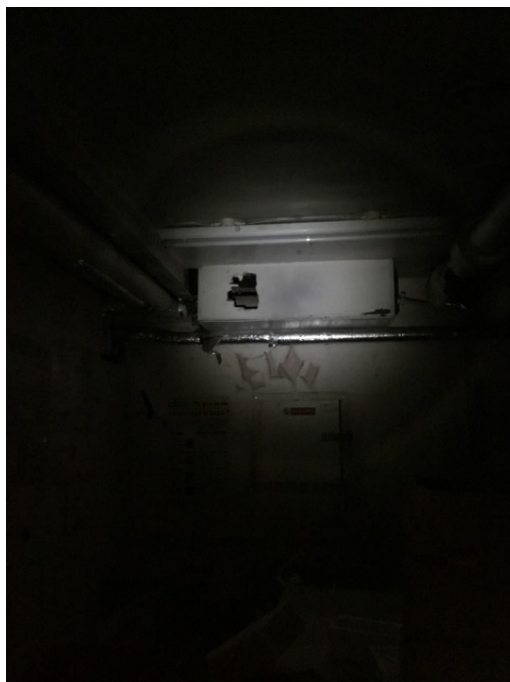
Thermal insulation to pipework

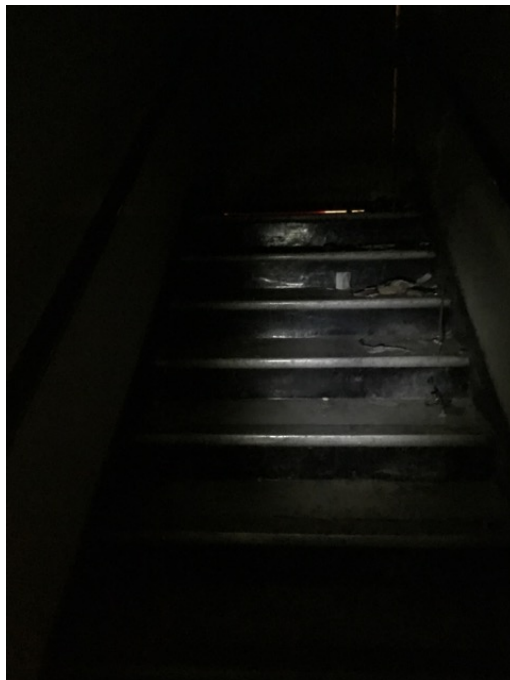
Lead Surveyor	Colin Bliss
Date of Survey	20/09/2017
Date of Next Re-inspection	
Item Description	Modern Lino and stair nosing
Level of Identification	
Location Name	16 / Changing room area / Basement
Sample No	
Product Type	
Extent of Damage	
Surface Treatment	
Asbestos Type	Not Applicable
Amount / Extent	
Accessibility	
Algorithm Score	0
<b>RECOMMENDATION</b>	Negative Sample - No Recommendation Required

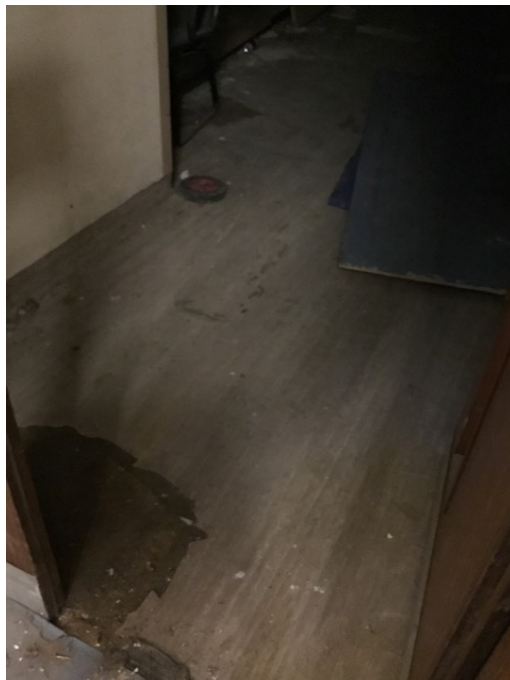
Lead Surveyor	Colin Bliss
Date of Survey	20/09/2017
Date of Next Re-inspection	
Item Description	Brown Lino to floor
Level of Identification	Sampled
Location Name	17 / Basement reception and bunkers / Basement
Sample No	23
Product Type	Vinyl & Vinyl Floor Tiles
Extent of Damage	
Surface Treatment	
Asbestos Type	NADIS - No Asbestos Detected in Sample
Amount / Extent	
Accessibility	
Algorithm Score	0
<b>RECOMMENDATION</b>	Negative Sample - No Recommendation Required

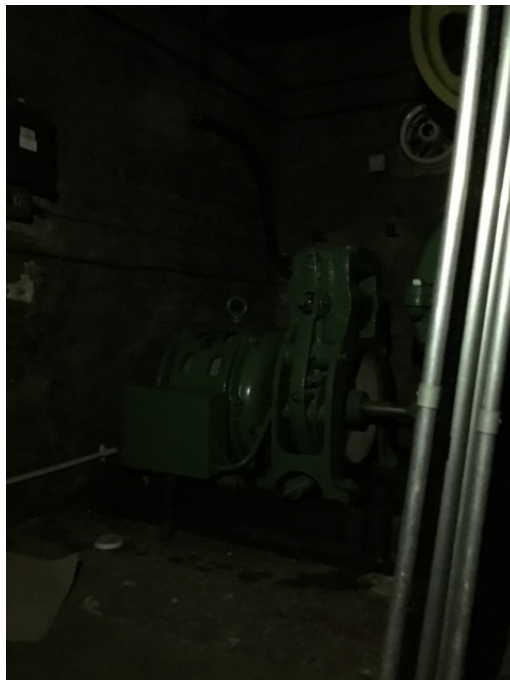
Presumed cement brake shoes

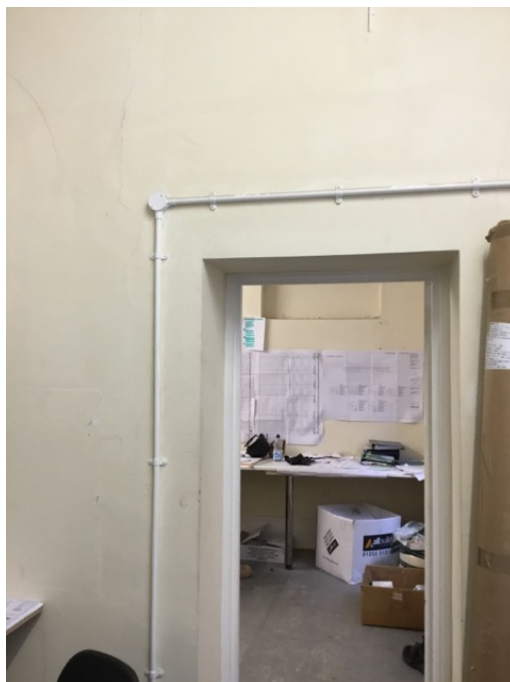
Lead Surveyor	Colin Bliss
Date of Survey	20/09/2017
Date of Next Re-inspection	
Item Description	Visual inspection of offices
Level of Identification	
Location Name	19 / Offices / Ground
Sample No	
Product Type	
Extent of Damage	
Surface Treatment	
Asbestos Type	Not Applicable
Amount / Extent	
Accessibility	
Algorithm Score	0
<b>RECOMMENDATION</b>	Negative Sample - No Recommendation Required

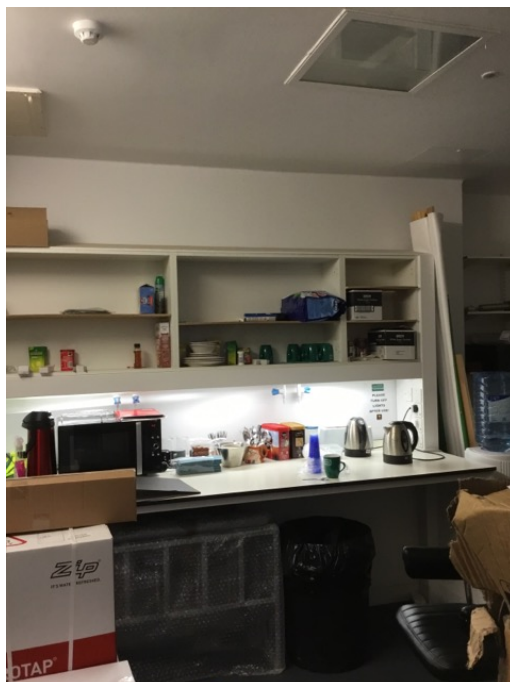
Lead Surveyor	Colin Bliss
Date of Survey	20/09/2017
Date of Next Re-inspection	
Item Description	Visual inspection into converted kitchen
Level of Identification	
Location Name	19 / Offices / Ground
Sample No	
Product Type	
Extent of Damage	
Surface Treatment	
Asbestos Type	Not Applicable
Amount / Extent	
Accessibility	
Algorithm Score	0
<b>RECOMMENDATION</b>	Negative Sample - No Recommendation Required

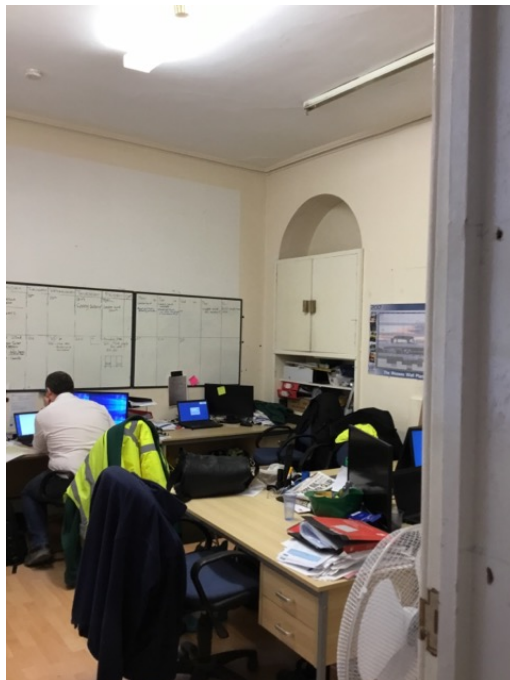
Lead Surveyor	Colin Bliss
Date of Survey	20/09/2017
Date of Next Re-inspection	
Item Description	Visual inspection of office
Level of Identification	
Location Name	19 / Offices / Ground
Sample No	
Product Type	
Extent of Damage	
Surface Treatment	
Asbestos Type	Not Applicable
Amount / Extent	
Accessibility	
Algorithm Score	0
<b>RECOMMENDATION</b>	Negative Sample - No Recommendation Required

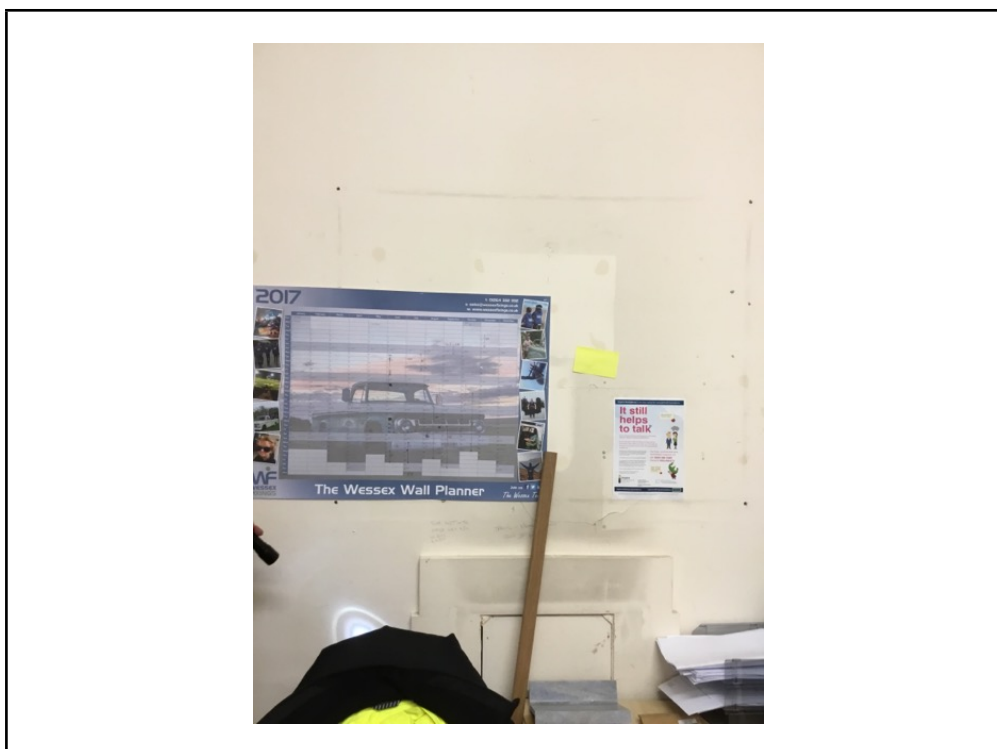
Lead Surveyor	Colin Bliss
Date of Survey	20/09/2017
Date of Next Re-inspection	20/09/2018
Item Description	No access into chimney
Level of Identification	Presumed
Location Name	19 / Offices / Ground
Sample No	
Product Type	
Extent of Damage	
Surface Treatment	
Asbestos Type	Not Applicable
Amount / Extent	
Accessibility	
Algorithm Score	12
<b>RECOMMENDATION</b>	No Access - Inspection Required

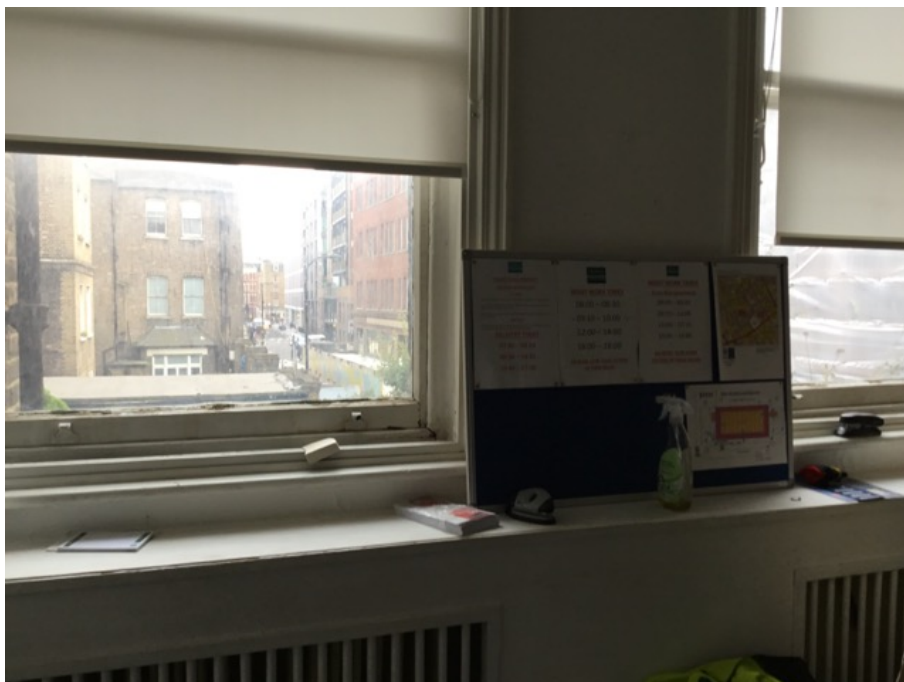
Lead Surveyor	Colin Bliss
Date of Survey	20/09/2017
Date of Next Re-inspection	20/09/2018
Item Description	Panel to radiator boxing
Level of Identification	Sampled
Location Name	20 / Offices / First
Sample No	26
Product Type	Insulating board
Extent of Damage	Low Damage
Surface Treatment	AIB Exposed Face Encapsulated
Asbestos Type	Chrysotile
Amount / Extent	4 LM
Accessibility	Unlikely Disturbance/Usually Inaccessible
Algorithm Score	3
<b>RECOMMENDATION</b>	Remove by Licensed Asbestos Contractor

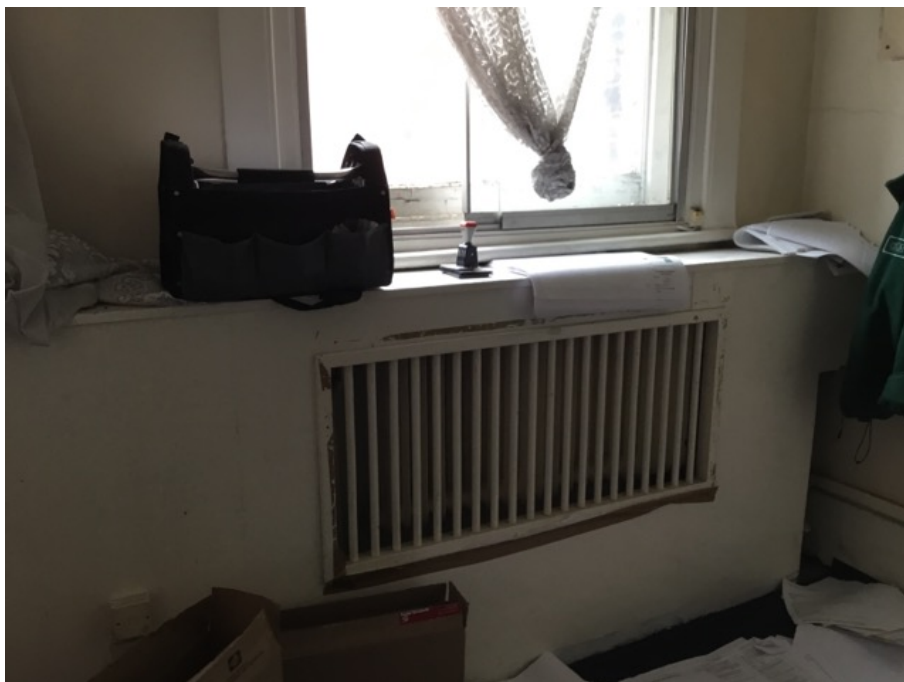
Lead Surveyor	Colin Bliss
Date of Survey	20/09/2017
Date of Next Re-inspection	20/09/2018
Item Description	Insulating board under radiator boxing
Level of Identification	Strongly Presumed
Location Name	21 / Corridor / Second
Sample No	
Product Type	Insulating board
Extent of Damage	Medium Damage
Surface Treatment	Unsealed board
Asbestos Type	Amosite / Chrysotile
Amount / Extent	
Accessibility	Unlikely Disturbance/Usually Inaccessible
Algorithm Score	4
<b>RECOMMENDATION</b>	Remove by Licensed Asbestos Contractor

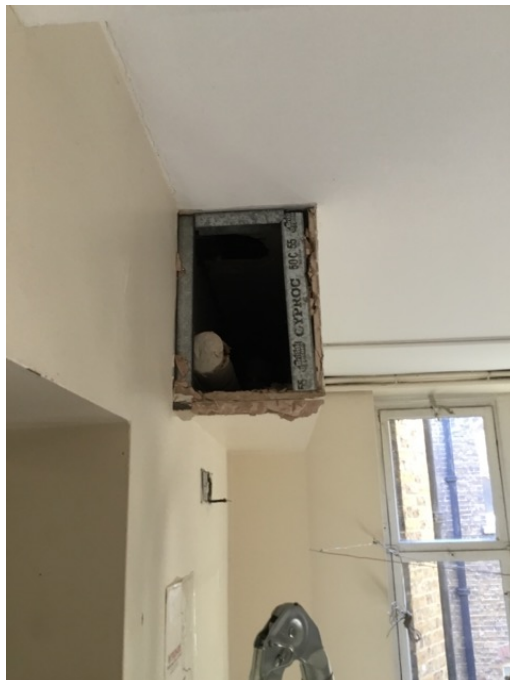
Lead Surveyor	Colin Bliss
Date of Survey	20/09/2017
Date of Next Re-inspection	
Item Description	Fibreglass lagged pipework within boxing
Level of Identification	
Location Name	10 / Section 6 / Second
Sample No	
Product Type	
Extent of Damage	
Surface Treatment	
Asbestos Type	Not Applicable
Amount / Extent	
Accessibility	
Algorithm Score	0
<b>RECOMMENDATION</b>	Negative Sample - No Recommendation Required

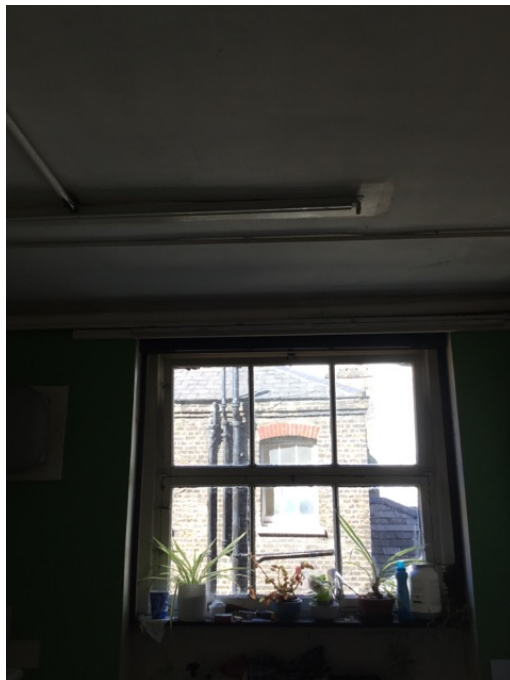
Lead Surveyor	Colin Bliss
Date of Survey	20/09/2017
Date of Next Re-inspection	
Item Description	Foam lagged high level pipework in kitchen
Level of Identification	
Location Name	10 / Section 6 / Second
Sample No	
Product Type	
Extent of Damage	
Surface Treatment	
Asbestos Type	Not Applicable
Amount / Extent	
Accessibility	
Algorithm Score	0
<b>RECOMMENDATION</b>	Negative Sample - No Recommendation Required

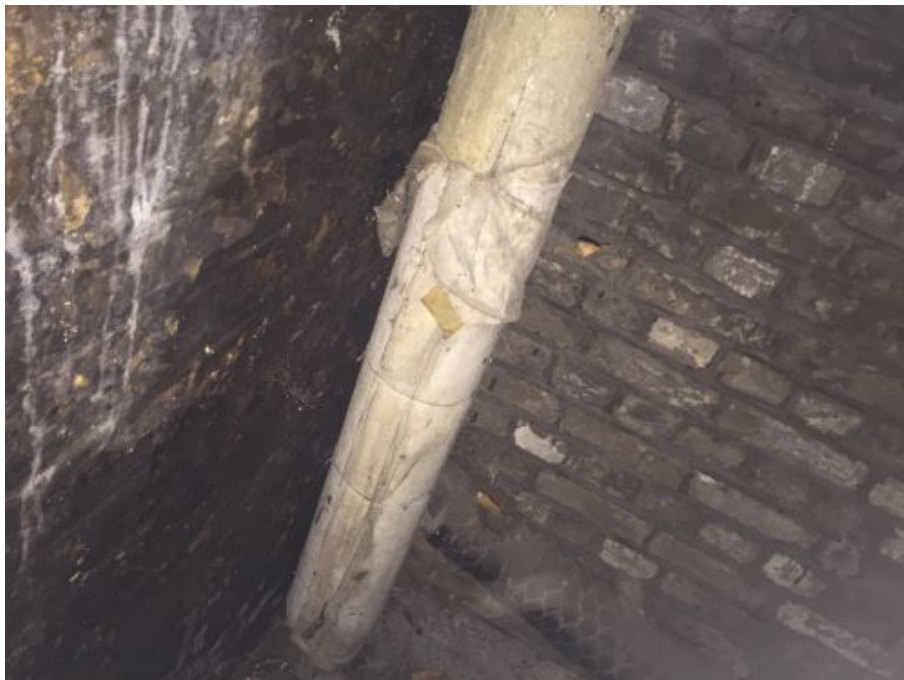
Thermal insulation to pipework and debris to floor / residue to walls

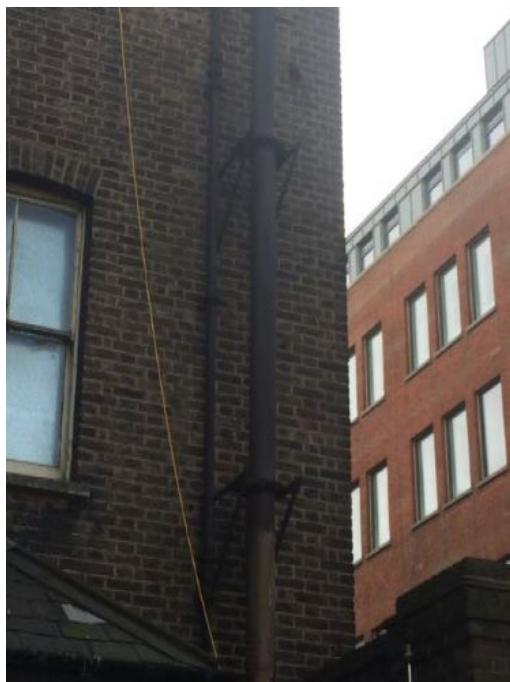
Gaskets to valves on pipework internal and external

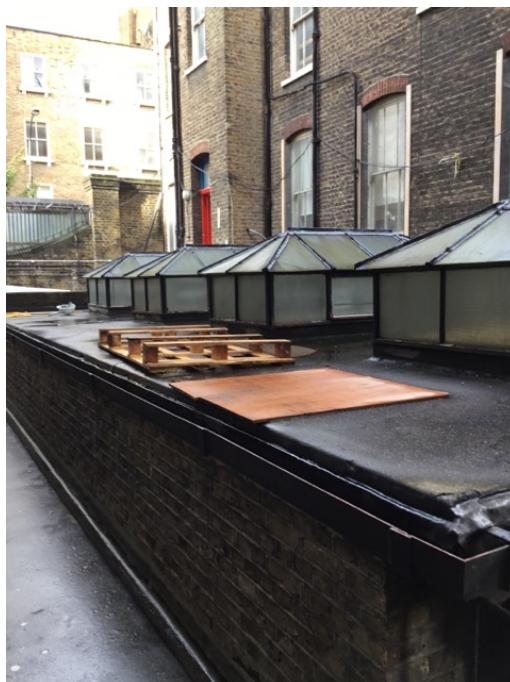
Textile rope to skylights

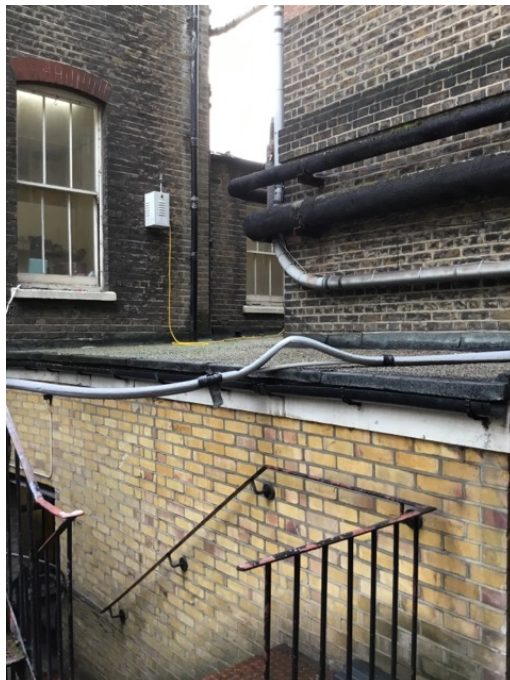
Lead Surveyor	Colin Bliss
Date of Survey	20/09/2017
Date of Next Re-inspection	
Item Description	Bitumen felt to roof by door to Reach offices
Level of Identification	Sampled
Location Name	/ External /
Sample No	29
Product Type	Bitumen & Roofing Felts
Extent of Damage	
Surface Treatment	
Asbestos Type	NADIS - No Asbestos Detected in Sample
Amount / Extent	
Accessibility	
Algorithm Score	0
<b>RECOMMENDATION</b>	Negative Sample - No Recommendation Required

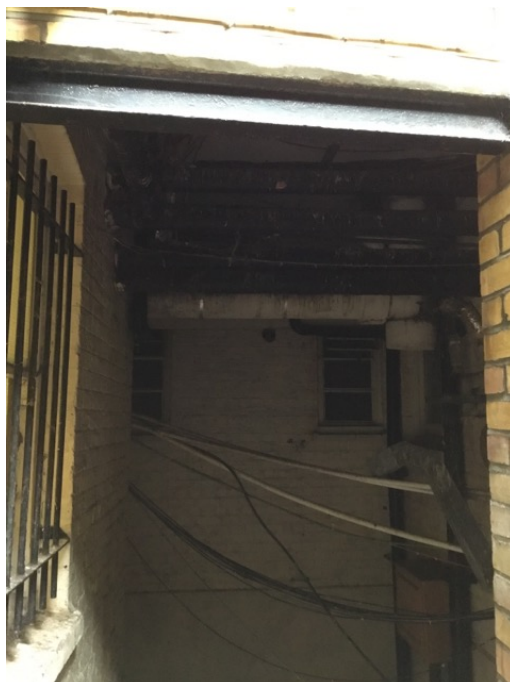
Lagging pipework is linked to the pipework in the basement of Annex building
