**REFURBISHMENT / DEMOLITION**  
**ASBESTOS SURVEY REPORT**

**Middlesex Hospital  
Cleveland Street  
London  
W1T4DR**

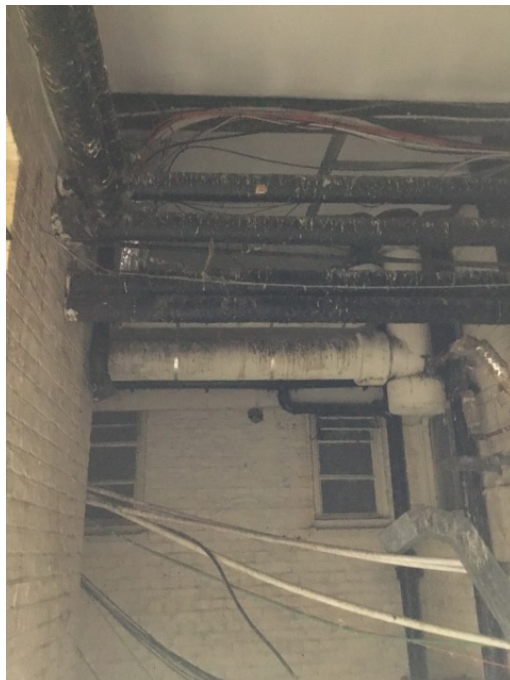
Non asbestos boarding

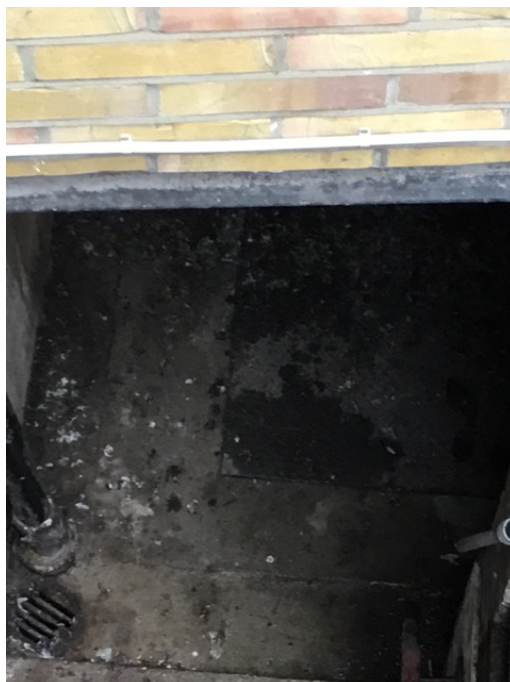
Limited access where the north building meets the Annex due to rat and pigeon excrements.

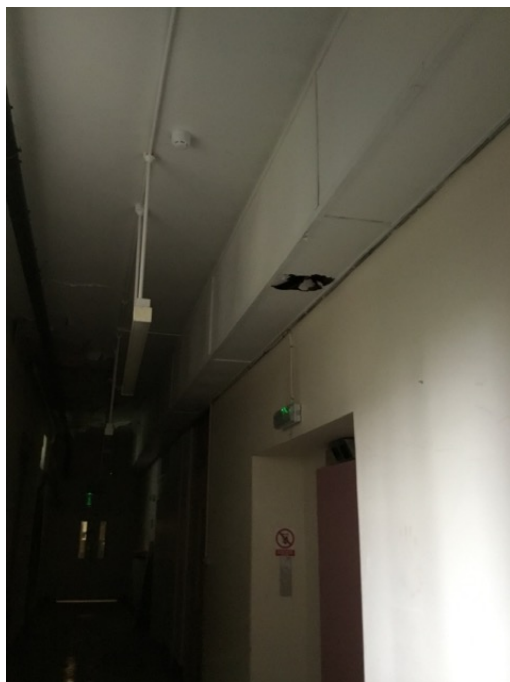
Lagging within high level boxing

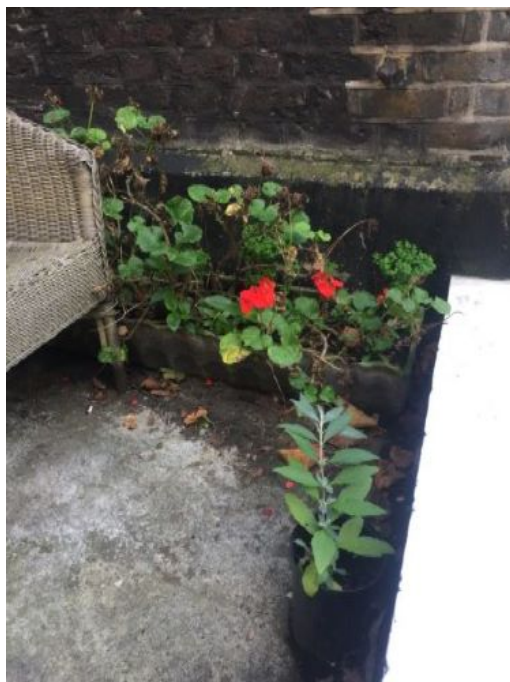
Cement plant holder
