**REFURBISHMENT / DEMOLITION**  
**ASBESTOS SURVEY REPORT**

**Middlesex Hospital  
Cleveland Street  
London  
W1T4DR**

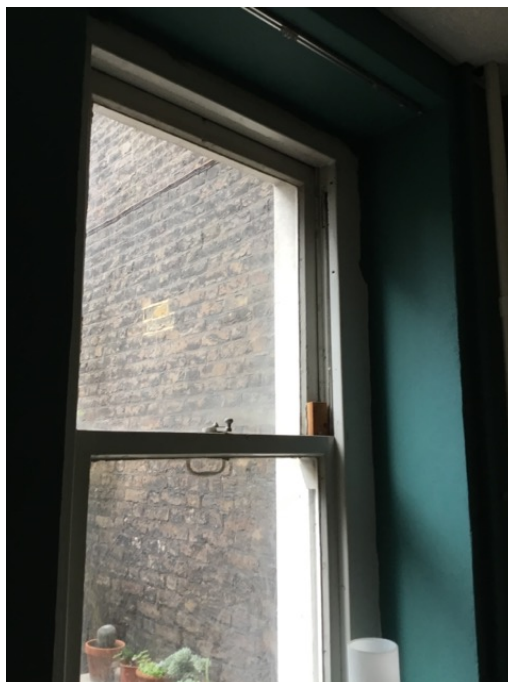
Lead Surveyor	Colin Bliss
Date of Survey	20/09/2017
Date of Next Re-inspection	
Item Description	Sash cord to window
Level of Identification	Sampled
Location Name	1 / Main reception / Ground
Sample No	01
Product Type	Textiles, Rope, Gaskets
Extent of Damage	
Surface Treatment	
Asbestos Type	NADIS - No Asbestos Detected in Sample
Amount / Extent	
Accessibility	
Algorithm Score	0
<b>RECOMMENDATION</b>	Negative Sample - No Recommendation Required

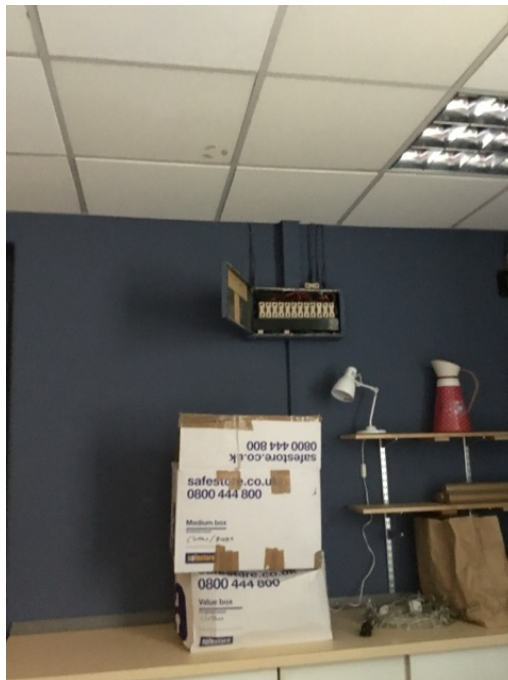
Lead Surveyor	Colin Bliss
Date of Survey	20/09/2017
Date of Next Re-inspection	20/09/2018
Item Description	Flash guards
Level of Identification	Presumed
Location Name	1 / Main reception / Ground
Sample No	
Product Type	Textiles, Rope, Gaskets
Extent of Damage	Good Condition
Surface Treatment	Unsealed Textiles
Asbestos Type	Chrysotile
Amount / Extent	10 No
Accessibility	Unlikely Disturbance/Usually Inaccessible
Algorithm Score	12
<b>RECOMMENDATION</b>	No Access - Inspection Required

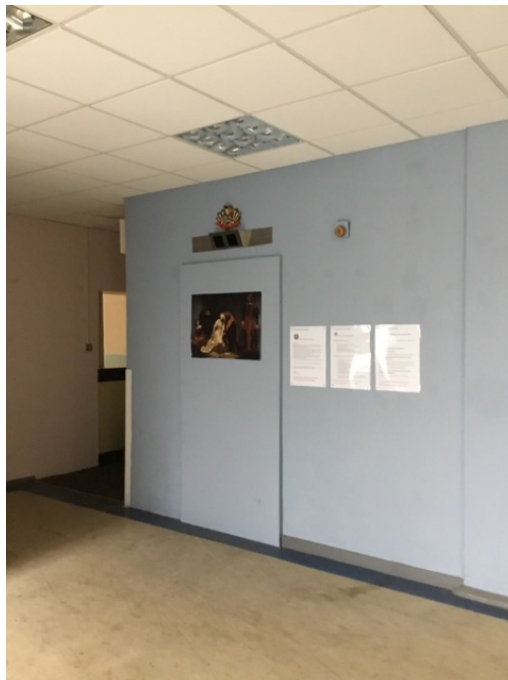
Lead Surveyor	Colin Bliss
Date of Survey	20/09/2017
Date of Next Re-inspection	20/09/2018
Item Description	Limited access to lift shaft
Level of Identification	Presumed
Location Name	1 / Main reception / Ground
Sample No	
Product Type	
Extent of Damage	
Surface Treatment	
Asbestos Type	Not Applicable
Amount / Extent	
Accessibility	
Algorithm Score	12
<b>RECOMMENDATION</b>	No Recommendation Required

Shafts have been viewed from the doors only, not the full shaft

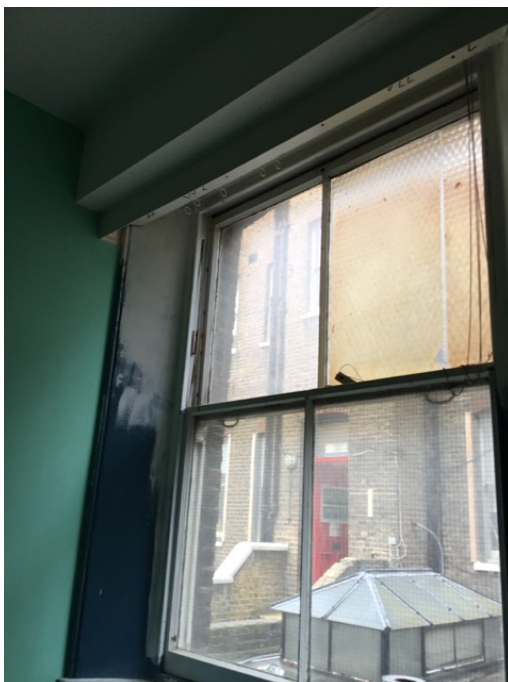
Lead Surveyor	Colin Bliss
Date of Survey	20/09/2017
Date of Next Re-inspection	
Item Description	Sash cord to window
Level of Identification	Strongly Presumed
Location Name	2 / Offices / Ground
Sample No	01
Product Type	Textiles, Rope, Gaskets
Extent of Damage	
Surface Treatment	
Asbestos Type	NADIS - No Asbestos Detected in Sample
Amount / Extent	
Accessibility	
Algorithm Score	0
<b>RECOMMENDATION</b>	Negative Sample - No Recommendation Required

Plaster onto masonry ceiling. Plaster onto masonry walls. Timber flooring.  
Timber doors, window frames and sill.

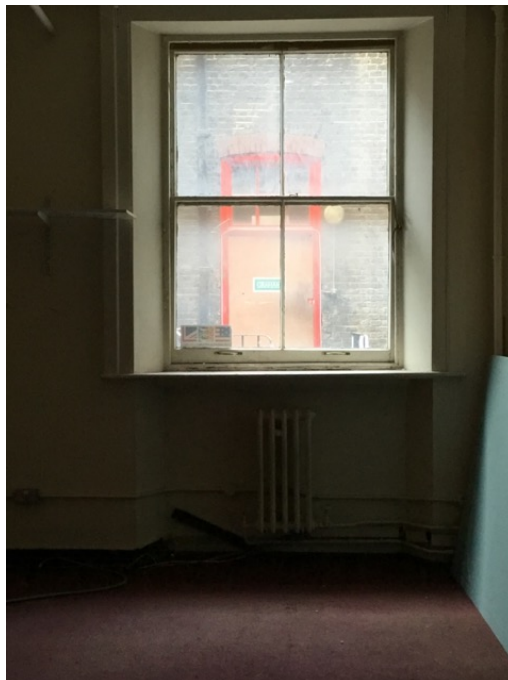
Lead Surveyor	Colin Bliss
Date of Survey	20/09/2017
Date of Next Re-inspection	
Item Description	Sash cord to window
Level of Identification	Strongly Presumed
Location Name	3 / Transport office / Ground
Sample No	01
Product Type	Textiles, Rope, Gaskets
Extent of Damage	
Surface Treatment	
Asbestos Type	NADIS - No Asbestos Detected in Sample
Amount / Extent	
Accessibility	
Algorithm Score	0
<b>RECOMMENDATION</b>	Negative Sample - No Recommendation Required

Plaster onto masonry ceiling. Plaster onto masonry walls. Timber flooring.  
Timber doors, window frames and sill.

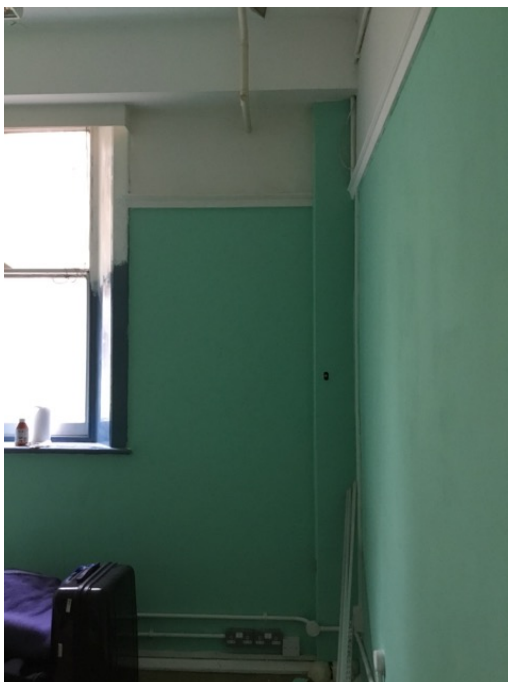
Lead Surveyor	Colin Bliss
Date of Survey	20/09/2017
Date of Next Re-inspection	
Item Description	Boxing
Level of Identification	
Location Name	3 / Transport office / Ground
Sample No	
Product Type	
Extent of Damage	
Surface Treatment	
Asbestos Type	Not Applicable
Amount / Extent	
Accessibility	
Algorithm Score	0
<b>RECOMMENDATION</b>	Negative Sample - No Recommendation Required

Plyboard boxing housing metal pipework

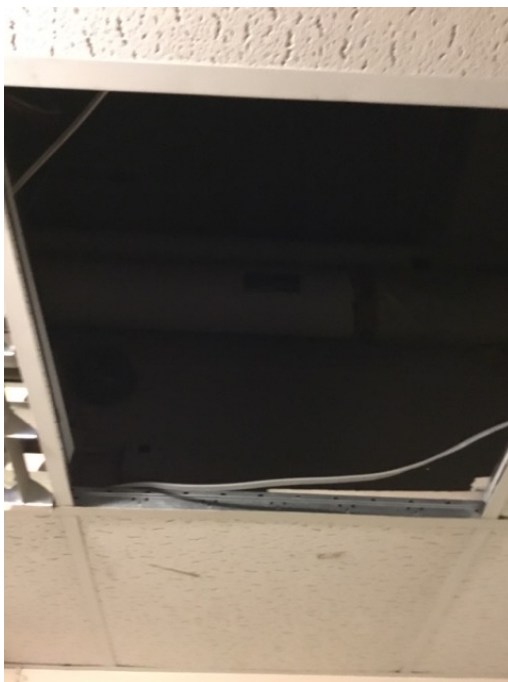
Lead Surveyor	Colin Bliss
Date of Survey	20/09/2017
Date of Next Re-inspection	20/09/2018
Item Description	Thermal insulation to pipework
Level of Identification	Sampled
Location Name	4 / Corridor / Ground
Sample No	02
Product Type	Lagging
Extent of Damage	Good Condition
Surface Treatment	Encapsulated Lagging & Spray
Asbestos Type	Amosite
Amount / Extent	6 LM
Accessibility	Unlikely Disturbance/Usually Inaccessible
Algorithm Score	4
<b>RECOMMENDATION</b>	Remove by Licensed Asbestos Contractor

In both corridors. It is unclear where this pipe is coming from or going presume within the fabrication of the building.

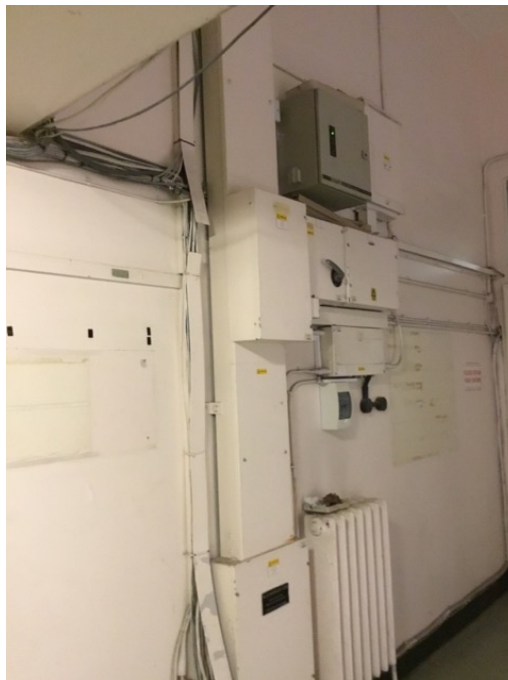
Lead Surveyor	Colin Bliss
Date of Survey	20/09/2017
Date of Next Re-inspection	20/09/2018
Item Description	Fuse Box
Level of Identification	Presumed
Location Name	4 / Corridor / Ground
Sample No	
Product Type	Textiles, Rope, Gaskets
Extent of Damage	Good Condition
Surface Treatment	Sealed Textiles
Asbestos Type	Chrysotile
Amount / Extent	5
Accessibility	Unlikely Disturbance/Usually Inaccessible
Algorithm Score	12
<b>RECOMMENDATION</b>	No Access - Inspection Required

Presumed textile to fuse boxes

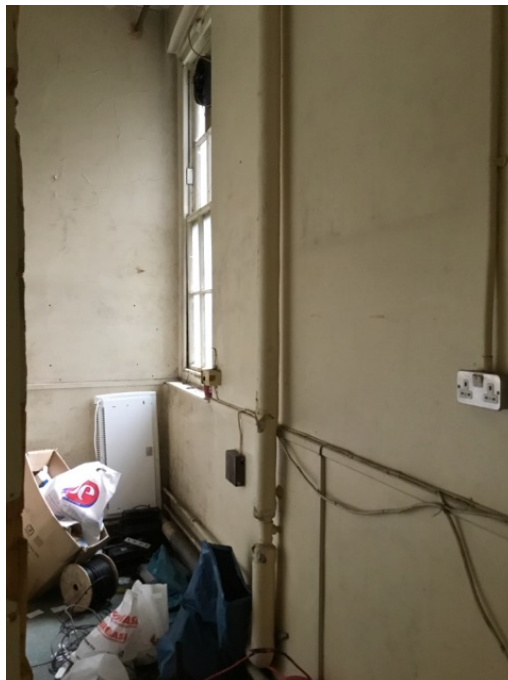
Lead Surveyor	Colin Bliss
Date of Survey	20/09/2017
Date of Next Re-inspection	20/09/2018
Item Description	Thermal insulation to pipework
Level of Identification	Sampled
Location Name	5 / Section 1 / Ground
Sample No	05
Product Type	Lagging
Extent of Damage	Medium Damage
Surface Treatment	Encapsulated Lagging & Spray
Asbestos Type	Amosite / Chrysotile
Amount / Extent	10 LM
Accessibility	Occasional Disturbance
Algorithm Score	6
<b>RECOMMENDATION</b>	Remove by Licensed Asbestos Contractor

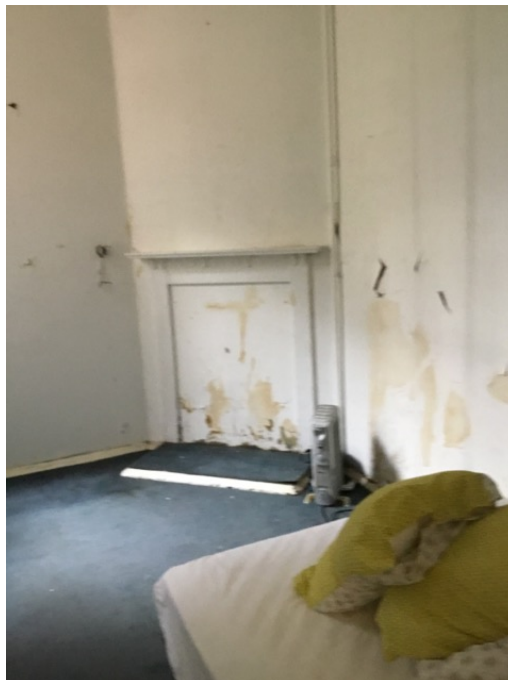
Lead Surveyor	Colin Bliss
Date of Survey	20/09/2017
Date of Next Re-inspection	
Item Description	Fireplace
Level of Identification	
Location Name	5 / Section 1 / Ground
Sample No	
Product Type	
Extent of Damage	
Surface Treatment	
Asbestos Type	Not Applicable
Amount / Extent	
Accessibility	
Algorithm Score	0
<b>RECOMMENDATION</b>	Negative Sample - No Recommendation Required

Bricked up fireplace

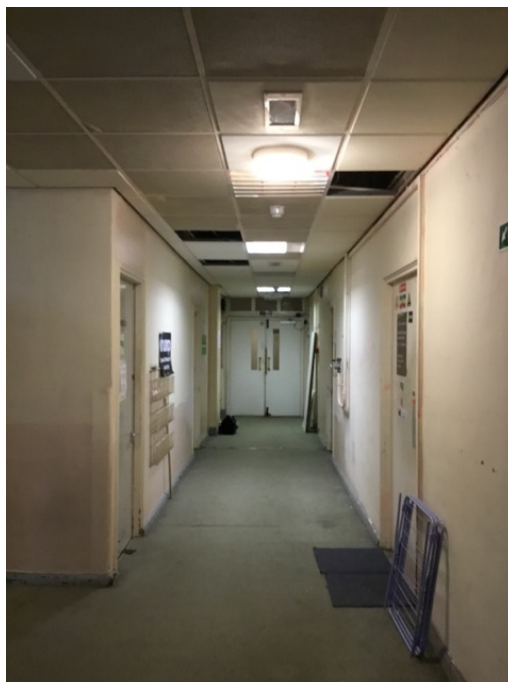
Lead Surveyor	Colin Bliss
Date of Survey	20/09/2017
Date of Next Re-inspection	
Item Description	Section 1
Level of Identification	
Location Name	5 / Section 1 / Ground
Sample No	
Product Type	
Extent of Damage	
Surface Treatment	
Asbestos Type	Not Applicable
Amount / Extent	
Accessibility	
Algorithm Score	0
<b>RECOMMENDATION</b>	Negative Sample - No Recommendation Required

Supalux panels upstands to MMMF suspended ceiling with plaster onto concrete ceiling. Sash cords to windows.

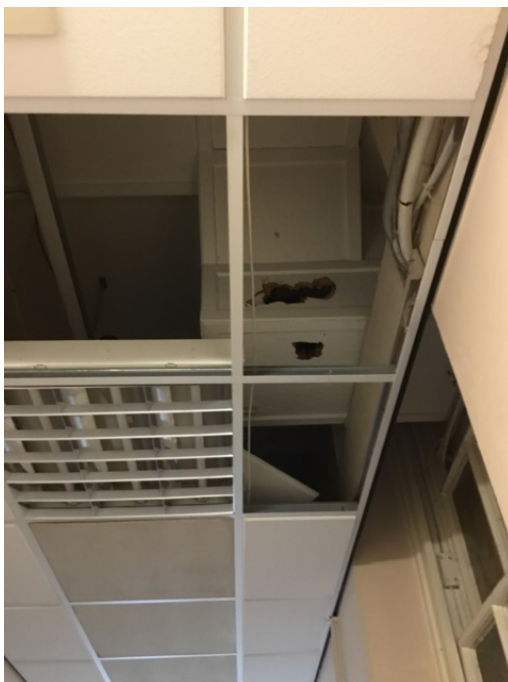
Lead Surveyor	Colin Bliss
Date of Survey	20/09/2017
Date of Next Re-inspection	
Item Description	Boxing within ceiling void
Level of Identification	
Location Name	5 / Section 1 / Ground
Sample No	
Product Type	
Extent of Damage	
Surface Treatment	
Asbestos Type	Not Applicable
Amount / Extent	
Accessibility	
Algorithm Score	0
<b>RECOMMENDATION</b>	Negative Sample - No Recommendation Required

Fibreboard boxing. Limited access within boxing.

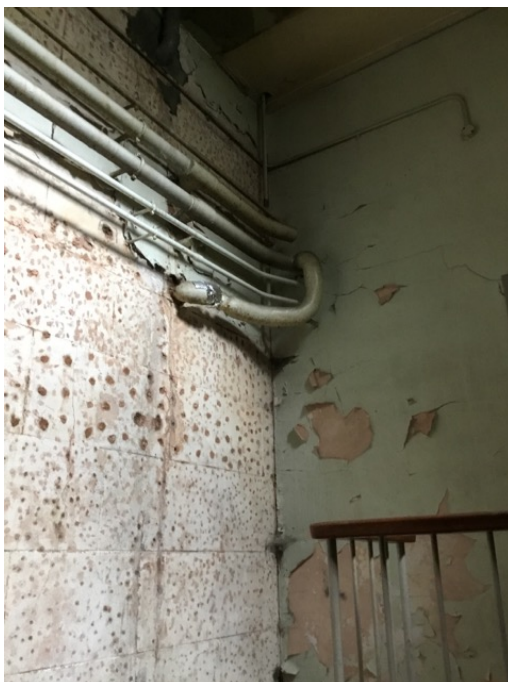
Lead Surveyor	Colin Bliss
Date of Survey	20/09/2017
Date of Next Re-inspection	20/09/2018
Item Description	Thermal insulation to pipework
Level of Identification	Strongly Presumed
Location Name	6 / Section 2 / Ground
Sample No	05
Product Type	Lagging
Extent of Damage	Medium Damage
Surface Treatment	Encapsulated Lagging & Spray
Asbestos Type	Amosite / Chrysotile
Amount / Extent	2 LM
Accessibility	Occasional Disturbance
Algorithm Score	6
<b>RECOMMENDATION</b>	Remove by Licensed Asbestos Contractor

Lagging appears to be running within the structure of the building.

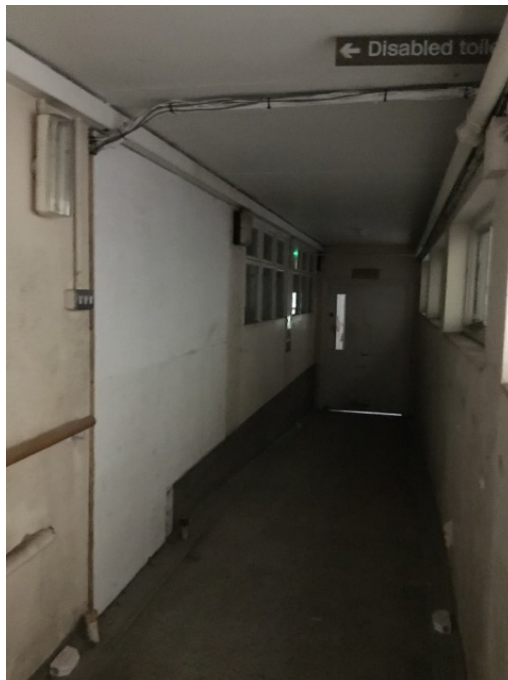
Lead Surveyor	Colin Bliss
Date of Survey	20/09/2017
Date of Next Re-inspection	
Item Description	Timber panel to windows within corridor
Level of Identification	
Location Name	6 / Section 2 / Ground
Sample No	
Product Type	
Extent of Damage	
Surface Treatment	
Asbestos Type	Not Applicable
Amount / Extent	
Accessibility	
Algorithm Score	0
<b>RECOMMENDATION</b>	Negative Sample - No Recommendation Required

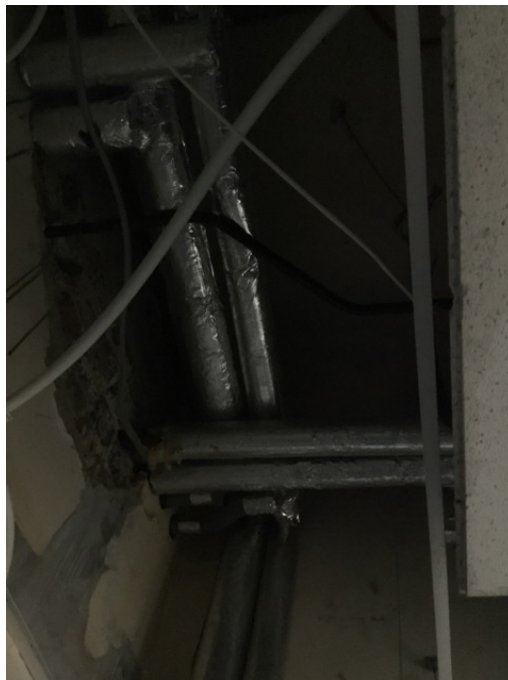
Lead Surveyor	Colin Bliss
Date of Survey	20/09/2017
Date of Next Re-inspection	
Item Description	Visual inspection of Section 3
Level of Identification	
Location Name	7 / Section 3 / First
Sample No	
Product Type	
Extent of Damage	
Surface Treatment	
Asbestos Type	NADIS - No Asbestos Detected in Sample
Amount / Extent	
Accessibility	
Algorithm Score	0
<b>RECOMMENDATION</b>	Negative Sample - No Recommendation Required

MMMF suspended ceiling opening to plasterboard ceiling. No access above plasterboard ceilings throughout this section. Some areas shows timber above plasterboard ceiling. Fibreglass lagged pipework within ceiling void.

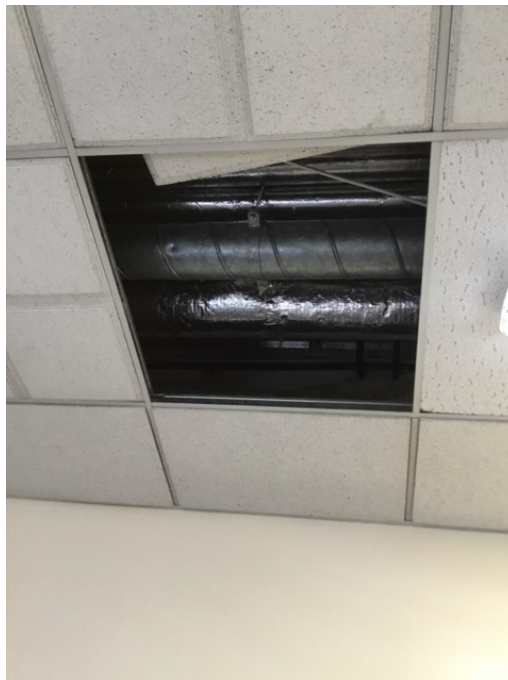
Lead Surveyor	Colin Bliss
Date of Survey	20/09/2017
Date of Next Re-inspection	
Item Description	Visual inspection of Section 4
Level of Identification	
Location Name	8 / Section 4 / First
Sample No	
Product Type	
Extent of Damage	
Surface Treatment	
Asbestos Type	Not Applicable
Amount / Extent	
Accessibility	
Algorithm Score	0
<b>RECOMMENDATION</b>	Negative Sample - No Recommendation Required

MMMF suspended ceiling opening to plasterboard ceiling. No access above plasterboard ceilings throughout this section. Some areas shows timber above plasterboard ceiling. Fibreglass lagged pipework within ceiling void.

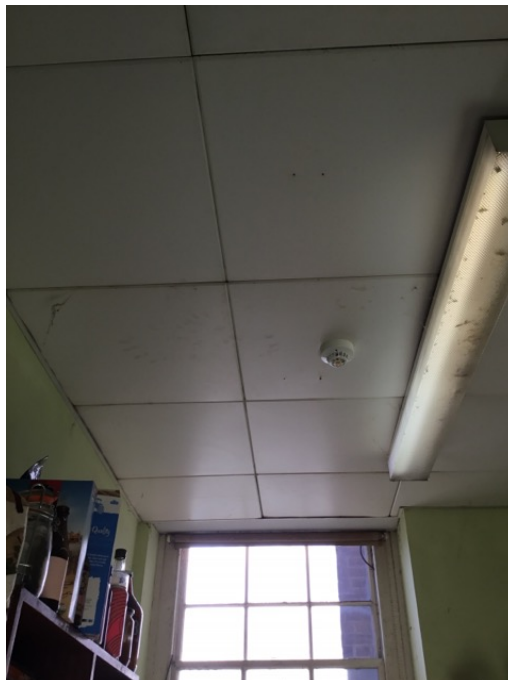
Lead Surveyor	Colin Bliss
Date of Survey	20/09/2017
Date of Next Re-inspection	
Item Description	Metal ceiling panels
Level of Identification	
Location Name	8 / Section 4 / First
Sample No	
Product Type	
Extent of Damage	
Surface Treatment	
Asbestos Type	Not Applicable
Amount / Extent	
Accessibility	
Algorithm Score	0
<b>RECOMMENDATION</b>	Negative Sample - No Recommendation Required

Limited access above metal panels.

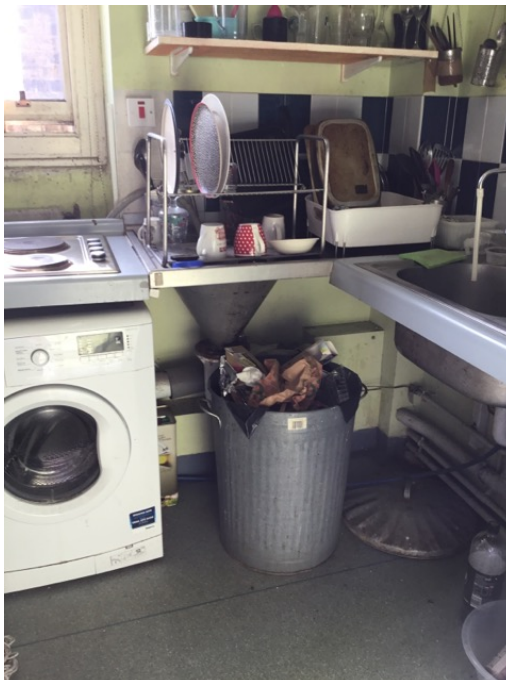
Lead Surveyor	Colin Bliss
Date of Survey	20/09/2017
Date of Next Re-inspection	
Item Description	No access into boxing's
Level of Identification	
Location Name	8 / Section 4 / First
Sample No	
Product Type	
Extent of Damage	
Surface Treatment	
Asbestos Type	Not Applicable
Amount / Extent	
Accessibility	
Algorithm Score	0
<b>RECOMMENDATION</b>	Negative Sample - No Recommendation Required

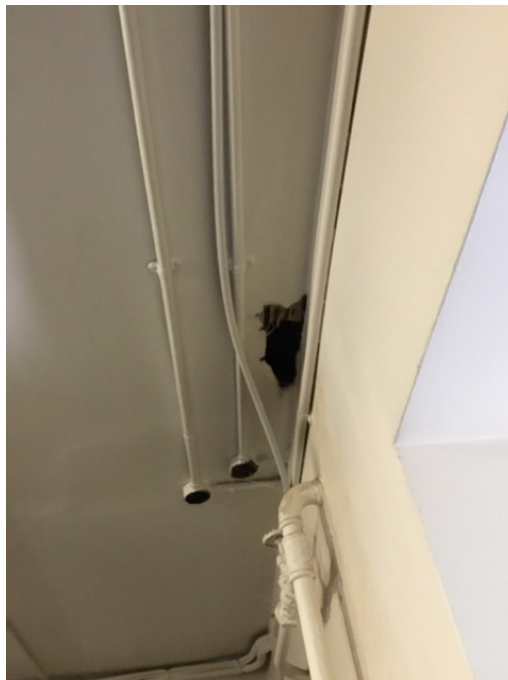
Lead Surveyor	Colin Bliss
Date of Survey	20/09/2017
Date of Next Re-inspection	
Item Description	Section 5 lathe and plaster ceilings
Level of Identification	
Location Name	9 / Section 5 / Second
Sample No	
Product Type	
Extent of Damage	
Surface Treatment	
Asbestos Type	Not Applicable
Amount / Extent	
Accessibility	
Algorithm Score	0
<b>RECOMMENDATION</b>	Negative Sample - No Recommendation Required

MMMF suspended ceiling opening to plasterboard ceiling. No access above plasterboard ceilings throughout this section. Some areas shows lathe and plaster ceiling . Fibreglass lagged pipework within ceiling void.

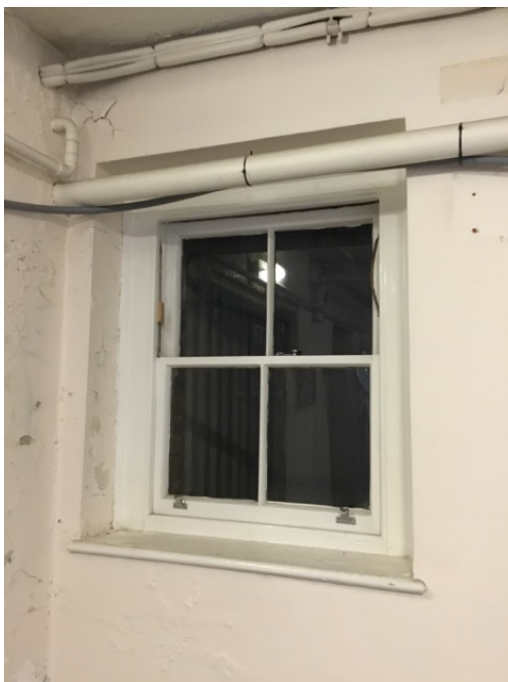
Lead Surveyor	Colin Bliss
Date of Survey	20/09/2017
Date of Next Re-inspection	
Item Description	Sash cord to windows
Level of Identification	Strongly Presumed
Location Name	9 / Section 5 / Second
Sample No	06
Product Type	Textiles, Rope, Gaskets
Extent of Damage	
Surface Treatment	
Asbestos Type	NADIS - No Asbestos Detected in Sample
Amount / Extent	
Accessibility	
Algorithm Score	0
<b>RECOMMENDATION</b>	Negative Sample - No Recommendation Required

To all sash windows throughout.

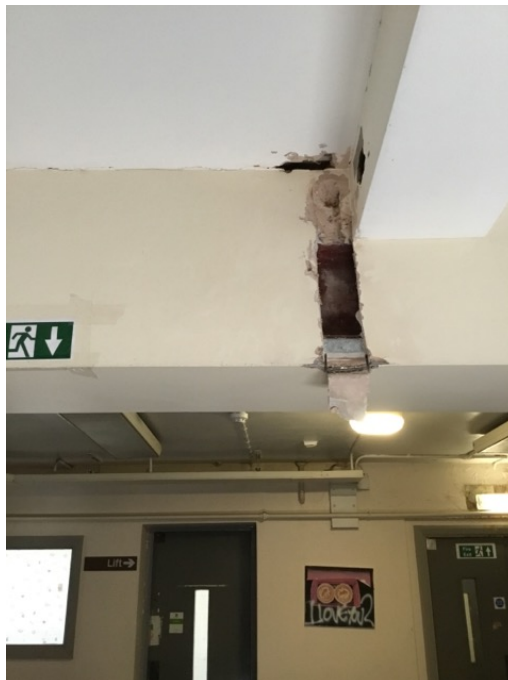
Lead Surveyor	Colin Bliss
Date of Survey	20/09/2017
Date of Next Re-inspection	
Item Description	Metal RSJ within masonry boxing
Level of Identification	
Location Name	9 / Section 5 / Second
Sample No	
Product Type	
Extent of Damage	
Surface Treatment	
Asbestos Type	Not Applicable
Amount / Extent	
Accessibility	
Algorithm Score	0
<b>RECOMMENDATION</b>	Negative Sample - No Recommendation Required

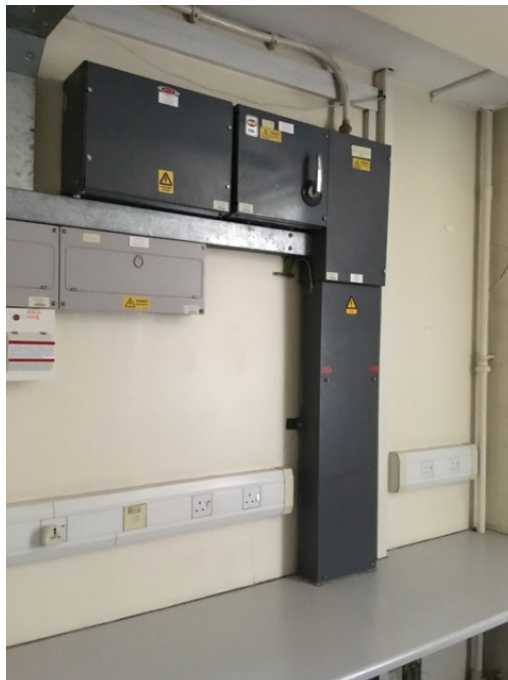
Lead Surveyor	Colin Bliss
Date of Survey	20/09/2017
Date of Next Re-inspection	20/09/2018
Item Description	No access into life electrical fuse boxes throughout
Level of Identification	Presumed
Location Name	9 / Section 5 / Second
Sample No	
Product Type	
Extent of Damage	
Surface Treatment	
Asbestos Type	Chrysotile
Amount / Extent	5 No
Accessibility	
Algorithm Score	12
<b>RECOMMENDATION</b>	No Access - Inspection Required

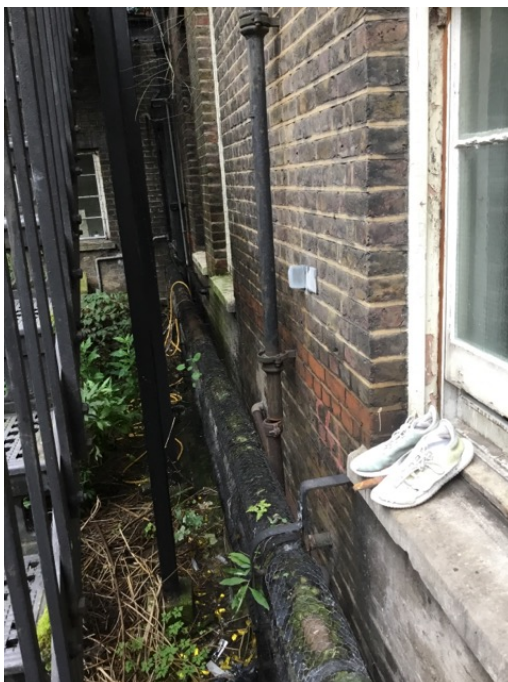
Lead Surveyor	Colin Bliss
Date of Survey	20/09/2017
Date of Next Re-inspection	20/09/2018
Item Description	Lagging
Level of Identification	Crossed Referenced
Location Name	/ External /
Sample No	07
Product Type	Thermal insulation
Extent of Damage	High Damage
Surface Treatment	Enclosed lagging
Asbestos Type	Crocidolite / Chrysotile
Amount / Extent	160 LM
Accessibility	Unlikely Disturbance/Usually Inaccessible
Algorithm Score	6
<b>RECOMMENDATION</b>	Remove by Licensed Asbestos Contractor

Same pipes as s007. Presume lagging is linked to ducting within boiler room.

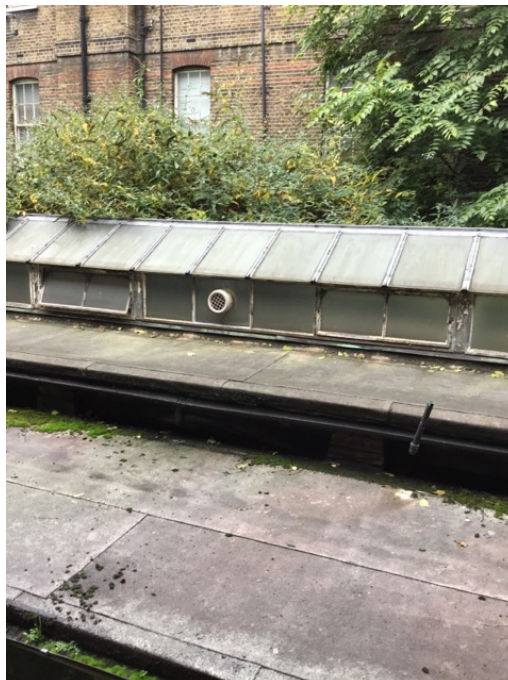
Lead Surveyor	Colin Bliss
Date of Survey	20/09/2017
Date of Next Re-inspection	20/09/2018
Item Description	Skylights
Level of Identification	Sampled
Location Name	/ External /
Sample No	28
Product Type	Textiles, Rope, Gaskets
Extent of Damage	Good Condition
Surface Treatment	Enclosed
Asbestos Type	Chrysotile
Amount / Extent	200 LM
Accessibility	Unlikely Disturbance/Usually Inaccessible
Algorithm Score	3
<b>RECOMMENDATION</b>	Remove by Approved Asbestos Contractor

Textile rope to skylights.

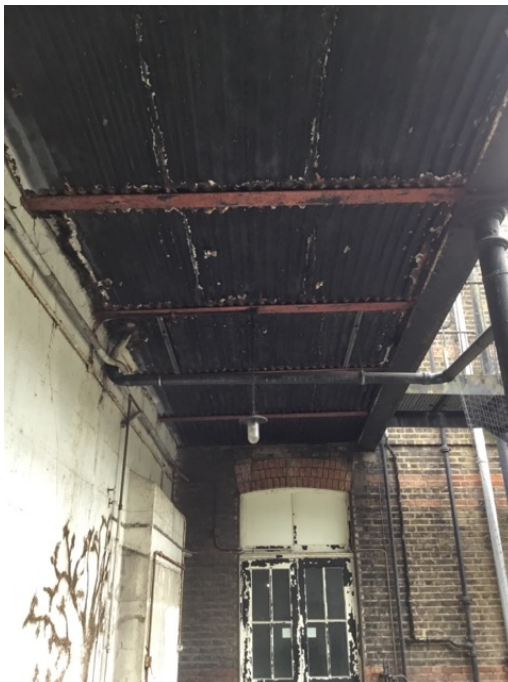
Lead Surveyor	Colin Bliss
Date of Survey	20/09/2017
Date of Next Re-inspection	
Item Description	Zinc roof
Level of Identification	
Location Name	/ External /
Sample No	
Product Type	
Extent of Damage	
Surface Treatment	
Asbestos Type	Not Applicable
Amount / Extent	
Accessibility	
Algorithm Score	0
<b>RECOMMENDATION</b>	Negative Sample - No Recommendation Required

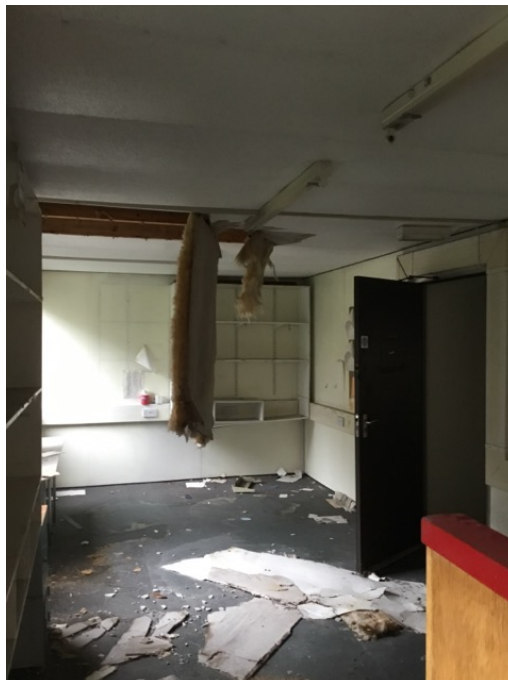
Lead Surveyor	Colin Bliss
Date of Survey	20/09/2017
Date of Next Re-inspection	
Item Description	Visual inspection of Cabin
Level of Identification	
Location Name	0 / Porta Cabin / First
Sample No	
Product Type	
Extent of Damage	
Surface Treatment	
Asbestos Type	Not Applicable
Amount / Extent	
Accessibility	
Algorithm Score	0
<b>RECOMMENDATION</b>	Negative Sample - No Recommendation Required

Fibreglass insulation. Painted decorative finish to ceiling not textured coating.

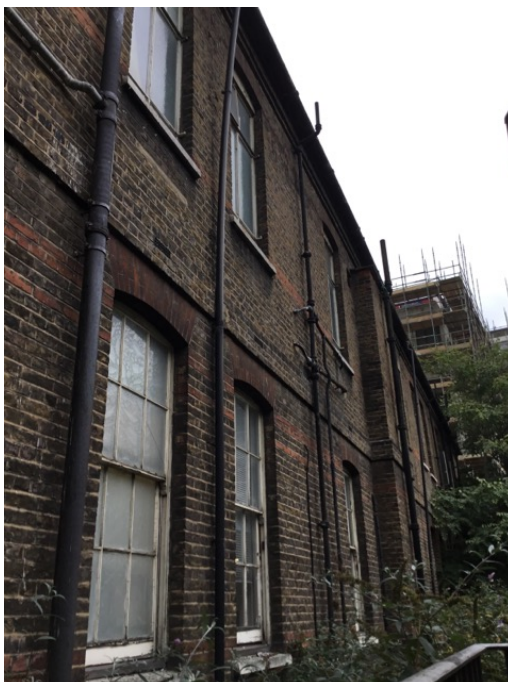
Lead Surveyor	Colin Bliss
Date of Survey	20/09/2017
Date of Next Re-inspection	20/09/2018
Item Description	Cement guttering
Level of Identification	Crossed Referenced
Location Name	/ External /
Sample No	10
Product Type	Cement
Extent of Damage	Good Condition
Surface Treatment	Unsealed Cement
Asbestos Type	Chrysotile
Amount / Extent	200 LM
Accessibility	Unlikely Disturbance/Usually Inaccessible
Algorithm Score	2
<b>RECOMMENDATION</b>	Remove by Licensed Asbestos Contractor

Guttering to both sides of the building.

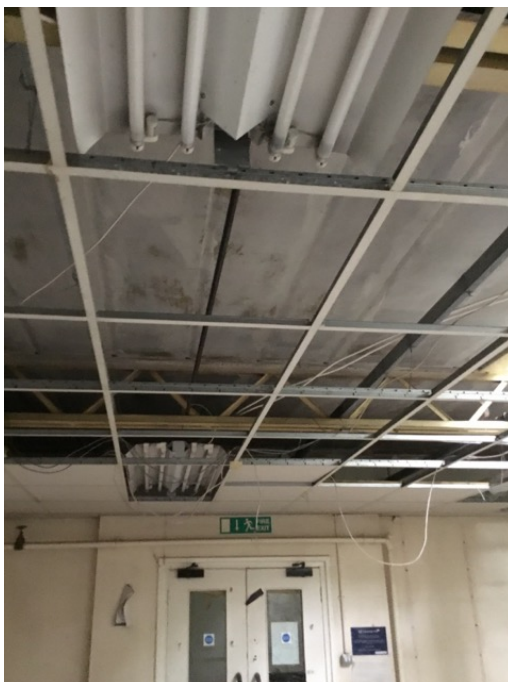
Lead Surveyor	Colin Bliss
Date of Survey	20/09/2017
Date of Next Re-inspection	20/09/2018
Item Description	Cement sheeting to underside of roof
Level of Identification	Sampled
Location Name	5 / Section 1 / Ground
Sample No	11
Product Type	Cement sheeting
Extent of Damage	Good Condition
Surface Treatment	Unsealed Cement
Asbestos Type	Chrysotile
Amount / Extent	250
Accessibility	Unlikely Disturbance/Usually Inaccessible
Algorithm Score	2
<b>RECOMMENDATION</b>	Remove by Licensed Asbestos Contractor

Presume to all flat roof area.

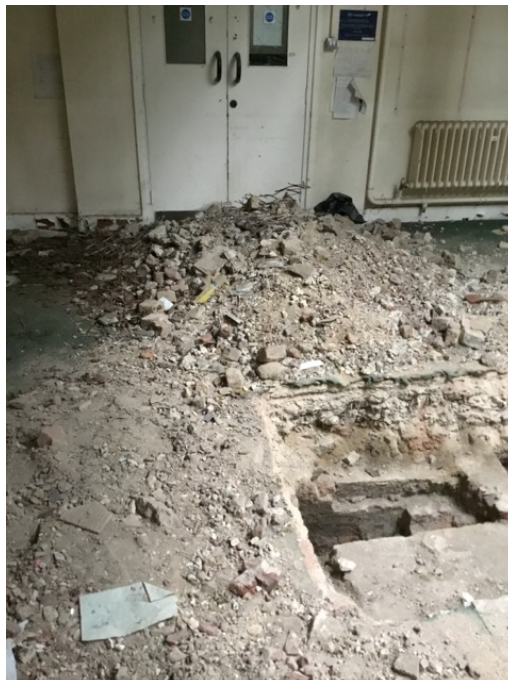
Lead Surveyor	Colin Bliss
Date of Survey	20/09/2017
Date of Next Re-inspection	
Item Description	Cement debris
Level of Identification	Sampled
Location Name	5 / Section 1 / Ground
Sample No	12
Product Type	Cement
Extent of Damage	
Surface Treatment	
Asbestos Type	NADIS - No Asbestos Detected in Sample
Amount / Extent	
Accessibility	
Algorithm Score	0
<b>RECOMMENDATION</b>	Negative Sample - No Recommendation Required

Presume throughout room.

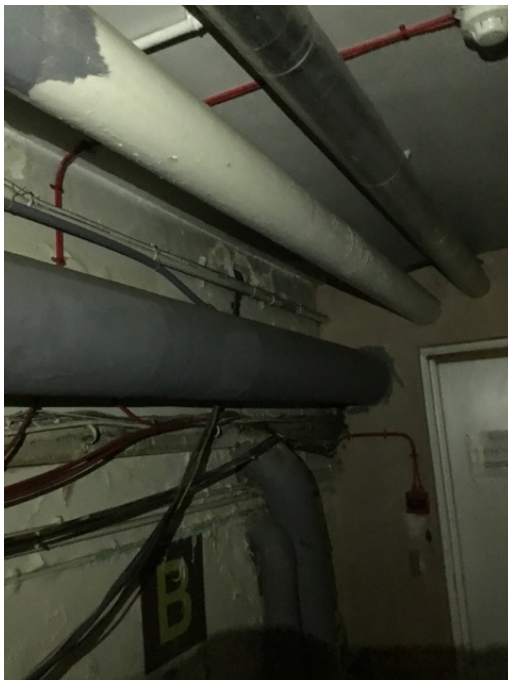
Lead Surveyor	Colin Bliss
Date of Survey	20/09/2017
Date of Next Re-inspection	20/09/2018
Item Description	Lagging debris
Level of Identification	Sampled
Location Name	13 / Corridor / Basement
Sample No	14
Product Type	Thermal Insulation
Extent of Damage	High Damage
Surface Treatment	Unsealed Lagging & Spray
Asbestos Type	Amosite / Chrysotile
Amount / Extent	200 M2
Accessibility	Unlikely Disturbance/Usually Inaccessible
Algorithm Score	11
<b>RECOMMENDATION</b>	Remove by Licensed Asbestos Contractor

To walls and beams.

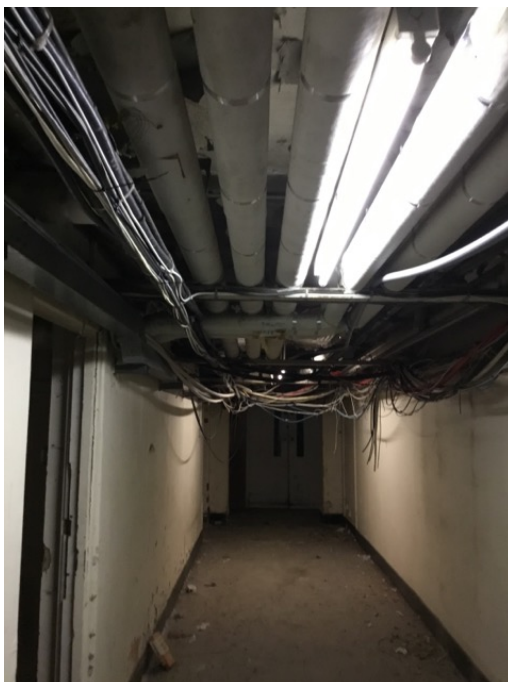
Lead Surveyor	Colin Bliss
Date of Survey	20/09/2017
Date of Next Re-inspection	20/09/2018
Item Description	Pipework
Level of Identification	Sampled
Location Name	13 / Corridor / Basement
Sample No	15
Product Type	Thermal insulation
Extent of Damage	Low Damage
Surface Treatment	Debris & Contamination
Asbestos Type	Amosite
Amount / Extent	300 LM
Accessibility	Unlikely Disturbance/Usually Inaccessible
Algorithm Score	6
<b>RECOMMENDATION</b>	Remove by Licensed Asbestos Contractor

Residue and debris below fibreglass insulation. All pipework Presumed to be contaminated

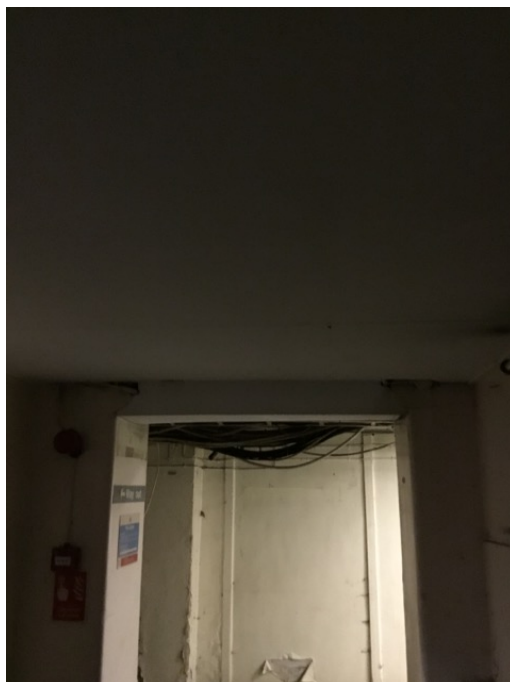
Lead Surveyor	Colin Bliss
Date of Survey	20/09/2017
Date of Next Re-inspection	
Item Description	Ceiling
Level of Identification	Sampled
Location Name	14 / Plant rooms / Basement
Sample No	16
Product Type	Insulating board
Extent of Damage	
Surface Treatment	
Asbestos Type	NADIS - No Asbestos Detected in Sample
Amount / Extent	
Accessibility	
Algorithm Score	0
<b>RECOMMENDATION</b>	Negative Sample - No Recommendation Required

Both rooms

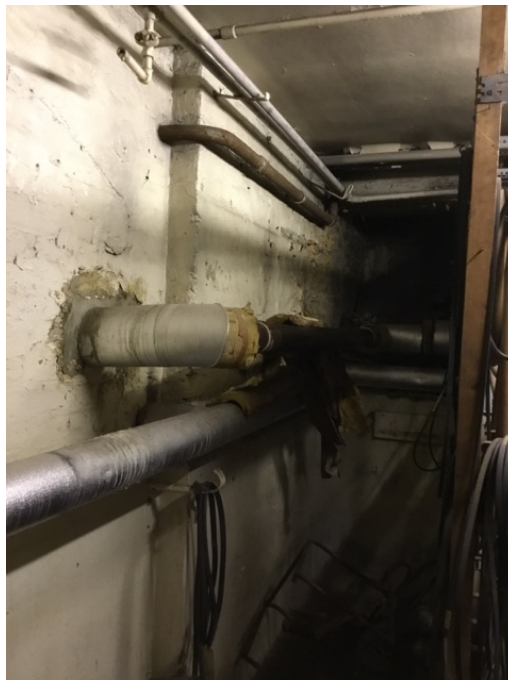
Lead Surveyor	Colin Bliss
Date of Survey	20/09/2017
Date of Next Re-inspection	20/09/2018
Item Description	Fibreglass insulation to pipework
Level of Identification	Crossed Referenced
Location Name	14 / Plant rooms / Basement
Sample No	15
Product Type	Unspecified Debris or Contamination
Extent of Damage	High Damage
Surface Treatment	Encapsulated Lagging & Spray
Asbestos Type	Amosite
Amount / Extent	200 LM
Accessibility	Unlikely Disturbance/Usually Inaccessible
Algorithm Score	10
<b>RECOMMENDATION</b>	Restrict Access and Remove

Residue and debris to pipework below fibre glass insulation

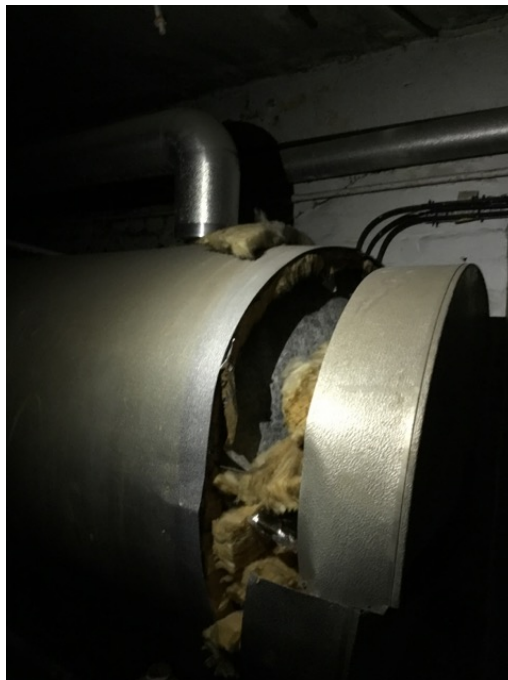
Lead Surveyor	Colin Bliss
Date of Survey	20/09/2017
Date of Next Re-inspection	20/09/2018
Item Description	Boiler
Level of Identification	Crossed Referenced
Location Name	13 / Corridor / Basement
Sample No	14
Product Type	Unspecified Debris or Contamination
Extent of Damage	High Damage
Surface Treatment	Encapsulated Lagging & Spray
Asbestos Type	Amosite / Chrysotile
Amount / Extent	4 No
Accessibility	Unlikely Disturbance/Usually Inaccessible
Algorithm Score	10
<b>RECOMMENDATION</b>	Restrict Access and Remove

Thermal insulation residues below fibre glass insulation

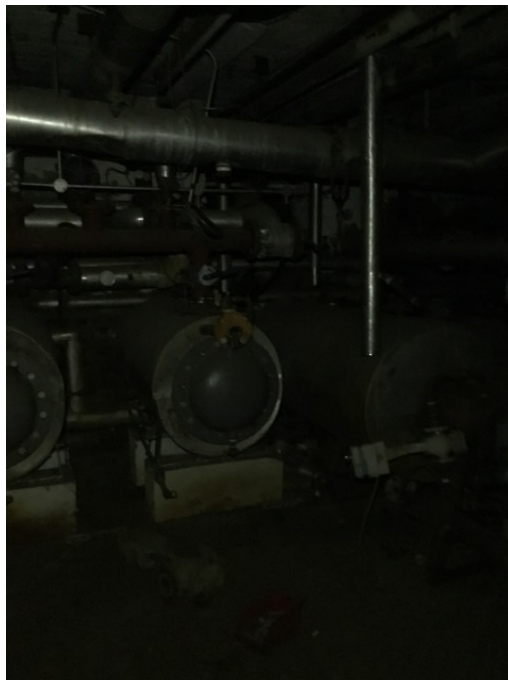
Lead Surveyor	Colin Bliss
Date of Survey	20/09/2017
Date of Next Re-inspection	20/09/2018
Item Description	Debris to walls and ceiling
Level of Identification	Crossed Referenced
Location Name	13 / Corridor / Basement
Sample No	14
Product Type	Thermal Insulation
Extent of Damage	High Damage
Surface Treatment	Debris & Contamination
Asbestos Type	Amosite / Chrysotile
Amount / Extent	100 M2
Accessibility	Easily Disturbed
Algorithm Score	11
<b>RECOMMENDATION</b>	Restrict Access and Remove

Presumed residue and debris to walls, ceiling and floors

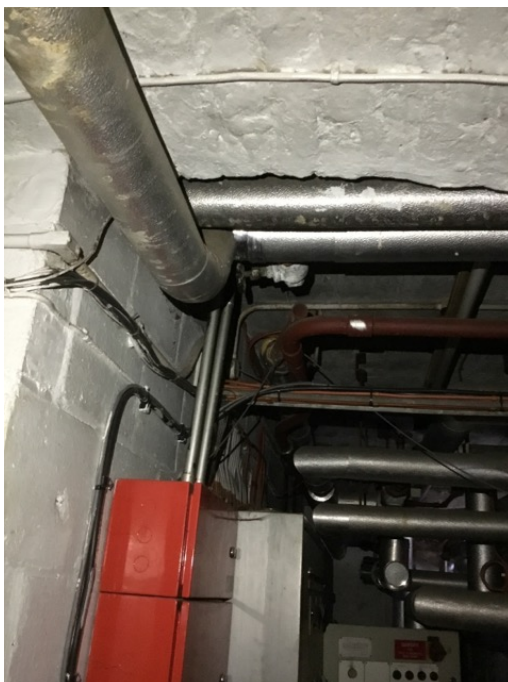
Lead Surveyor	Colin Bliss
Date of Survey	20/09/2017
Date of Next Re-inspection	20/09/2018
Item Description	Pipework
Level of Identification	Strongly Presumed
Location Name	14 / Plant rooms / Basement
Sample No	15
Product Type	Thermal insulation
Extent of Damage	Good Condition
Surface Treatment	Enclosed Spray & Lagging
Asbestos Type	Amosite
Amount / Extent	200 LM
Accessibility	Unlikely Disturbance/Usually Inaccessible
Algorithm Score	3
<b>RECOMMENDATION</b>	Remove by Licensed Asbestos Contractor

Presumed residue and debris to pipework below fibre glass insulation

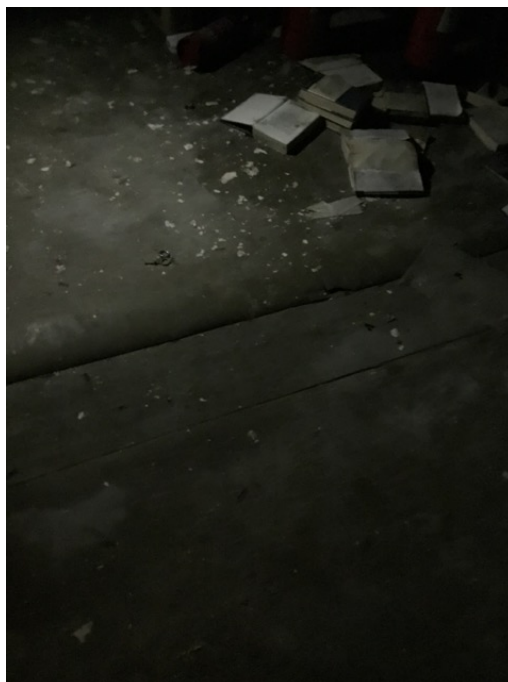
Lead Surveyor	Colin Bliss
Date of Survey	20/09/2017
Date of Next Re-inspection	
Item Description	Lino to floor
Level of Identification	Strongly Presumed
Location Name	15 / Room / Basement
Sample No	19
Product Type	Vinyl & Vinyl Floor Tiles
Extent of Damage	
Surface Treatment	
Asbestos Type	NADIS - No Asbestos Detected in Sample
Amount / Extent	
Accessibility	
Algorithm Score	0
<b>RECOMMENDATION</b>	Negative Sample - No Recommendation Required

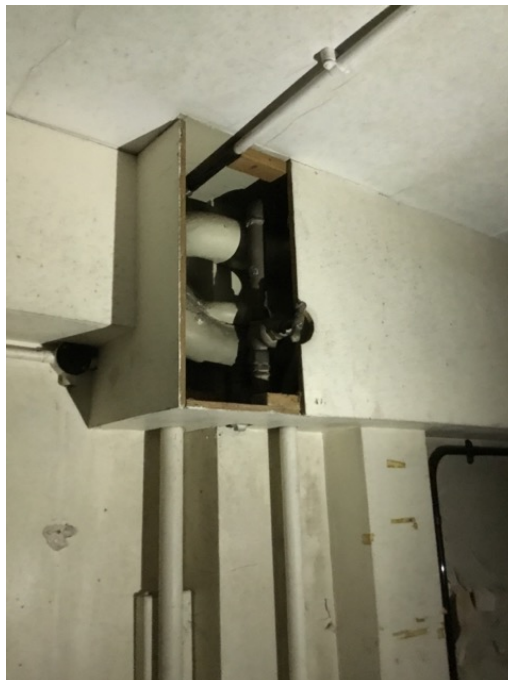
Lead Surveyor	Colin Bliss
Date of Survey	20/09/2017
Date of Next Re-inspection	20/09/2018
Item Description	Lagging to pipework in boxing
Level of Identification	Crossed Referenced
Location Name	15 / Room / Basement
Sample No	22
Product Type	Thermal insulation
Extent of Damage	Low Damage
Surface Treatment	Enclosed Spray & Lagging
Asbestos Type	Amosite / Chrysotile
Amount / Extent	20 LM
Accessibility	Unlikely Disturbance/Usually Inaccessible
Algorithm Score	4
<b>RECOMMENDATION</b>	Remove by Licensed Asbestos Contractor

Presume lagging to pipework throughout boxing.

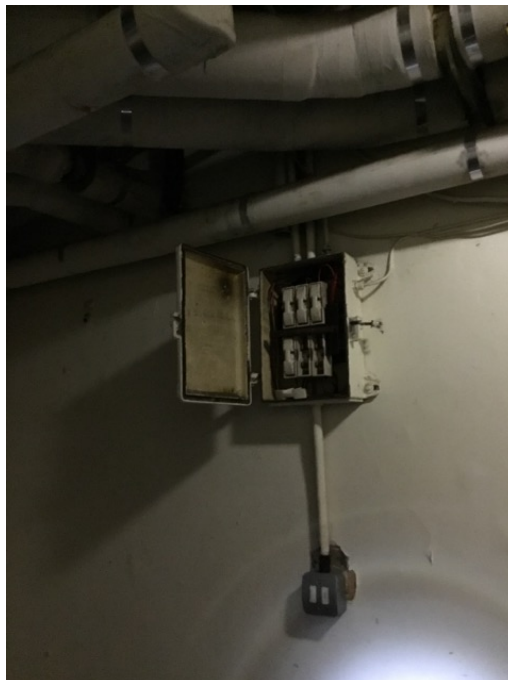
Lead Surveyor	Colin Bliss
Date of Survey	20/09/2017
Date of Next Re-inspection	
Item Description	Rope to fuse box
Level of Identification	Sampled
Location Name	15 / Room / Basement
Sample No	20
Product Type	Textiles, Rope, Gaskets
Extent of Damage	
Surface Treatment	
Asbestos Type	NADIS - No Asbestos Detected in Sample
Amount / Extent	
Accessibility	
Algorithm Score	0
<b>RECOMMENDATION</b>	Negative Sample - No Recommendation Required

Textile rope to fuse box

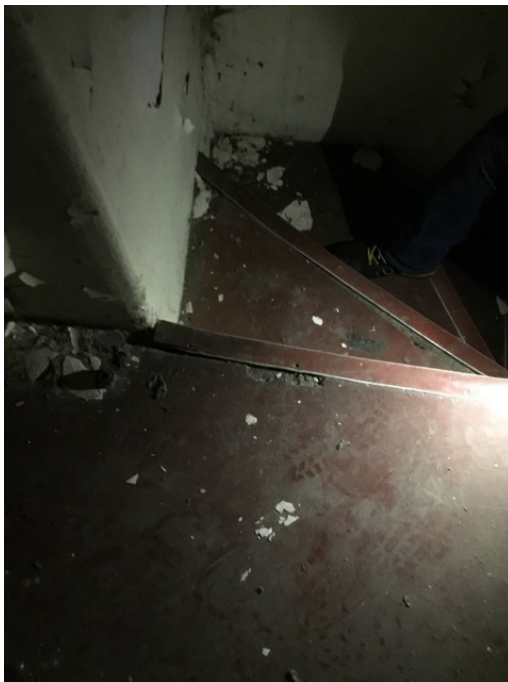
Lead Surveyor	Colin Bliss
Date of Survey	20/09/2017
Date of Next Re-inspection	20/09/2018
Item Description	Stair Nosing Strip
Level of Identification	Sampled
Location Name	16 / Changing room area / Basement
Sample No	35
Product Type	Stair nosing
Extent of Damage	Medium Damage
Surface Treatment	Composite/Plastic/Resins/Bitumen
Asbestos Type	Chrysotile
Amount / Extent	10 LM
Accessibility	Routinely Disturbed
Algorithm Score	3
<b>RECOMMENDATION</b>	Remove by Approved Asbestos Contractor

Red stair nosing

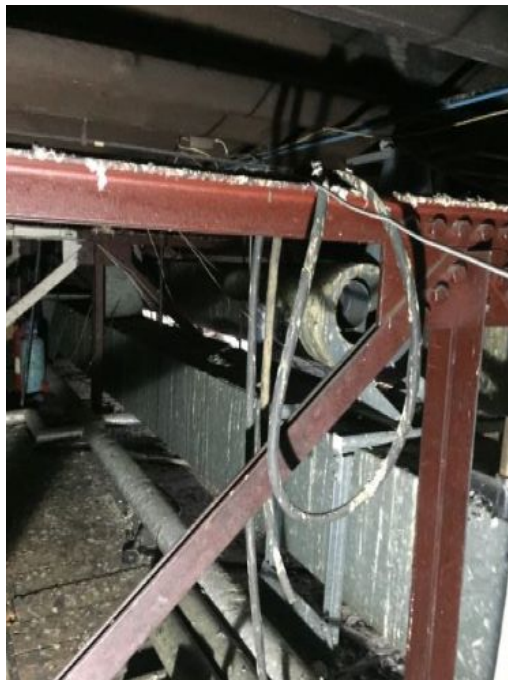
Lead Surveyor	Colin Bliss
Date of Survey	20/09/2017
Date of Next Re-inspection	20/09/2018
Item Description	Lift plant room
Level of Identification	
Location Name	11 / Section 8 / Third
Sample No	
Product Type	
Extent of Damage	
Surface Treatment	
Asbestos Type	Amosite / Chrysotile
Amount / Extent	
Accessibility	
Algorithm Score	2
<b>RECOMMENDATION</b>	No Recommendation Required

Visual inspection, no asbestos materials found, room contaminated with bird feces

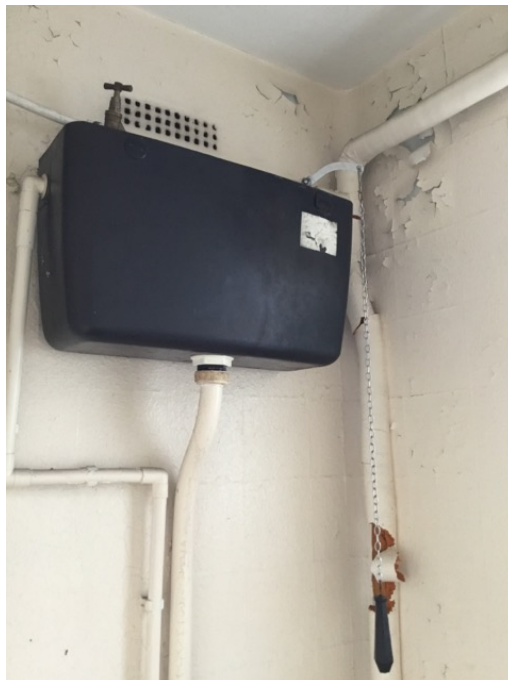
Lead Surveyor	Colin Bliss
Date of Survey	20/09/2017
Date of Next Re-inspection	20/09/2018
Item Description	Toilet cistern
Level of Identification	Presumed
Location Name	11 / Section 8 / Third
Sample No	
Product Type	Asbestos Reinforced Composite
Extent of Damage	Low Damage
Surface Treatment	Composite/Plastic/Resins/Bitumen
Asbestos Type	Chrysotile
Amount / Extent	2 No
Accessibility	Unlikely Disturbance/Usually Inaccessible
Algorithm Score	12
<b>RECOMMENDATION</b>	Remove by Approved Asbestos Contractor

X2 cisterns in two toilets.

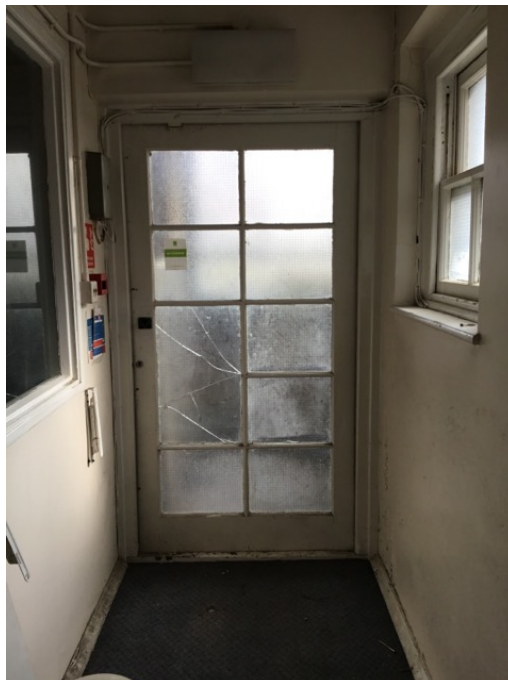
Lead Surveyor	Colin Bliss
Date of Survey	20/09/2017
Date of Next Re-inspection	20/09/2018
Item Description	No access to external rear
Level of Identification	Presumed
Location Name	11 / Section 8 / Third
Sample No	
Product Type	
Extent of Damage	
Surface Treatment	
Asbestos Type	Not Applicable
Amount / Extent	
Accessibility	
Algorithm Score	12
<b>RECOMMENDATION</b>	No Access - Inspection Required

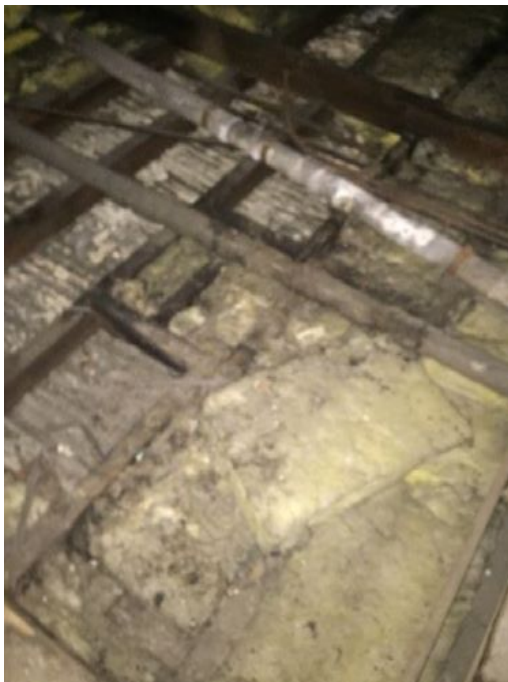
Lead Surveyor	Colin Bliss
Date of Survey	20/09/2017
Date of Next Re-inspection	20/09/2018
Item Description	Loft space pipework and floor
Level of Identification	Sampled
Location Name	11 / Section 8 / Third
Sample No	38
Product Type	Thermal Insulation
Extent of Damage	Medium Damage
Surface Treatment	Unsealed Lagging & Spray
Asbestos Type	Amosite / Chrysotile
Amount / Extent	200 LM
Accessibility	Unlikely Disturbance/Usually Inaccessible
Algorithm Score	10
<b>RECOMMENDATION</b>	Restrict Access and Remove by Licensed Contractor

Thermal insulation to pipework 200 linea mtrs, debris to floor 150 mtrs sq

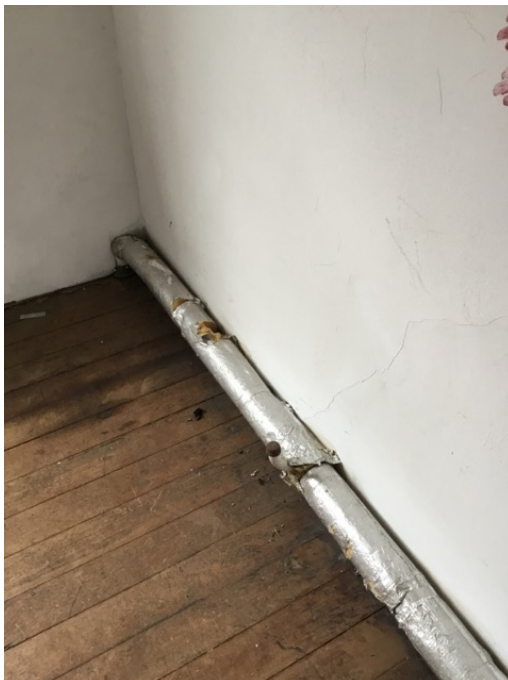
Lead Surveyor	Colin Bliss
Date of Survey	20/09/2017
Date of Next Re-inspection	
Item Description	Fibreglass lagged pipework
Level of Identification	
Location Name	11 / Section 8 / Third
Sample No	
Product Type	
Extent of Damage	
Surface Treatment	
Asbestos Type	Not Applicable
Amount / Extent	
Accessibility	
Algorithm Score	0
<b>RECOMMENDATION</b>	Negative Sample - No Recommendation Required

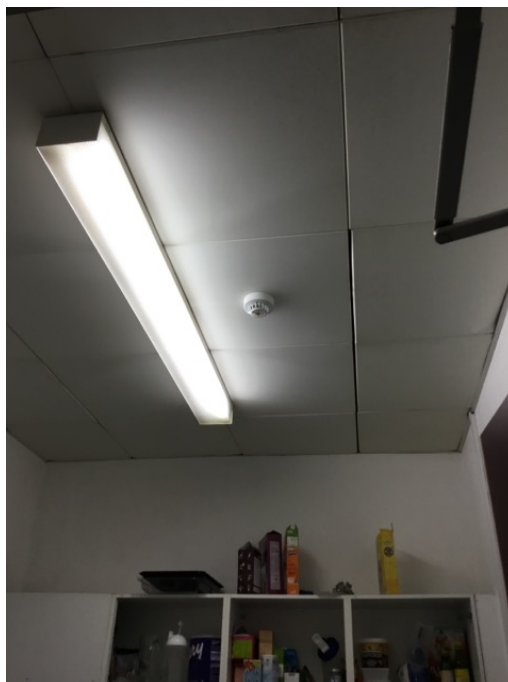
Lead Surveyor	Colin Bliss
Date of Survey	20/09/2017
Date of Next Re-inspection	
Item Description	Visual inspection of ceiling
Level of Identification	
Location Name	12 / Reach Active Section 9 / First
Sample No	
Product Type	
Extent of Damage	
Surface Treatment	
Asbestos Type	Not Applicable
Amount / Extent	
Accessibility	
Algorithm Score	0
<b>RECOMMENDATION</b>	Negative Sample - No Recommendation Required

Metal panel ceiling with plasterboard ceiling above and fibreglass lagged pipes.
