**REFURBISHMENT / DEMOLITION**  
**ASBESTOS SURVEY REPORT**

**Middlesex Hospital  
Cleveland Street  
London  
W1T4DR**

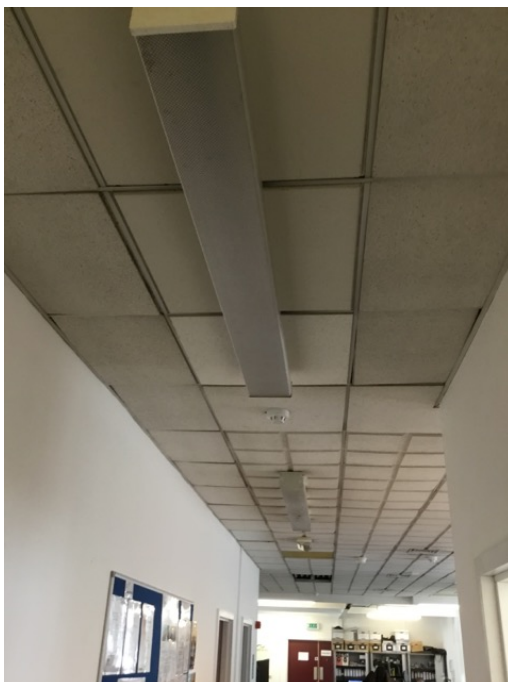
Lead Surveyor	Colin Bliss
Date of Survey	20/09/2017
Date of Next Re-inspection	
Item Description	MMMF suspended ceiling
Level of Identification	
Location Name	12 / Reach Active Section 9 / First
Sample No	
Product Type	
Extent of Damage	
Surface Treatment	
Asbestos Type	Not Applicable
Amount / Extent	
Accessibility	
Algorithm Score	0
<b>RECOMMENDATION</b>	Negative Sample - No Recommendation Required

MMMF suspended ceiling opening to plasterboard ceiling above and fibreglass lagged pipework. With experience and history of the building thus far I can presume original concrete ceiling above.

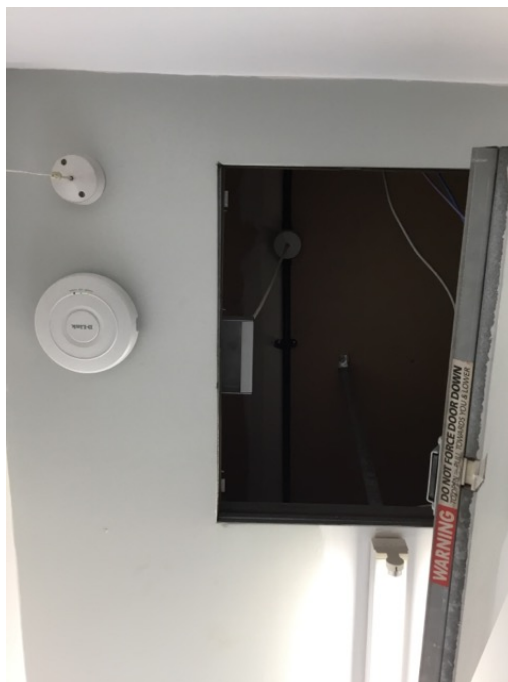
Lead Surveyor	Colin Bliss
Date of Survey	20/09/2017
Date of Next Re-inspection	
Item Description	Plasterboard ceiling within photocopy room
Level of Identification	
Location Name	12 / Reach Active Section 9 / First
Sample No	
Product Type	
Extent of Damage	
Surface Treatment	
Asbestos Type	Not Applicable
Amount / Extent	
Accessibility	
Algorithm Score	0
<b>RECOMMENDATION</b>	Negative Sample - No Recommendation Required

Ceiling opening to a solid masonry ceiling.

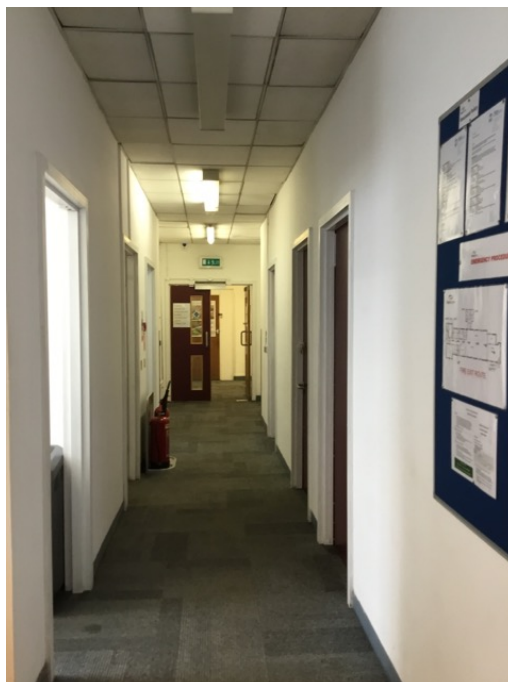
Lead Surveyor	Colin Bliss
Date of Survey	20/09/2017
Date of Next Re-inspection	
Item Description	Plasterboard partition walls and masonry walls
Level of Identification	
Location Name	12 / Reach Active Section 9 / First
Sample No	
Product Type	
Extent of Damage	
Surface Treatment	
Asbestos Type	Not Applicable
Amount / Extent	
Accessibility	
Algorithm Score	0
<b>RECOMMENDATION</b>	Negative Sample - No Recommendation Required

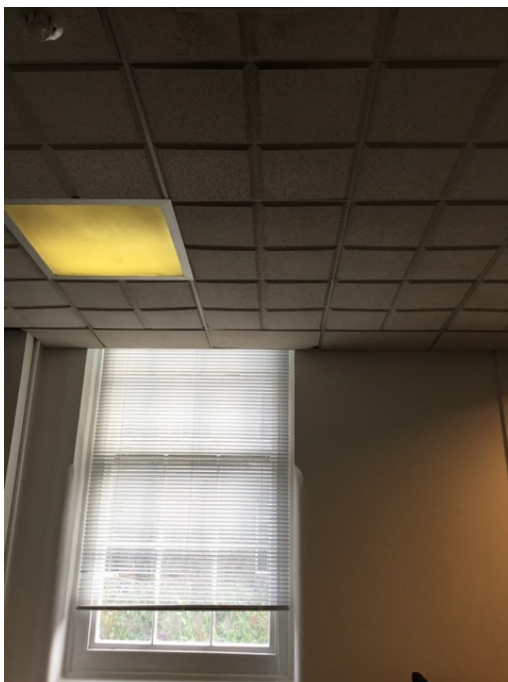
Lead Surveyor	Colin Bliss
Date of Survey	20/09/2017
Date of Next Re-inspection	
Item Description	No access to upstands to perimeter of rooms.
Level of Identification	
Location Name	12 / Reach Active Section 9 / First
Sample No	
Product Type	
Extent of Damage	
Surface Treatment	
Asbestos Type	Not Applicable
Amount / Extent	
Accessibility	
Algorithm Score	0
<b>RECOMMENDATION</b>	Negative Sample - No Recommendation Required

Ceiling throughout this section is false and consist of upstand. Plasterboard upstands

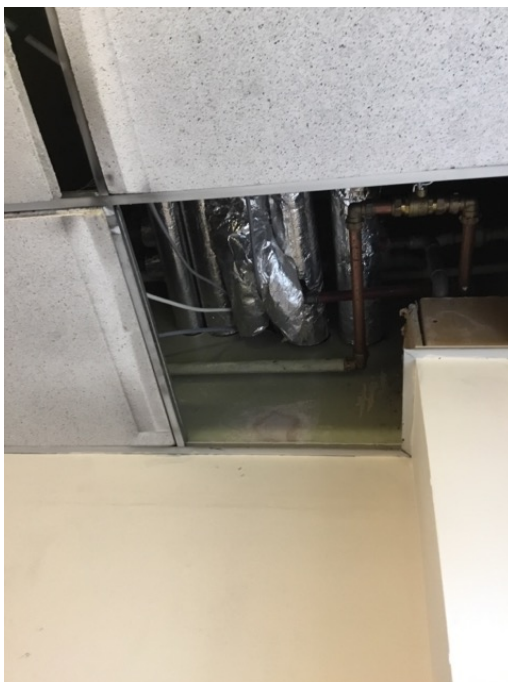
Lead Surveyor	Colin Bliss
Date of Survey	20/09/2017
Date of Next Re-inspection	
Item Description	MMMF lagged pipes with ceiling void of toilet areas
Level of Identification	
Location Name	12 / Reach Active Section 9 / First
Sample No	
Product Type	
Extent of Damage	
Surface Treatment	
Asbestos Type	Not Applicable
Amount / Extent	
Accessibility	
Algorithm Score	0
<b>RECOMMENDATION</b>	Negative Sample - No Recommendation Required

Modern Lino and carpet to flooring.

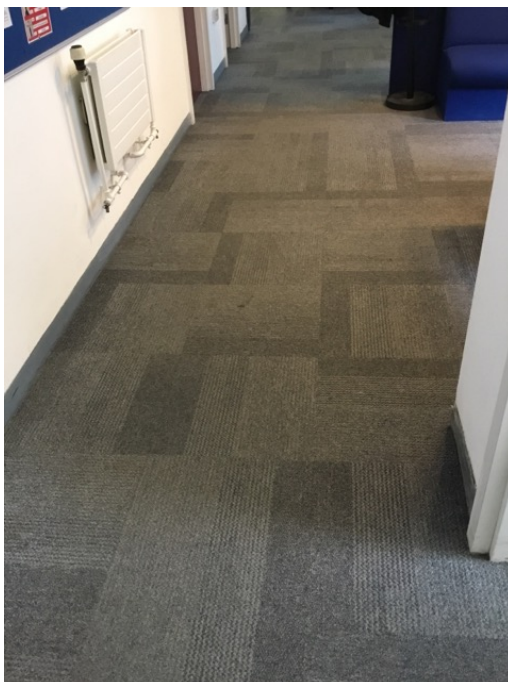
Lead Surveyor	Colin Bliss
Date of Survey	20/09/2017
Date of Next Re-inspection	
Item Description	Flooring
Level of Identification	
Location Name	12 / Reach Active Section 9 / First
Sample No	
Product Type	
Extent of Damage	
Surface Treatment	
Asbestos Type	Not Applicable
Amount / Extent	
Accessibility	
Algorithm Score	0
<b>RECOMMENDATION</b>	Negative Sample - No Recommendation Required

Carpet throughout except for wc which has lino. Carpet tiles onto modern Lino unto concrete screed.

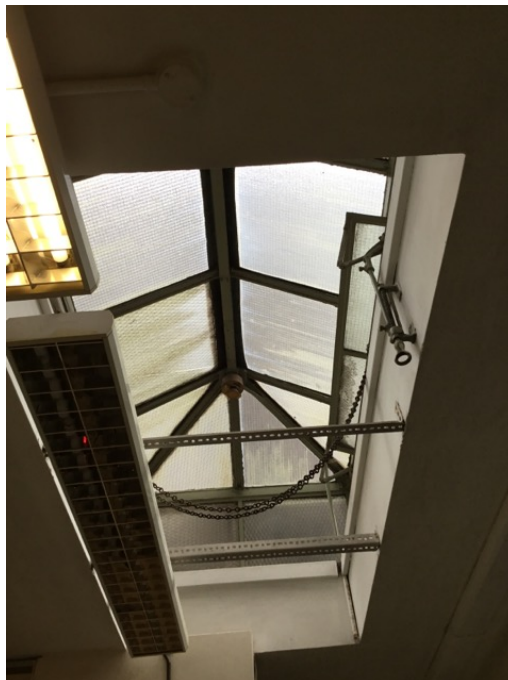
Lead Surveyor	Colin Bliss
Date of Survey	20/09/2017
Date of Next Re-inspection	20/09/2018
Item Description	Skylights
Level of Identification	Presumed
Location Name	18 / <b>Basement under North Building</b> / Basement
Sample No	
Product Type	Textiles, Rope, Gaskets
Extent of Damage	Good Condition
Surface Treatment	Sealed Textiles
Asbestos Type	Chrysotile
Amount / Extent	15 No
Accessibility	Unlikely Disturbance/Usually Inaccessible
Algorithm Score	12
<b>RECOMMENDATION</b>	Remove by Approved Asbestos Contractor

Presumed textile rope to skylight

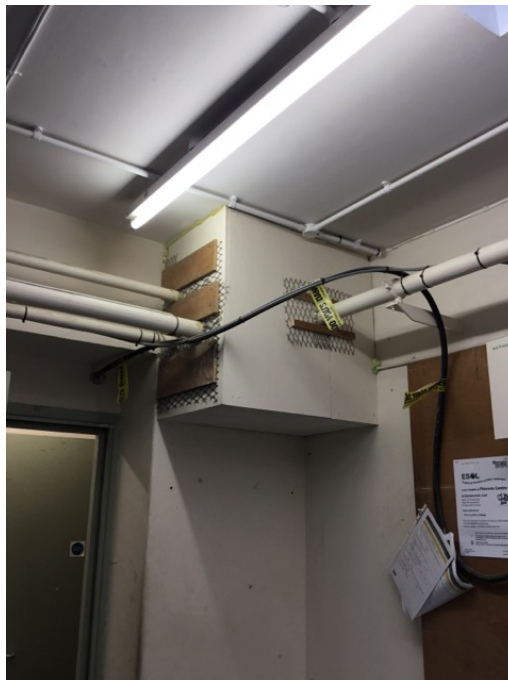
Lead Surveyor	Colin Bliss
Date of Survey	20/09/2017
Date of Next Re-inspection	20/09/2018
Item Description	No access into boxing
Level of Identification	Presumed
Location Name	18 / <b>Basement under North Building</b> / Basement
Sample No	
Product Type	
Extent of Damage	
Surface Treatment	
Asbestos Type	Not Applicable
Amount / Extent	
Accessibility	
Algorithm Score	12
<b>RECOMMENDATION</b>	No Access - Inspection Required

No access into boxing's throughout.

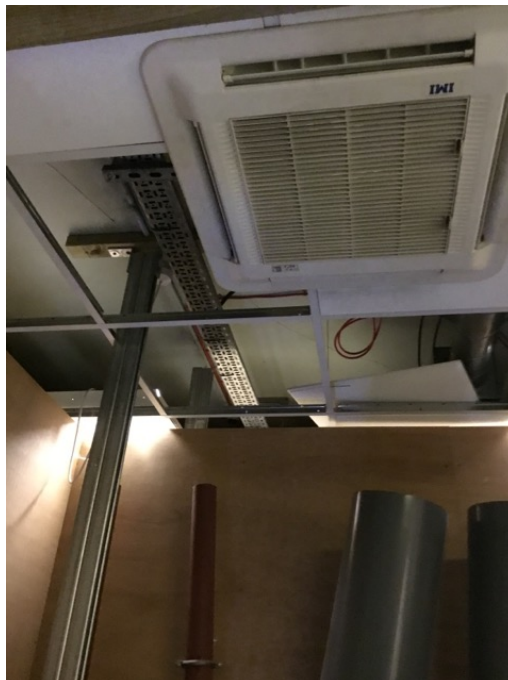
Lead Surveyor	Colin Bliss
Date of Survey	20/09/2017
Date of Next Re-inspection	
Item Description	MMMF suspended ceiling
Level of Identification	
Location Name	18 / <b>Basement under North Building</b> / Basement
Sample No	
Product Type	
Extent of Damage	
Surface Treatment	
Asbestos Type	Not Applicable
Amount / Extent	
Accessibility	
Algorithm Score	0
<b>RECOMMENDATION</b>	Negative Sample - No Recommendation Required

Ceiling void with lathe and plaster ceiling. Housing metal ducting.

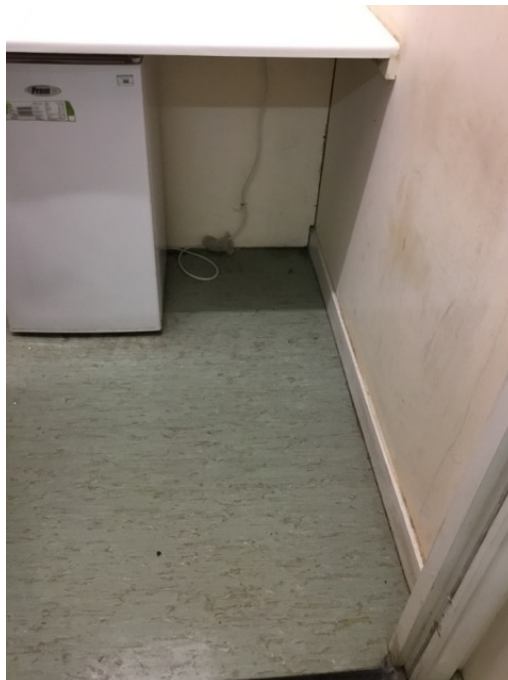
Lead Surveyor	Colin Bliss
Date of Survey	20/09/2017
Date of Next Re-inspection	
Item Description	Modern Lino to kitchen floor
Level of Identification	
Location Name	18 / <b>Basement under North Building</b> / Basement
Sample No	
Product Type	
Extent of Damage	
Surface Treatment	
Asbestos Type	Not Applicable
Amount / Extent	
Accessibility	
Algorithm Score	0
<b>RECOMMENDATION</b>	Negative Sample - No Recommendation Required

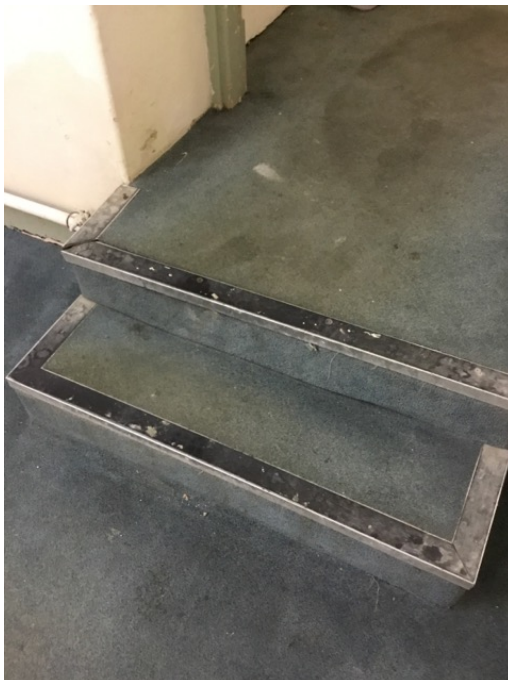
Lead Surveyor	Colin Bliss
Date of Survey	20/09/2017
Date of Next Re-inspection	
Item Description	Modern stair nosing
Level of Identification	
Location Name	18 / <b>Basement under North Building</b> / Basement
Sample No	
Product Type	
Extent of Damage	
Surface Treatment	
Asbestos Type	Not Applicable
Amount / Extent	
Accessibility	
Algorithm Score	0
<b>RECOMMENDATION</b>	Negative Sample - No Recommendation Required

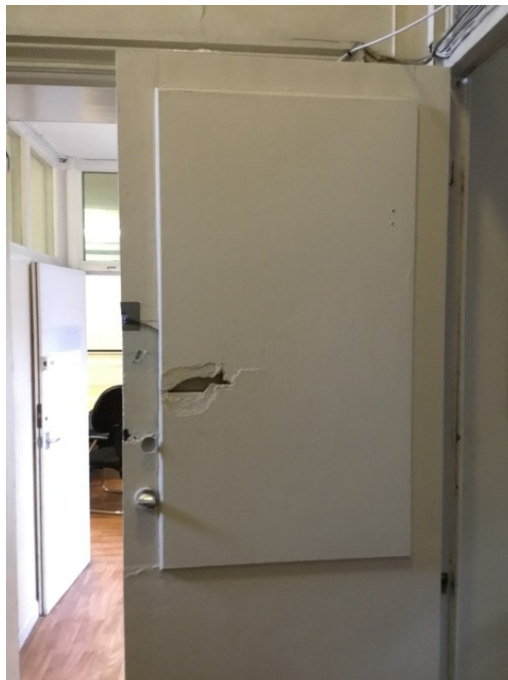
Lead Surveyor	Colin Bliss
Date of Survey	20/09/2017
Date of Next Re-inspection	20/09/2018
Item Description	Cement panel behind door
Level of Identification	Sampled
Location Name	20 / Offices / First
Sample No	25
Product Type	Asbestos Cement
Extent of Damage	Medium Damage
Surface Treatment	Sealed Cement
Asbestos Type	Chrysotile
Amount / Extent	2 M2
Accessibility	Unlikely Disturbance/Usually Inaccessible
Algorithm Score	4
<b>RECOMMENDATION</b>	Remove by Licensed Asbestos Contractor

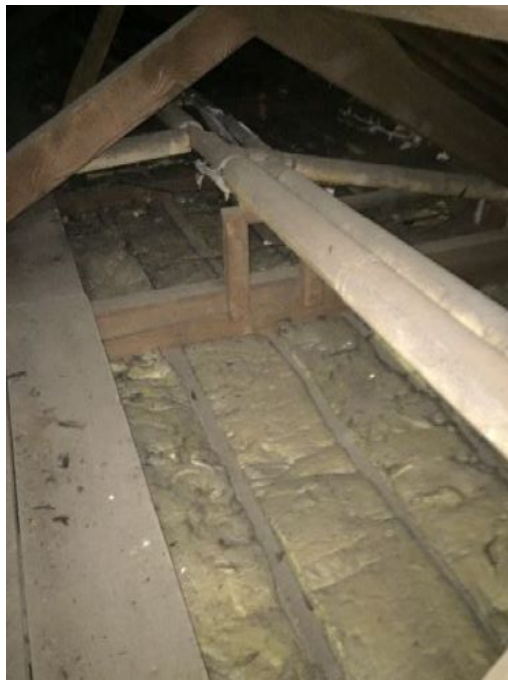
Lead Surveyor	Colin Bliss
Date of Survey	20/09/2017
Date of Next Re-inspection	20/09/2018
Item Description	Loft space pipework
Level of Identification	Crossed Referenced
Location Name	21 / Corridor / Second
Sample No	42
Product Type	Thermal Insulation
Extent of Damage	High Damage
Surface Treatment	Debris & Contamination
Asbestos Type	Amosite / Chrysotile
Amount / Extent	300 LM
Accessibility	Unlikely Disturbance/Usually Inaccessible
Algorithm Score	11
<b>RECOMMENDATION</b>	Restrict Access and Remove by Licensed Contractor

Thermal insulation to pipework and debris to floor total floor space 180 sq mtrs

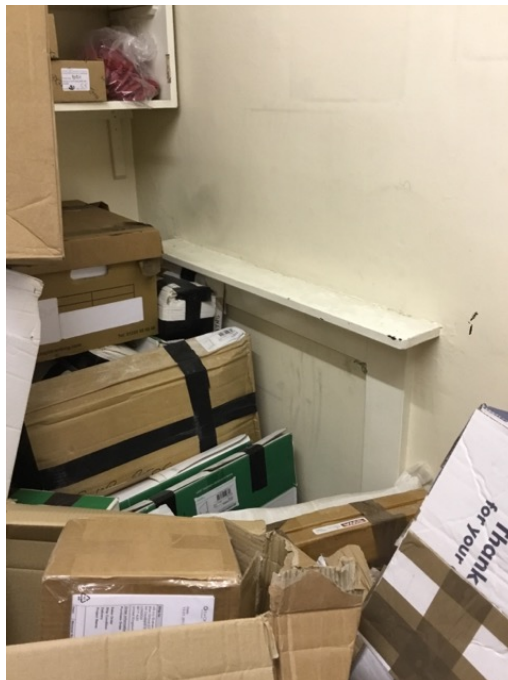
Lead Surveyor	Colin Bliss
Date of Survey	20/09/2017
Date of Next Re-inspection	20/09/2018
Item Description	Cement panel to fire place
Level of Identification	Presumed
Location Name	21 / Corridor / Second
Sample No	
Product Type	Asbestos Cement
Extent of Damage	Good Condition
Surface Treatment	Sealed Cement
Asbestos Type	Chrysotile
Amount / Extent	1 M2
Accessibility	Unlikely Disturbance/Usually Inaccessible
Algorithm Score	12
<b>RECOMMENDATION</b>	Remove by Licensed Asbestos Contractor

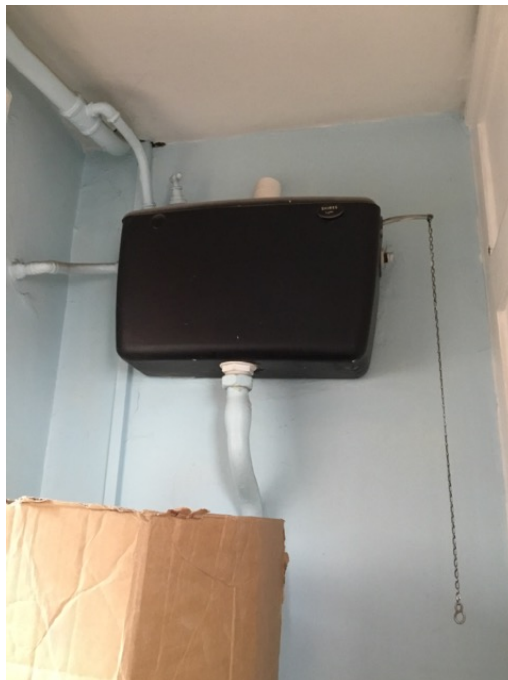
Lead Surveyor	Colin Bliss
Date of Survey	20/09/2017
Date of Next Re-inspection	20/09/2018
Item Description	Cistern within toilet
Level of Identification	Presumed
Location Name	21 / Corridor / Second
Sample No	
Product Type	Asbestos Reinforced Composite
Extent of Damage	Low Damage
Surface Treatment	Composite/Plastic/Resins/Bitumen
Asbestos Type	Chrysotile
Amount / Extent	1 No
Accessibility	Unlikely Disturbance/Usually Inaccessible
Algorithm Score	12
<b>RECOMMENDATION</b>	Remove by Licensed Asbestos Contractor

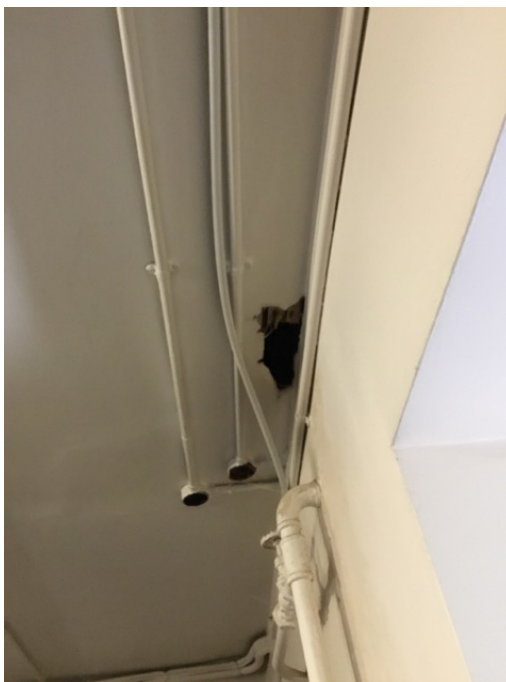
Lead Surveyor	Colin Bliss
Date of Survey	20/09/2017
Date of Next Re-inspection	
Item Description	Section 5 lathe and plaster ceilings
Level of Identification	
Location Name	10 / Section 6 / Second
Sample No	
Product Type	
Extent of Damage	
Surface Treatment	
Asbestos Type	Not Applicable
Amount / Extent	
Accessibility	
Algorithm Score	0
<b>RECOMMENDATION</b>	Negative Sample - No Recommendation Required

MMMF suspended ceiling opening to plasterboard ceiling. No access above plasterboard ceilings throughout this section. Some areas shows lathe and plaster ceiling . Fibreglass lagged pipework within ceiling void.

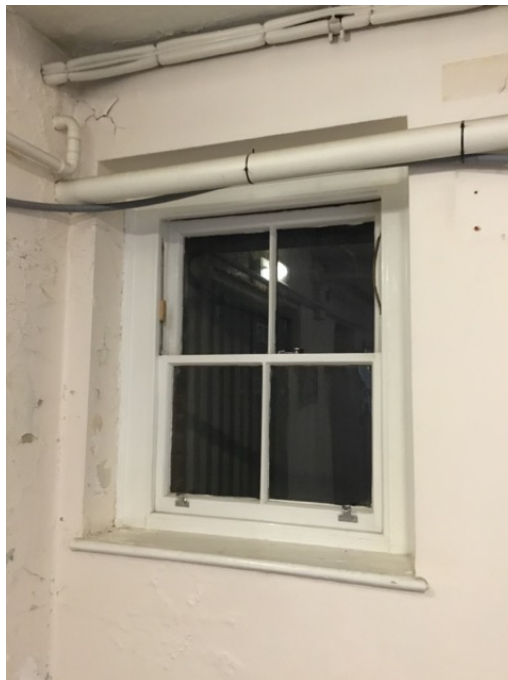
Lead Surveyor	Colin Bliss
Date of Survey	20/09/2017
Date of Next Re-inspection	
Item Description	Sash cord to windows
Level of Identification	Strongly Presumed
Location Name	10 / Section 6 / Second
Sample No	06
Product Type	Textiles, Rope, Gaskets
Extent of Damage	
Surface Treatment	
Asbestos Type	NADIS - No Asbestos Detected in Sample
Amount / Extent	
Accessibility	
Algorithm Score	0
<b>RECOMMENDATION</b>	Negative Sample - No Recommendation Required

To all sash windows throughout.

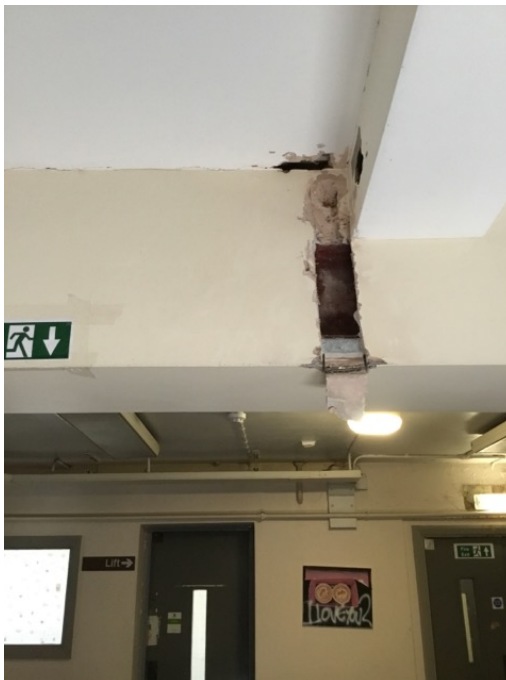
Lead Surveyor	Colin Bliss
Date of Survey	20/09/2017
Date of Next Re-inspection	
Item Description	Metal RSJ within masonry boxing
Level of Identification	
Location Name	10 / Section 6 / Second
Sample No	
Product Type	
Extent of Damage	
Surface Treatment	
Asbestos Type	Not Applicable
Amount / Extent	
Accessibility	
Algorithm Score	0
<b>RECOMMENDATION</b>	Negative Sample - No Recommendation Required

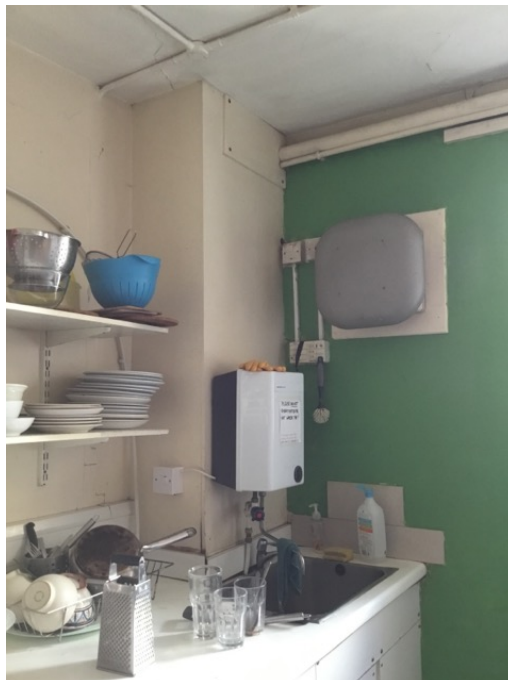
Lead Surveyor	Colin Bliss
Date of Survey	20/09/2017
Date of Next Re-inspection	
Item Description	No access into boxing in kitchen
Level of Identification	Presumed
Location Name	10 / Section 6 / Second
Sample No	
Product Type	
Extent of Damage	
Surface Treatment	
Asbestos Type	Not Applicable
Amount / Extent	
Accessibility	
Algorithm Score	0
<b>RECOMMENDATION</b>	Negative Sample - No Recommendation Required

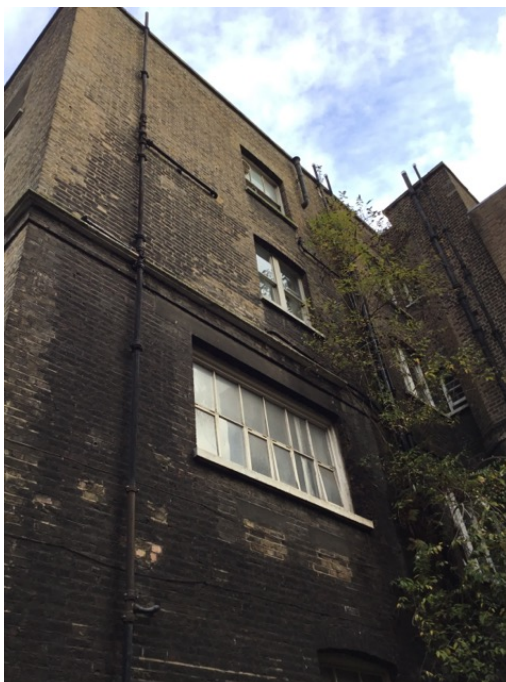
Lead Surveyor	Colin Bliss
Date of Survey	20/09/2017
Date of Next Re-inspection	20/09/2018
Item Description	Cement cowl
Level of Identification	Presumed
Location Name	/ External /
Sample No	
Product Type	Asbestos Cement
Extent of Damage	Good Condition
Surface Treatment	Unsealed Cement
Asbestos Type	Chrysotile
Amount / Extent	1 No
Accessibility	Unlikely Disturbance/Usually Inaccessible
Algorithm Score	12
<b>RECOMMENDATION</b>	Remove by Approved Asbestos Contractor

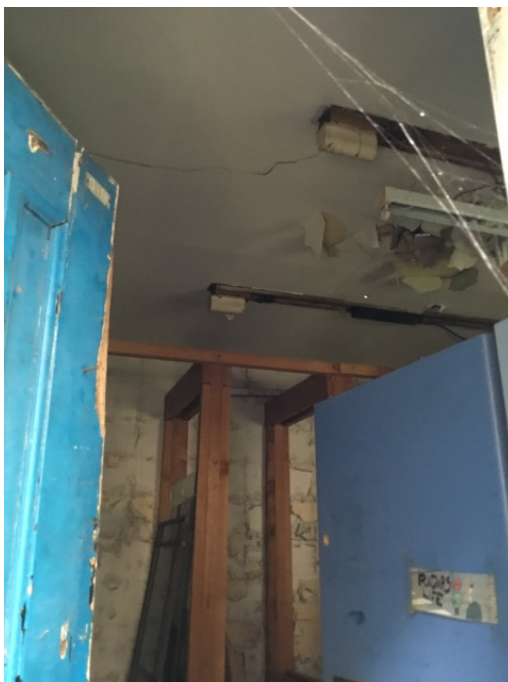
Lead Surveyor	Colin Bliss
Date of Survey	20/09/2017
Date of Next Re-inspection	20/09/2018
Item Description	Insulating board to ceiling
Level of Identification	Presumed
Location Name	/ External /
Sample No	
Product Type	Insulating board
Extent of Damage	Medium Damage
Surface Treatment	Unsealed AIB, Boards and Paper
Asbestos Type	Amosite / Chrysotile
Amount / Extent	30 M2
Accessibility	Unlikely Disturbance/Usually Inaccessible
Algorithm Score	12
<b>RECOMMENDATION</b>	Remove by Licensed Asbestos Contractor

Limited access due to rubbish stored

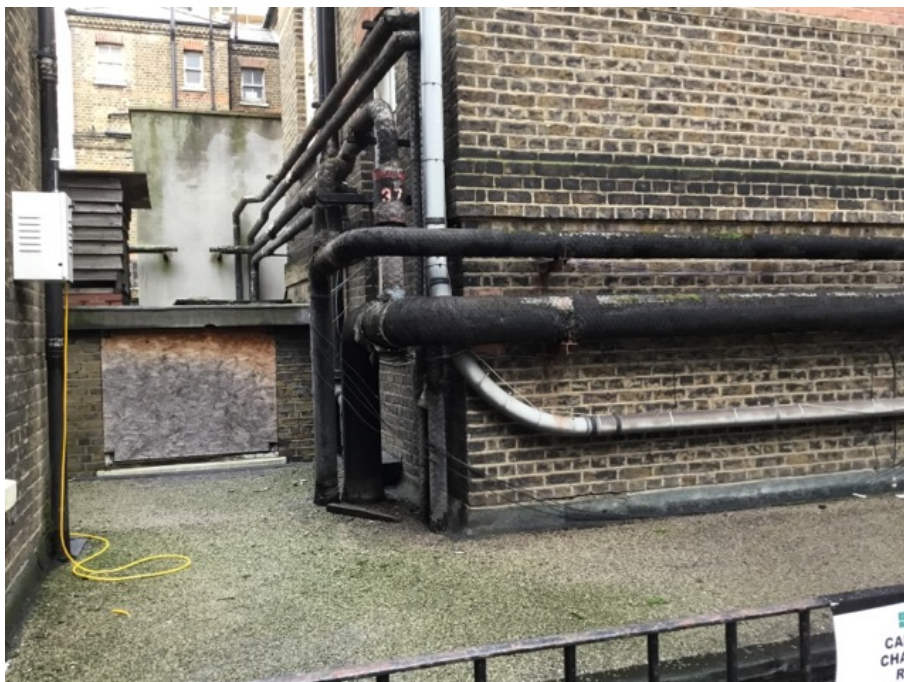
Lead Surveyor	Colin Bliss
Date of Survey	20/09/2017
Date of Next Re-inspection	20/09/2018
Item Description	Thermal lagging to pipework
Level of Identification	Sampled
Location Name	/ External /
Sample No	53
Product Type	Thermal Insulation
Extent of Damage	High Damage
Surface Treatment	Unsealed Lagging & Spray
Asbestos Type	Amosite / Chrysotile
Amount / Extent	100 LM
Accessibility	Unlikely Disturbance/Usually Inaccessible
Algorithm Score	11
<b>RECOMMENDATION</b>	Remove by Licensed Asbestos Contractor

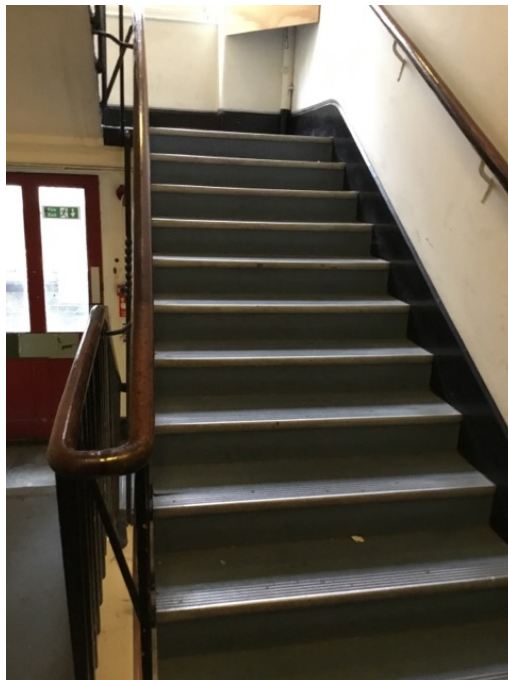
Lead Surveyor	Colin Bliss
Date of Survey	20/09/2017
Date of Next Re-inspection	
Item Description	Stairwell
Level of Identification	
Location Name	22 / Stairwell B basement to 3 floor / Ground
Sample No	
Product Type	
Extent of Damage	
Surface Treatment	
Asbestos Type	Not Applicable
Amount / Extent	
Accessibility	
Algorithm Score	0
<b>RECOMMENDATION</b>	Negative Sample - No Recommendation Required

Lino to floor with metal stair nosing

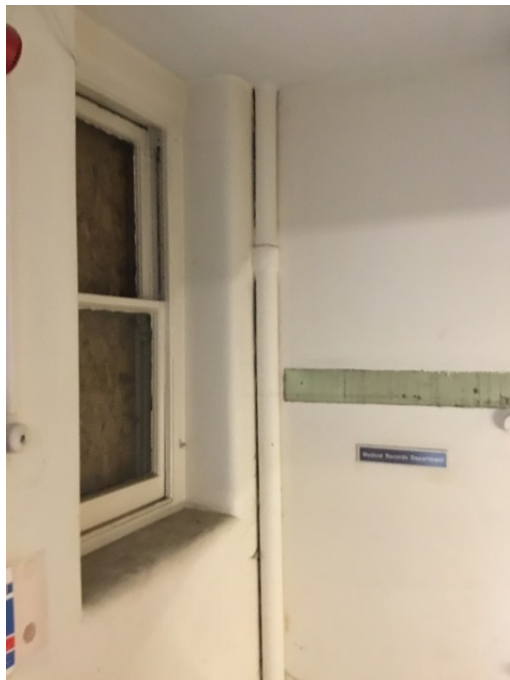
Lead Surveyor	Colin Bliss
Date of Survey	20/09/2017
Date of Next Re-inspection	
Item Description	Metal pipework to corner of stair
Level of Identification	
Location Name	22 / Stairwell B basement to 3 floor / Ground
Sample No	
Product Type	
Extent of Damage	
Surface Treatment	
Asbestos Type	Not Applicable
Amount / Extent	
Accessibility	
Algorithm Score	0
<b>RECOMMENDATION</b>	Negative Sample - No Recommendation Required

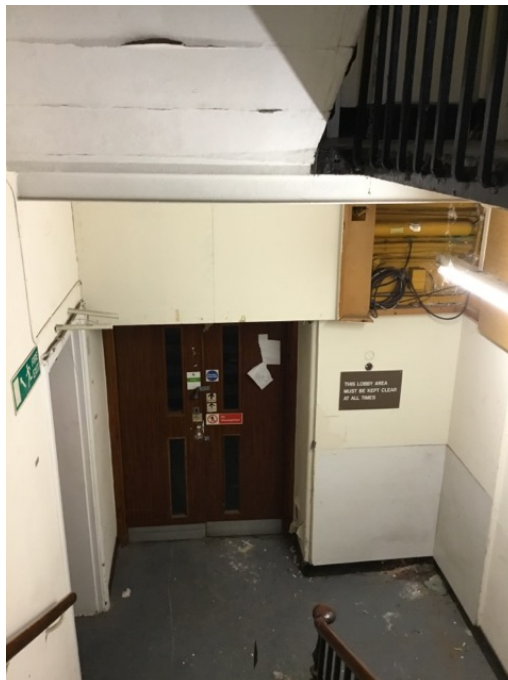
Lead Surveyor	Colin Bliss
Date of Survey	20/09/2017
Date of Next Re-inspection	20/09/2018
Item Description	Thermal insulation to pipework within boxing
Level of Identification	Crossed Referenced
Location Name	22 / Stairwell B basement to 3 floor / Ground
Sample No	22
Product Type	Thermal insulation
Extent of Damage	Low Damage
Surface Treatment	Enclosed Spray & Lagging
Asbestos Type	Amosite / Chrysotile
Amount / Extent	30 LM
Accessibility	Occasional Disturbance
Algorithm Score	4
<b>RECOMMENDATION</b>	Remove by Licensed Asbestos Contractor

Presume lagging going to rooms left and right hence measurement.

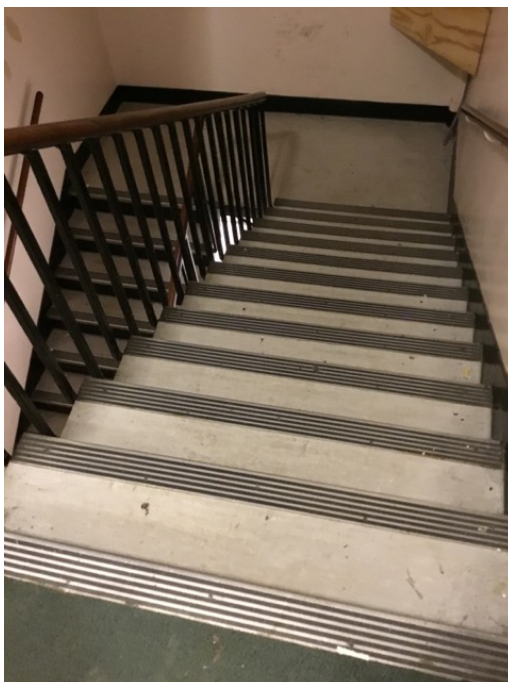
Lead Surveyor	Colin Bliss
Date of Survey	20/09/2017
Date of Next Re-inspection	
Item Description	Stairwell
Level of Identification	
Location Name	23 / Stairwell A basement to 3 floor / Ground
Sample No	
Product Type	
Extent of Damage	
Surface Treatment	
Asbestos Type	Not Applicable
Amount / Extent	
Accessibility	
Algorithm Score	0
<b>RECOMMENDATION</b>	Negative Sample - No Recommendation Required

Modern lino to floor with metal stair nosing

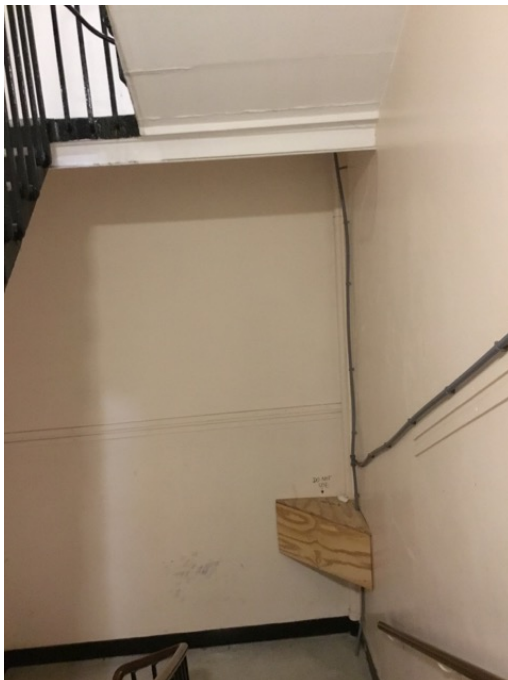
Lead Surveyor	Colin Bliss
Date of Survey	20/09/2017
Date of Next Re-inspection	
Item Description	Metal pipework to corner of stair
Level of Identification	
Location Name	23 / Stairwell A basement to 3 floor / Ground
Sample No	
Product Type	
Extent of Damage	
Surface Treatment	
Asbestos Type	Not Applicable
Amount / Extent	
Accessibility	
Algorithm Score	0
<b>RECOMMENDATION</b>	Negative Sample - No Recommendation Required

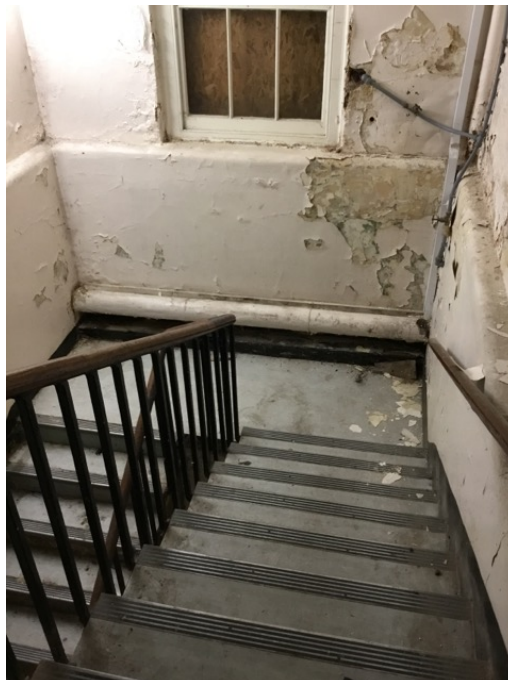
Lead Surveyor	Colin Bliss
Date of Survey	20/09/2017
Date of Next Re-inspection	20/09/2018
Item Description	Thermal insulation within low level boxing
Level of Identification	Crossed Referenced
Location Name	23 / Stairwell A basement to 3 floor / Ground
Sample No	04
Product Type	Thermal Insulation
Extent of Damage	High Damage
Surface Treatment	Encapsulated Lagging & Spray
Asbestos Type	Crocidolite / Chrysotile
Amount / Extent	5 LM
Accessibility	Easily Disturbed
Algorithm Score	11
<b>RECOMMENDATION</b>	Restrict Access and Remove by Licensed Contractor

Presumed thermal insulation to pipework, debris also visible to floor

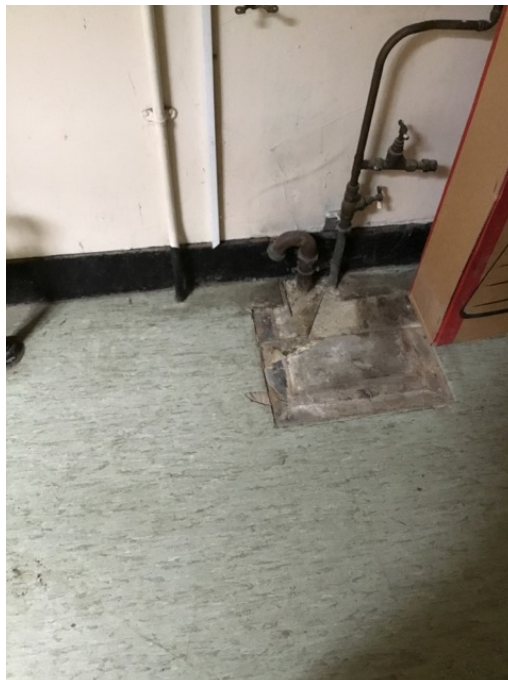
Lead Surveyor	Colin Bliss
Date of Survey	20/09/2017
Date of Next Re-inspection	
Item Description	Tiles to floor
Level of Identification	Sampled
Location Name	4 / Corridor / Ground
Sample No	36
Product Type	Vinyl & Vinyl Floor Tiles
Extent of Damage	
Surface Treatment	
Asbestos Type	
Amount / Extent	
Accessibility	
Algorithm Score	0
<b>RECOMMENDATION</b>	Negative Sample - No Recommendation Required

Presume throughout under lino.

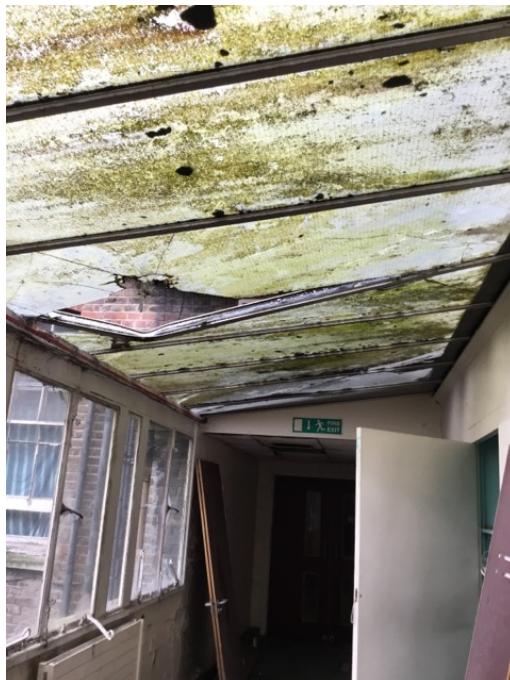
Lead Surveyor	Colin Bliss
Date of Survey	20/09/2017
Date of Next Re-inspection	20/09/2018
Item Description	Rope gasket to skylights
Level of Identification	Strongly Presumed
Location Name	24 / Corridor / First
Sample No	27
Product Type	Textiles, Rope, Gaskets
Extent of Damage	Low Damage
Surface Treatment	Unsealed Textiles
Asbestos Type	Chrysotile
Amount / Extent	40 LM
Accessibility	Occasional Disturbance
Algorithm Score	6
<b>RECOMMENDATION</b>	Remove by Licensed Asbestos Contractor

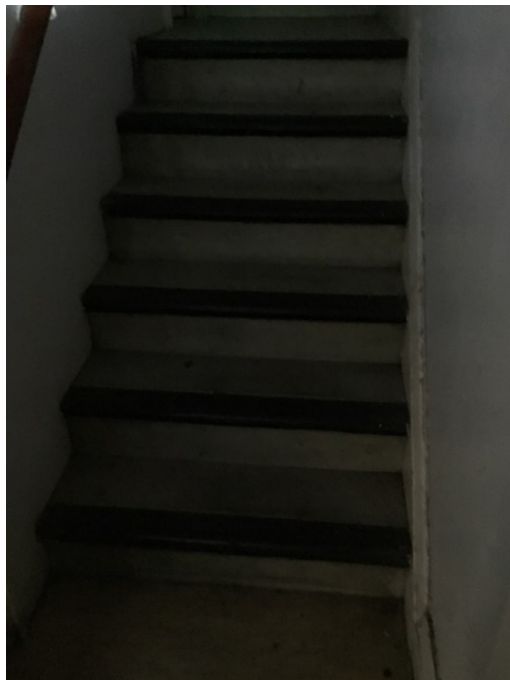
Lead Surveyor	Colin Bliss
Date of Survey	20/09/2017
Date of Next Re-inspection	
Item Description	Lino and stair nosing to stairs
Level of Identification	Sampled
Location Name	25 / Entire ground floor / Ground
Sample No	30
Product Type	Vinyl & Vinyl Floor Tiles
Extent of Damage	
Surface Treatment	
Asbestos Type	NADIS - No Asbestos Detected in Sample
Amount / Extent	
Accessibility	
Algorithm Score	0
<b>RECOMMENDATION</b>	Negative Sample - No Recommendation Required

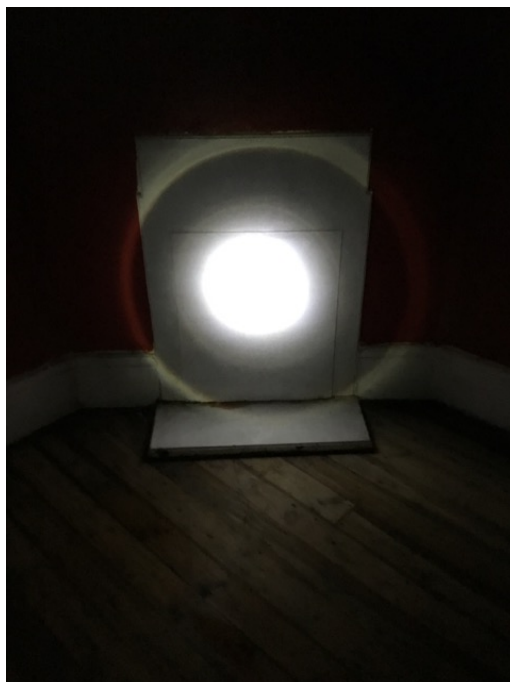
Lead Surveyor	Colin Bliss
Date of Survey	20/09/2017
Date of Next Re-inspection	20/09/2018
Item Description	No access into chimney
Level of Identification	Presumed
Location Name	25 / Entire ground floor / Ground
Sample No	
Product Type	
Extent of Damage	
Surface Treatment	
Asbestos Type	Not Applicable
Amount / Extent	
Accessibility	
Algorithm Score	12
<b>RECOMMENDATION</b>	No Access - Inspection Required

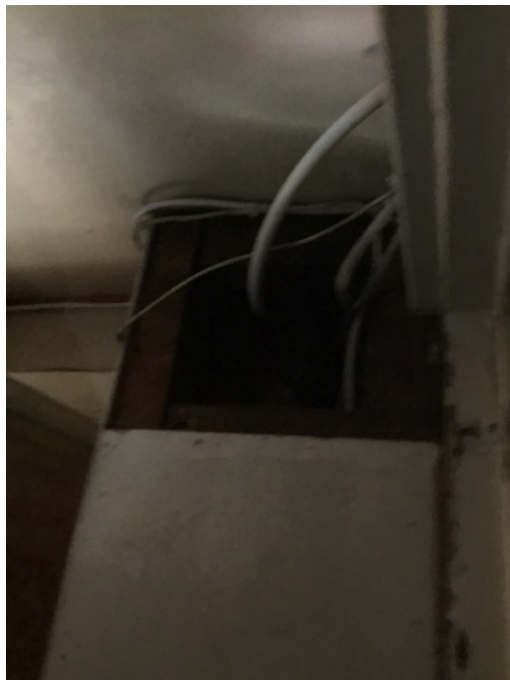
Lead Surveyor	Colin Bliss
Date of Survey	20/09/2017
Date of Next Re-inspection	
Item Description	Timber boxing behind entry door.
Level of Identification	
Location Name	25 / Entire ground floor / Ground
Sample No	
Product Type	
Extent of Damage	
Surface Treatment	
Asbestos Type	Not Applicable
Amount / Extent	
Accessibility	
Algorithm Score	0
<b>RECOMMENDATION</b>	Negative Sample - No Recommendation Required

Boxing housing electrical cable and soil pipe.

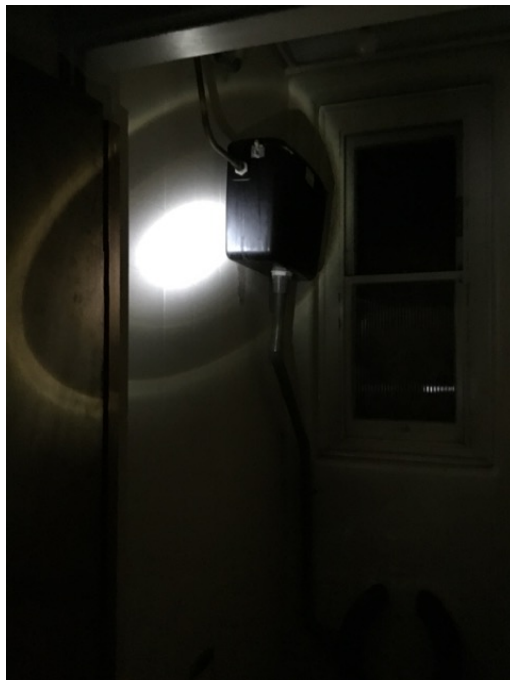
Lead Surveyor	Colin Bliss
Date of Survey	20/09/2017
Date of Next Re-inspection	20/09/2018
Item Description	Toilet cisterns
Level of Identification	Presumed
Location Name	25 / Entire ground floor / Ground
Sample No	
Product Type	Asbestos Reinforced Composite
Extent of Damage	Good Condition
Surface Treatment	Composite/Plastic/Resins/Bitumen
Asbestos Type	Chrysotile
Amount / Extent	2 No
Accessibility	Unlikely Disturbance/Usually Inaccessible
Algorithm Score	12
<b>RECOMMENDATION</b>	Remove by Licensed Asbestos Contractor

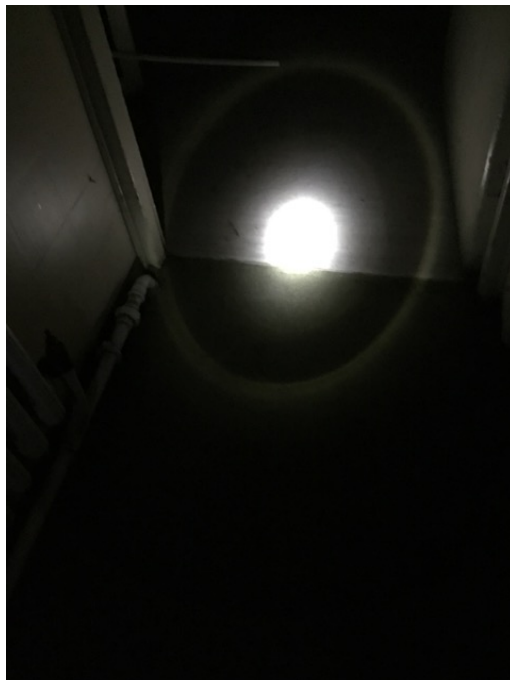
Lead Surveyor	Colin Bliss
Date of Survey	20/09/2017
Date of Next Re-inspection	
Item Description	Modern Lino to floor
Level of Identification	
Location Name	25 / Entire ground floor / Ground
Sample No	
Product Type	
Extent of Damage	
Surface Treatment	
Asbestos Type	Not Applicable
Amount / Extent	
Accessibility	
Algorithm Score	0
<b>RECOMMENDATION</b>	Negative Sample - No Recommendation Required

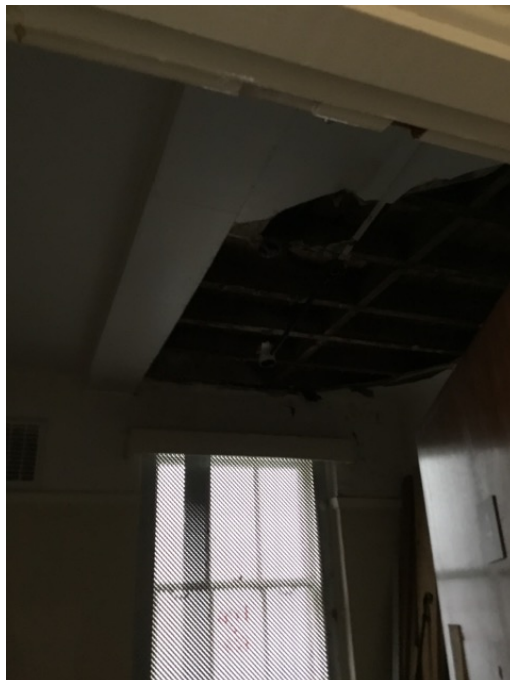
Lead Surveyor	Colin Bliss
Date of Survey	20/09/2017
Date of Next Re-inspection	
Item Description	Lathe and plaster ceiling
Level of Identification	
Location Name	26 / Entire first floor / First
Sample No	
Product Type	
Extent of Damage	
Surface Treatment	
Asbestos Type	Not Applicable
Amount / Extent	
Accessibility	
Algorithm Score	0
<b>RECOMMENDATION</b>	Negative Sample - No Recommendation Required

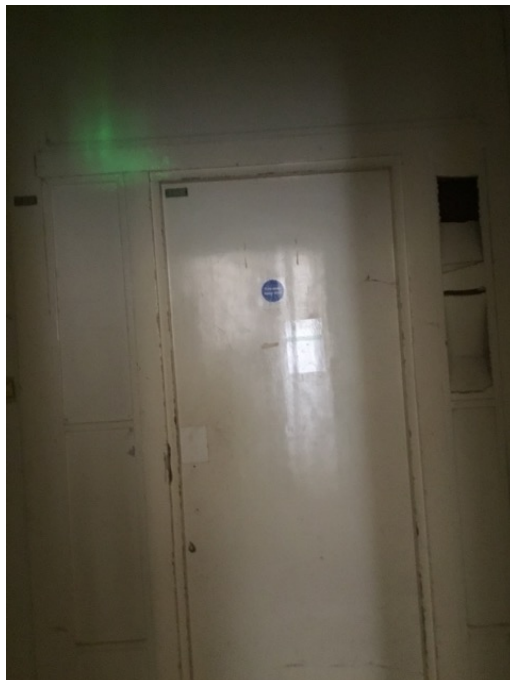
Lead Surveyor	Colin Bliss
Date of Survey	20/09/2017
Date of Next Re-inspection	
Item Description	Supalux panel to side of door and header
Level of Identification	
Location Name	26 / Entire first floor / First
Sample No	
Product Type	
Extent of Damage	
Surface Treatment	
Asbestos Type	Not Applicable
Amount / Extent	
Accessibility	
Algorithm Score	0
<b>RECOMMENDATION</b>	Negative Sample - No Recommendation Required

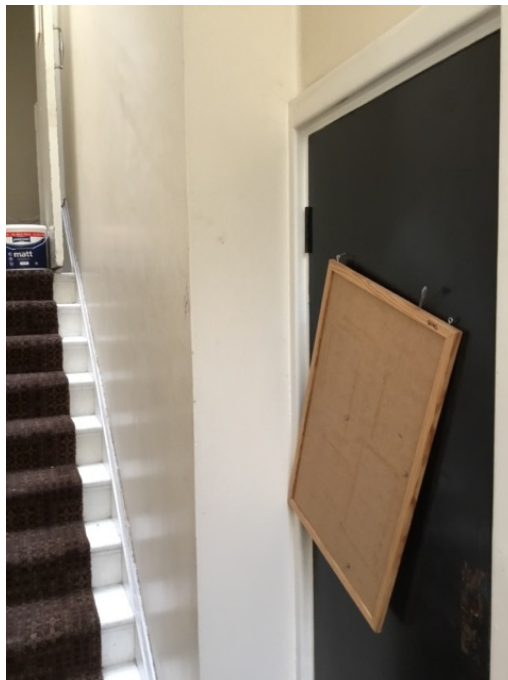
Lead Surveyor	Colin Bliss
Date of Survey	20/09/2017
Date of Next Re-inspection	
Item Description	All Areas / Items
Level of Identification	
Location Name	26 / Entire first floor / First
Sample No	
Product Type	
Extent of Damage	
Surface Treatment	
Asbestos Type	Not Applicable
Amount / Extent	
Accessibility	
Algorithm Score	0
<b>RECOMMENDATION</b>	Negative Sample - No Recommendation Required

Visual inspection no suspect materials found

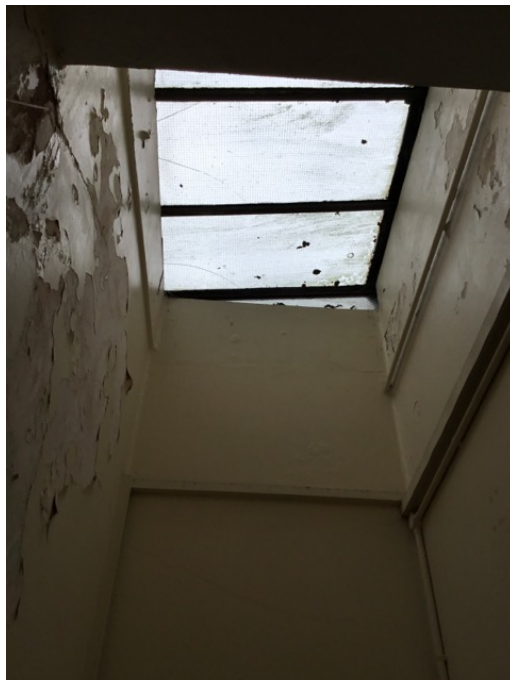
Lead Surveyor	Colin Bliss
Date of Survey	20/09/2017
Date of Next Re-inspection	20/09/2018
Item Description	Presume rope gasket to skylight
Level of Identification	Presumed
Location Name	26 / Entire first floor / First
Sample No	
Product Type	Textiles, Rope, Gaskets
Extent of Damage	Good Condition
Surface Treatment	Sealed Textiles
Asbestos Type	Chrysotile
Amount / Extent	10 LM
Accessibility	Unlikely Disturbance/Usually Inaccessible
Algorithm Score	12
<b>RECOMMENDATION</b>	Remove by Approved Asbestos Contractor

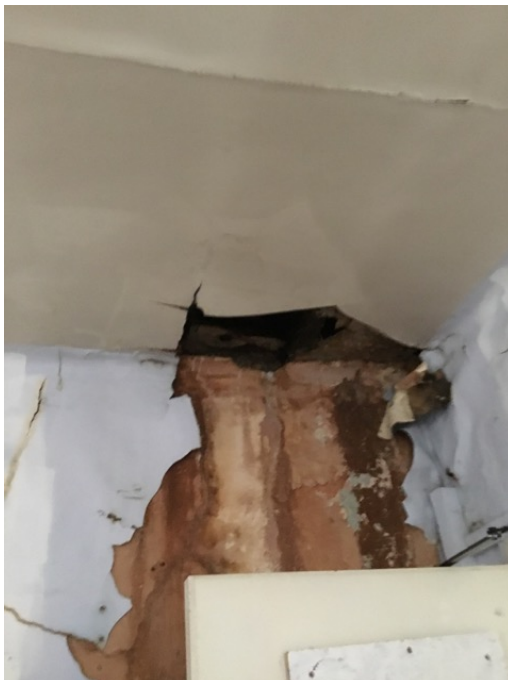
Lead Surveyor	Colin Bliss
Date of Survey	20/09/2017
Date of Next Re-inspection	
Item Description	Lathe and plaster ceiling
Level of Identification	
Location Name	27 / Entire second floor / Second
Sample No	
Product Type	
Extent of Damage	
Surface Treatment	
Asbestos Type	Not Applicable
Amount / Extent	
Accessibility	
Algorithm Score	0
<b>RECOMMENDATION</b>	Negative Sample - No Recommendation Required

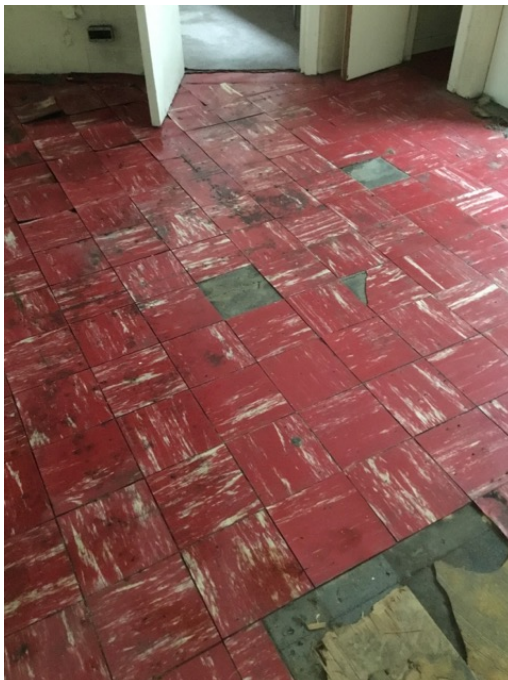
Lead Surveyor	Colin Bliss
Date of Survey	20/09/2017
Date of Next Re-inspection	
Item Description	Red tiles to floor
Level of Identification	Sampled
Location Name	27 / Entire second floor / Second
Sample No	31
Product Type	Vinyl & Vinyl Floor Tiles
Extent of Damage	
Surface Treatment	
Asbestos Type	NADIS - No Asbestos Detected in Sample
Amount / Extent	
Accessibility	
Algorithm Score	0
<b>RECOMMENDATION</b>	Negative Sample - No Recommendation Required

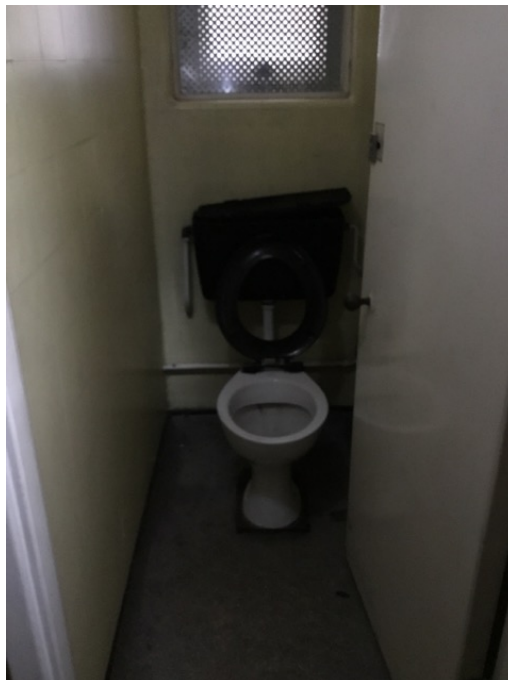
Lead Surveyor	Colin Bliss
Date of Survey	20/09/2017
Date of Next Re-inspection	20/09/2018
Item Description	Toilet cistern
Level of Identification	Presumed
Location Name	26 / Entire first floor / First
Sample No	
Product Type	Asbestos Reinforced Composite
Extent of Damage	Low Damage
Surface Treatment	Composite/Plastic/Resins/Bitumen
Asbestos Type	Chrysotile
Amount / Extent	1 No
Accessibility	Unlikely Disturbance/Usually Inaccessible
Algorithm Score	12
<b>RECOMMENDATION</b>	Remove by Approved Asbestos Contractor

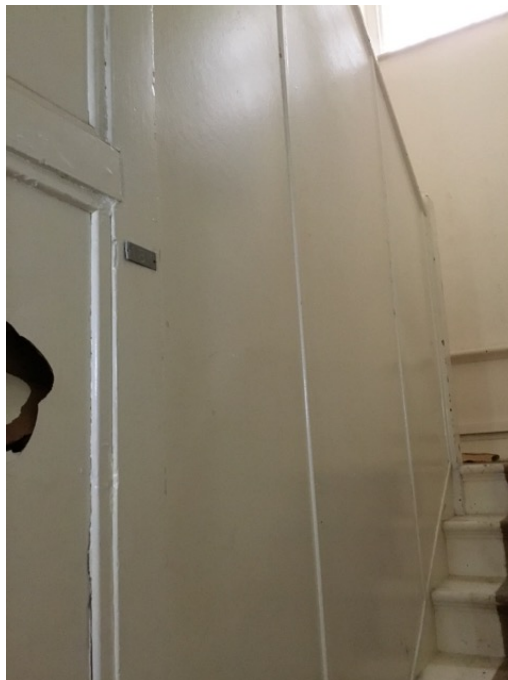
Lead Surveyor	Colin Bliss
Date of Survey	20/09/2017
Date of Next Re-inspection	20/09/2018
Item Description	Cement panels to side of stairs from 2nd to ground
Level of Identification	Sampled
Location Name	27 / Entire second floor / Second
Sample No	32
Product Type	Asbestos Cement
Extent of Damage	Good Condition
Surface Treatment	Sealed Cement
Asbestos Type	Chrysotile
Amount / Extent	20 M2
Accessibility	Unlikely Disturbance/Usually Inaccessible
Algorithm Score	2
<b>RECOMMENDATION</b>	No Recommendation Required

Removed October 25th 2017

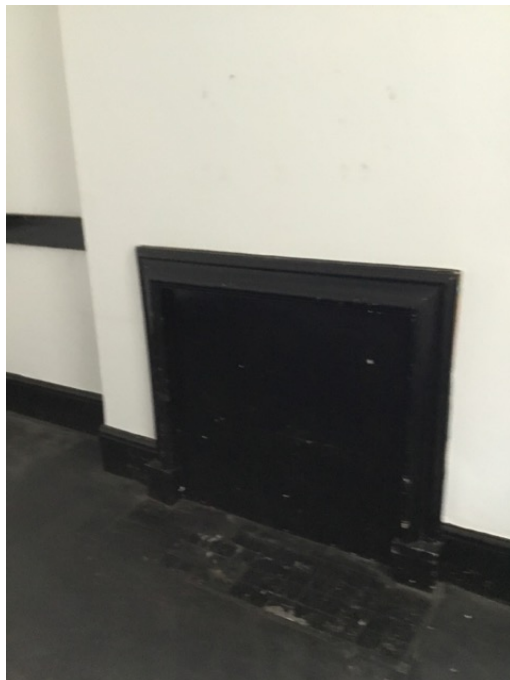
Lead Surveyor	Colin Bliss
Date of Survey	20/09/2017
Date of Next Re-inspection	
Item Description	Insulating board to fire place
Level of Identification	Sampled
Location Name	27 / Entire second floor / Second
Sample No	33
Product Type	Insulating board
Extent of Damage	
Surface Treatment	
Asbestos Type	NADIS - No Asbestos Detected in Sample
Amount / Extent	
Accessibility	
Algorithm Score	0
<b>RECOMMENDATION</b>	Negative Sample - No Recommendation Required

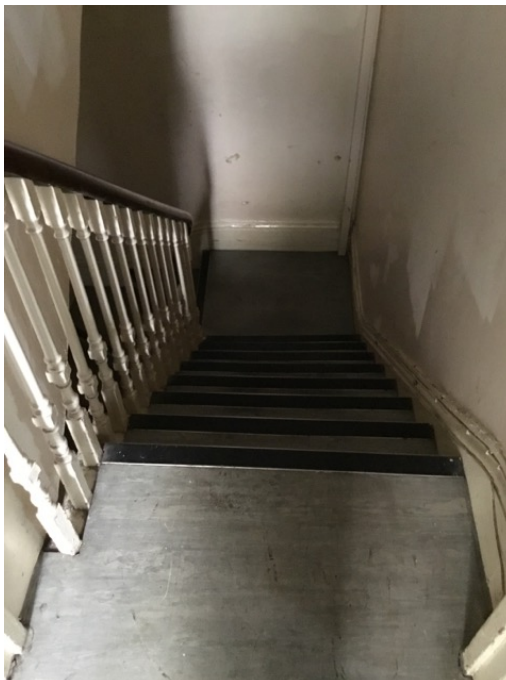
Lead Surveyor	Colin Bliss
Date of Survey	20/09/2017
Date of Next Re-inspection	
Item Description	Modern Lino and stair nosing
Level of Identification	
Location Name	27 / Entire second floor / Second
Sample No	
Product Type	
Extent of Damage	
Surface Treatment	
Asbestos Type	Not Applicable
Amount / Extent	
Accessibility	
Algorithm Score	0
<b>RECOMMENDATION</b>	Negative Sample - No Recommendation Required

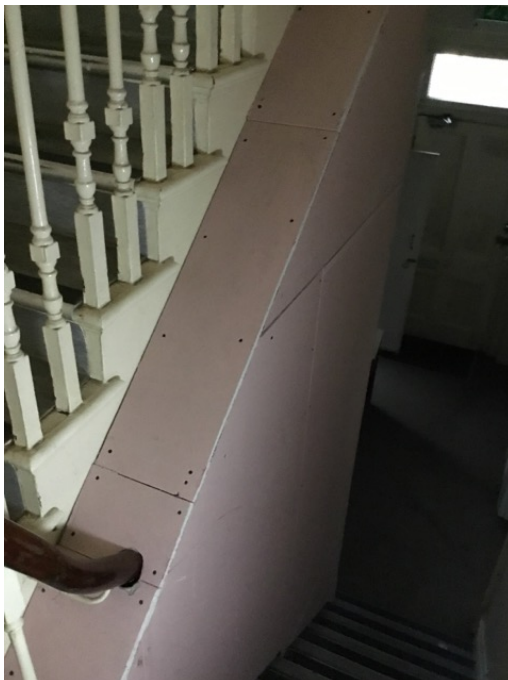
Lead Surveyor	Colin Bliss
Date of Survey	20/09/2017
Date of Next Re-inspection	
Item Description	Plasterboard boxing
Level of Identification	
Location Name	25 / Entire ground floor / Ground
Sample No	
Product Type	
Extent of Damage	
Surface Treatment	
Asbestos Type	Not Applicable
Amount / Extent	
Accessibility	
Algorithm Score	0
<b>RECOMMENDATION</b>	Negative Sample - No Recommendation Required
