**REFURBISHMENT / DEMOLITION**  
**ASBESTOS SURVEY REPORT**

**Middlesex Hospital  
Cleveland Street  
London  
W1T4DR**

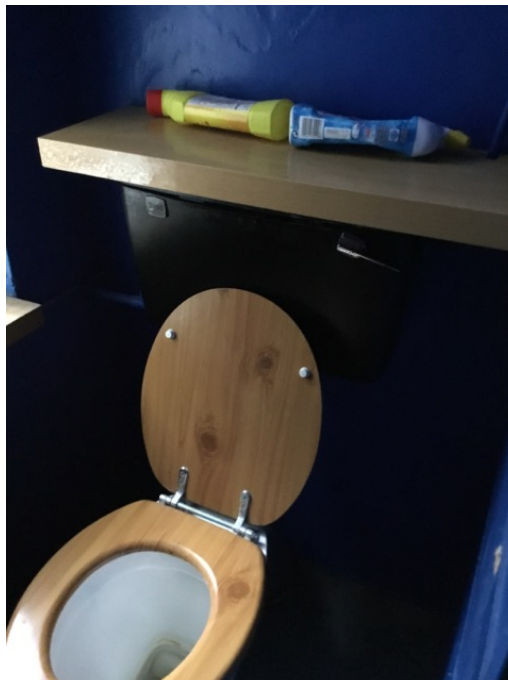
Lead Surveyor	Colin Bliss
Date of Survey	20/09/2017
Date of Next Re-inspection	20/09/2018
Item Description	Toilet cistern
Level of Identification	Presumed
Location Name	25 / Entire ground floor / Ground
Sample No	
Product Type	Asbestos Reinforced Composite
Extent of Damage	Good Condition
Surface Treatment	Composite/Plastic/Resins/Bitumen
Asbestos Type	Chrysotile
Amount / Extent	1 No
Accessibility	Unlikely Disturbance/Usually Inaccessible
Algorithm Score	12
<b>RECOMMENDATION</b>	Remove by Approved Asbestos Contractor

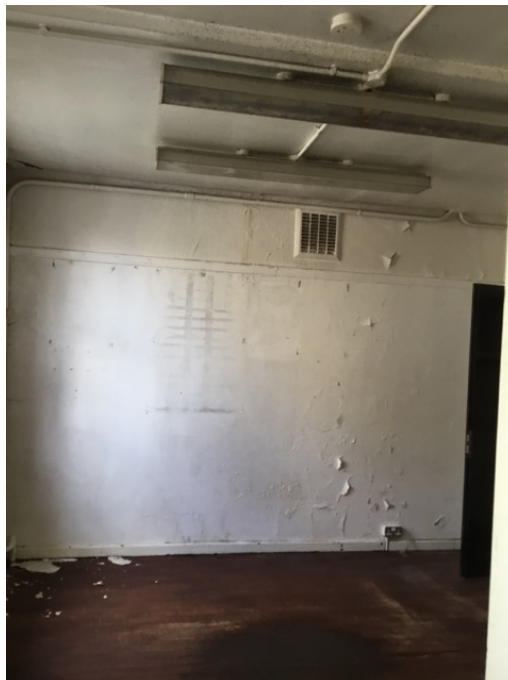
Lead Surveyor	Colin Bliss
Date of Survey	20/09/2017
Date of Next Re-inspection	
Item Description	Visual inspection of room
Level of Identification	
Location Name	28 / Entire third floor / Third
Sample No	
Product Type	
Extent of Damage	
Surface Treatment	
Asbestos Type	Not Applicable
Amount / Extent	
Accessibility	
Algorithm Score	0
<b>RECOMMENDATION</b>	Negative Sample - No Recommendation Required

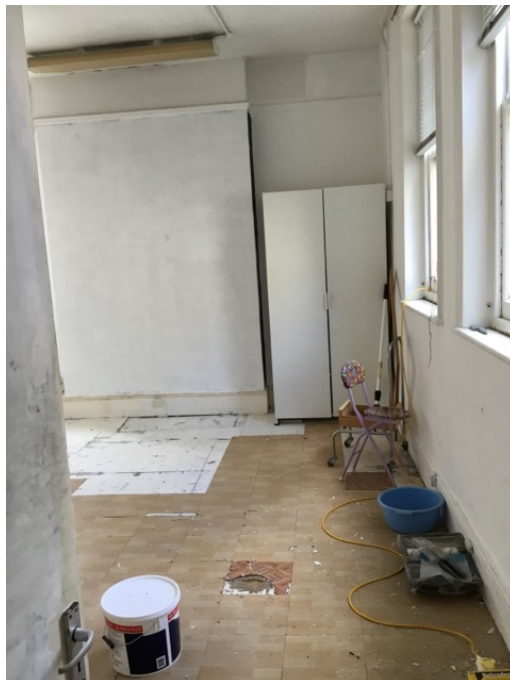
Lead Surveyor	Colin Bliss
Date of Survey	20/09/2017
Date of Next Re-inspection	
Item Description	Visual inspection of room
Level of Identification	
Location Name	28 / Entire third floor / Third
Sample No	
Product Type	
Extent of Damage	
Surface Treatment	
Asbestos Type	Not Applicable
Amount / Extent	
Accessibility	
Algorithm Score	0
<b>RECOMMENDATION</b>	Negative Sample - No Recommendation Required

Timber flooring under laminated tiles.

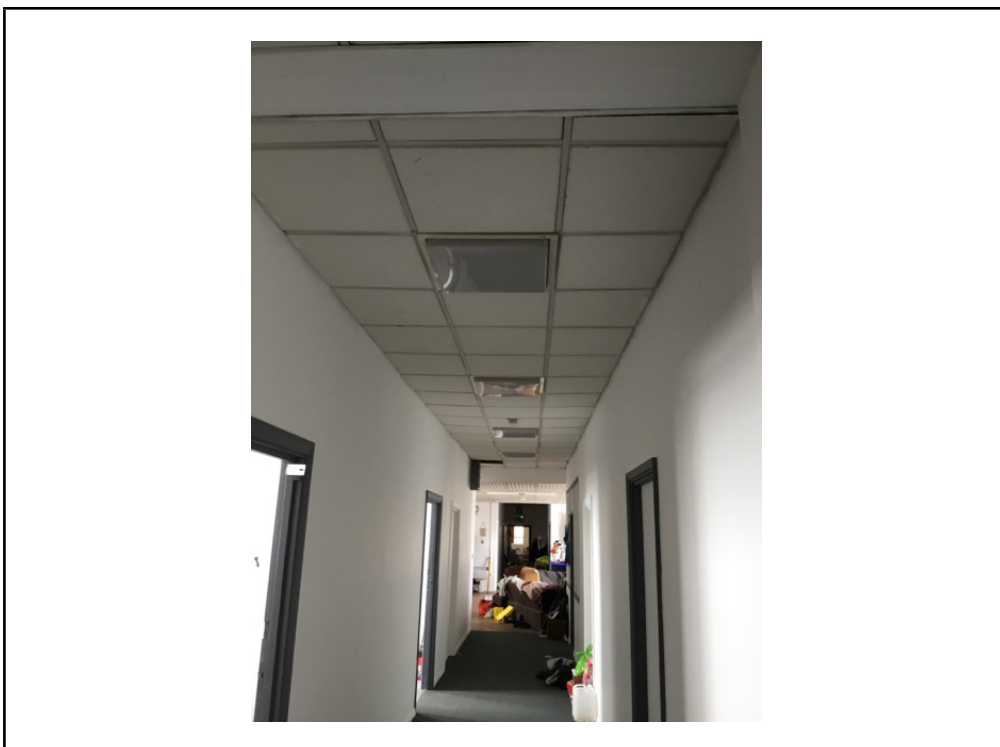
Lead Surveyor	Colin Bliss
Date of Survey	20/09/2017
Date of Next Re-inspection	
Item Description	MMMF suspended ceiling
Level of Identification	
Location Name	29 / Section 7 / Second
Sample No	
Product Type	
Extent of Damage	
Surface Treatment	
Asbestos Type	Not Applicable
Amount / Extent	
Accessibility	
Algorithm Score	0
<b>RECOMMENDATION</b>	Negative Sample - No Recommendation Required

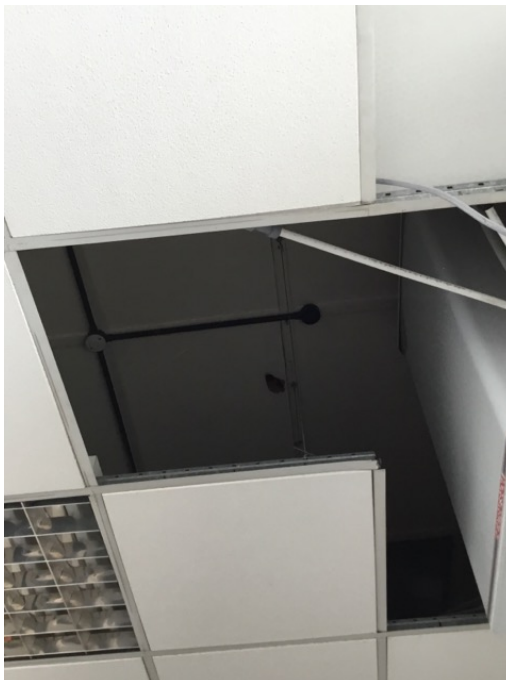
Lead Surveyor	Colin Bliss
Date of Survey	20/09/2017
Date of Next Re-inspection	
Item Description	Fibreboard ceiling above MMMF suspended ceiling
Level of Identification	
Location Name	29 / Section 7 / Second
Sample No	
Product Type	
Extent of Damage	
Surface Treatment	
Asbestos Type	Not Applicable
Amount / Extent	
Accessibility	
Algorithm Score	0
<b>RECOMMENDATION</b>	Negative Sample - No Recommendation Required

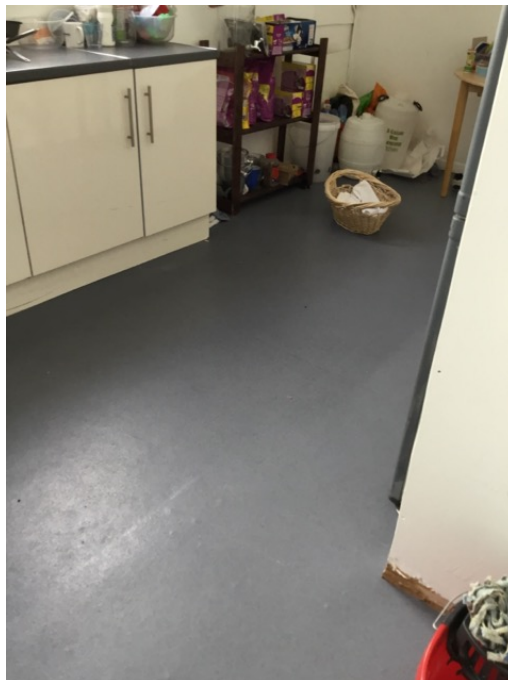
Lead Surveyor	Colin Bliss
Date of Survey	20/09/2017
Date of Next Re-inspection	
Item Description	Modern Lino to floor in kitchen
Level of Identification	
Location Name	29 / Section 7 / Second
Sample No	
Product Type	
Extent of Damage	
Surface Treatment	
Asbestos Type	Not Applicable
Amount / Extent	
Accessibility	
Algorithm Score	0
<b>RECOMMENDATION</b>	Negative Sample - No Recommendation Required

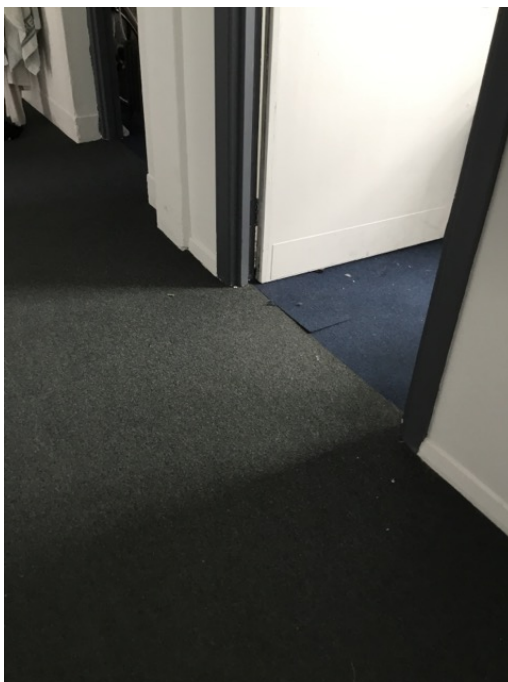
Lead Surveyor	Colin Bliss
Date of Survey	20/09/2017
Date of Next Re-inspection	
Item Description	Modern Lino under carpet
Level of Identification	
Location Name	29 / Section 7 / Second
Sample No	
Product Type	
Extent of Damage	
Surface Treatment	
Asbestos Type	Not Applicable
Amount / Extent	
Accessibility	
Algorithm Score	0
<b>RECOMMENDATION</b>	Negative Sample - No Recommendation Required

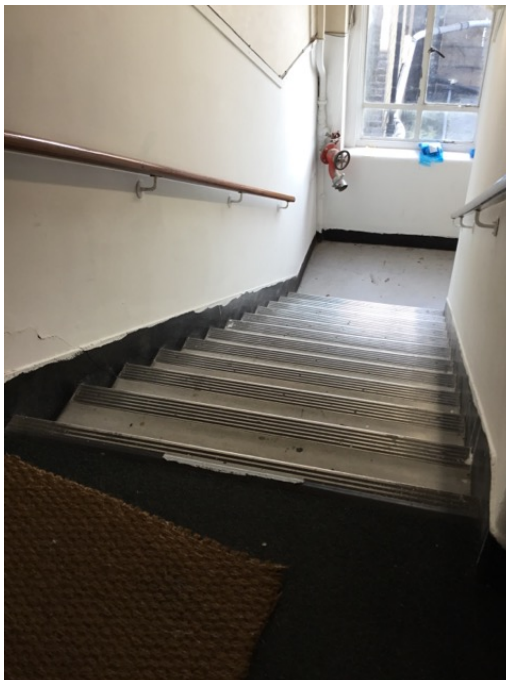
Lead Surveyor	Colin Bliss
Date of Survey	20/09/2017
Date of Next Re-inspection	
Item Description	Lino to stairs with metal stair nosing
Level of Identification	
Location Name	29 / Section 7 / Second
Sample No	
Product Type	
Extent of Damage	
Surface Treatment	
Asbestos Type	Not Applicable
Amount / Extent	
Accessibility	
Algorithm Score	0
<b>RECOMMENDATION</b>	Negative Sample - No Recommendation Required

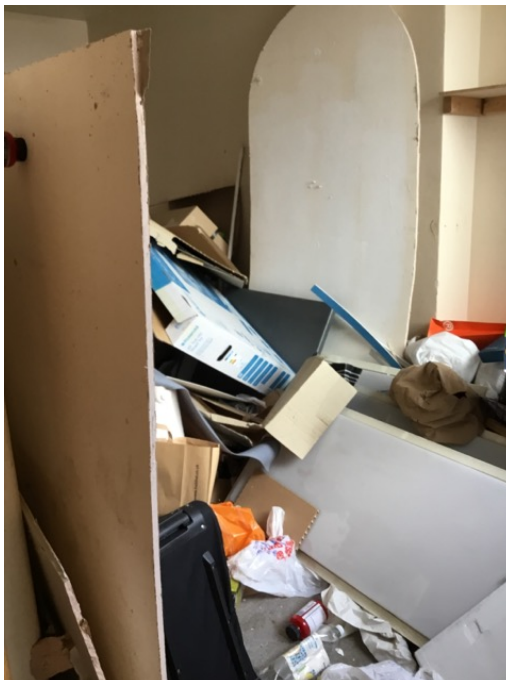
Lead Surveyor	Colin Bliss
Date of Survey	20/09/2017
Date of Next Re-inspection	
Item Description	Limited access into room due to stored items
Level of Identification	
Location Name	29 / Section 7 / Second
Sample No	
Product Type	
Extent of Damage	
Surface Treatment	
Asbestos Type	Not Applicable
Amount / Extent	
Accessibility	
Algorithm Score	0
<b>RECOMMENDATION</b>	Negative Sample - No Recommendation Required

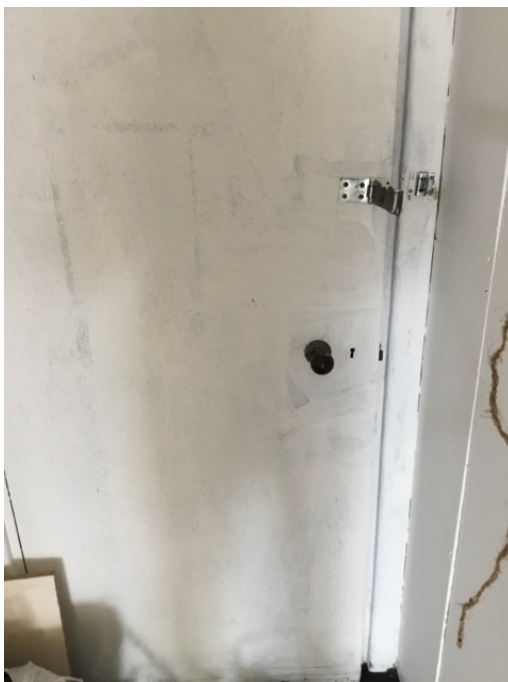
Lead Surveyor	Colin Bliss
Date of Survey	20/09/2017
Date of Next Re-inspection	20/09/2018
Item Description	Bakerlite knob to door
Level of Identification	Presumed
Location Name	29 / Section 7 / Second
Sample No	
Product Type	Asbestos Reinforced Composite
Extent of Damage	Good Condition
Surface Treatment	Composite/Plastic/Resins/Bitumen
Asbestos Type	Chrysotile
Amount / Extent	1 No
Accessibility	Unlikely Disturbance/Usually Inaccessible
Algorithm Score	12
<b>RECOMMENDATION</b>	Remove by Approved Asbestos Contractor

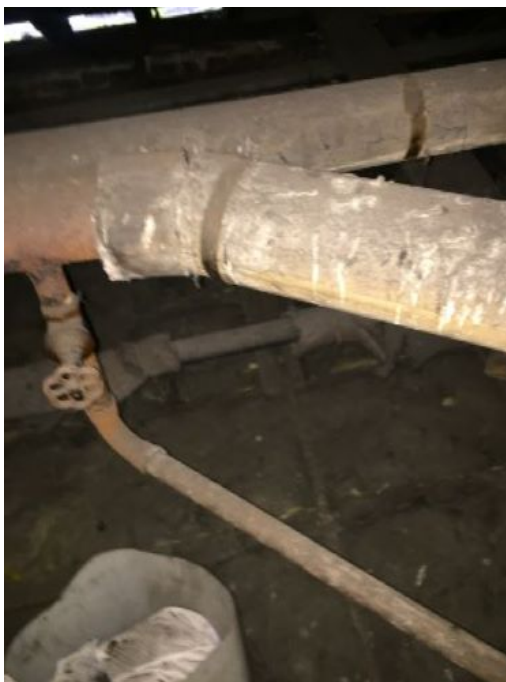
Lead Surveyor	Colin Bliss
Date of Survey	20/09/2017
Date of Next Re-inspection	20/09/2018
Item Description	Loft space pipework
Level of Identification	Sampled
Location Name	29 / Section 7 / Second
Sample No	42
Product Type	Thermal Insulation
Extent of Damage	High Damage
Surface Treatment	Debris & Contamination
Asbestos Type	Amosite / Chrysotile
Amount / Extent	300 LM
Accessibility	Unlikely Disturbance/Usually Inaccessible
Algorithm Score	11
<b>RECOMMENDATION</b>	Restrict Access and Remove by Licensed Contractor

Thermal insulation to pipework and contamination to floor area Loft area 180 sq mtrs

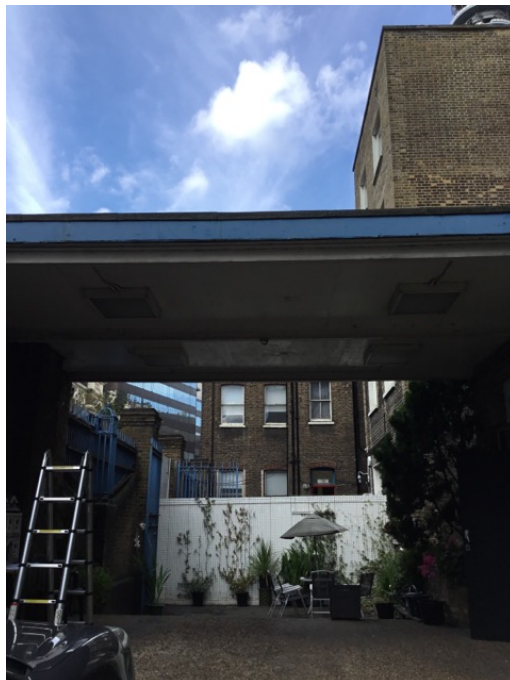
Lead Surveyor	Colin Bliss
Date of Survey	20/09/2017
Date of Next Re-inspection	20/09/2018
Item Description	Insulating board to ceiling of canopy
Level of Identification	Sampled
Location Name	/ External /
Sample No	37
Product Type	Insulating board
Extent of Damage	Low Damage
Surface Treatment	AIB Exposed Face Encapsulated
Asbestos Type	Amosite / Chrysotile
Amount / Extent	20 M2
Accessibility	Unlikely Disturbance/Usually Inaccessible
Algorithm Score	4
<b>RECOMMENDATION</b>	Remove by Licensed Asbestos Contractor

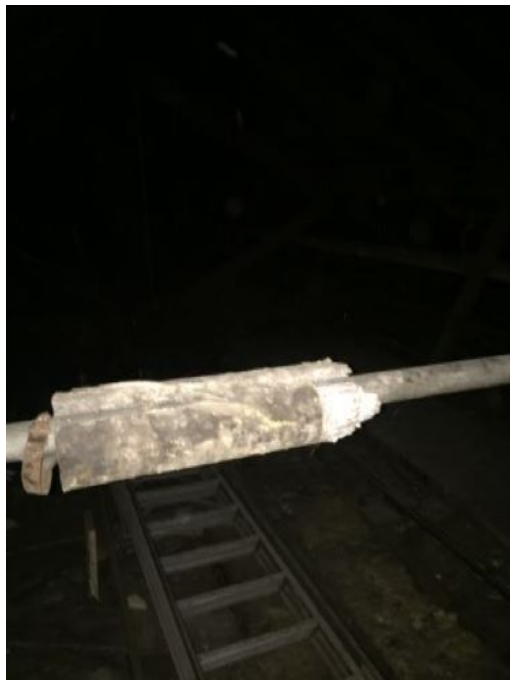
Lead Surveyor	Colin Bliss
Date of Survey	20/09/2017
Date of Next Re-inspection	20/09/2018
Item Description	Loft space pipework
Level of Identification	Crossed Referenced
Location Name	21 / Corridor / Second
Sample No	46
Product Type	Thermal Insulation
Extent of Damage	High Damage
Surface Treatment	Debris & Contamination
Asbestos Type	Amosite / Chrysotile
Amount / Extent	300 LM
Accessibility	Unlikely Disturbance/Usually Inaccessible
Algorithm Score	11
<b>RECOMMENDATION</b>	Restrict Access and Remove by Licensed Contractor

Thermal insulation to pipework and debris to floor, total floor space 180 sq mtrs

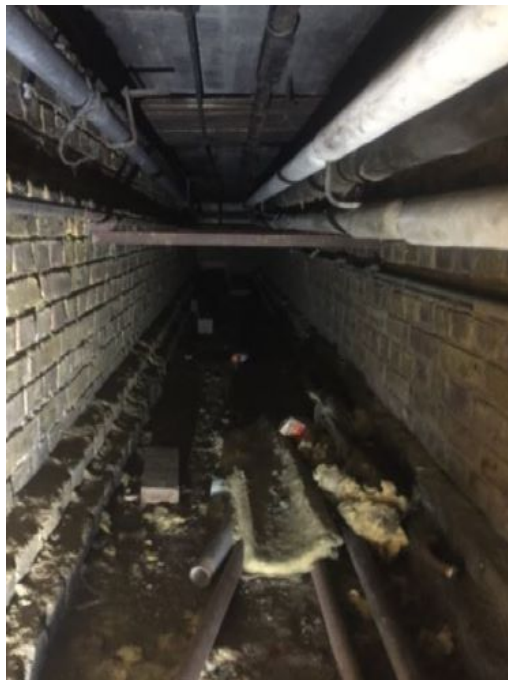
Lead Surveyor	Colin Bliss
Date of Survey	20/09/2017
Date of Next Re-inspection	20/09/2018
Item Description	tunnel 1
Level of Identification	Sampled
Location Name	000 / Basement tunnels / Basement
Sample No	44
Product Type	Thermal Insulation
Extent of Damage	High Damage
Surface Treatment	Debris & Contamination
Asbestos Type	Amosite / Chrysotile
Amount / Extent	100 LM
Accessibility	Unlikely Disturbance/Usually Inaccessible
Algorithm Score	11
<b>RECOMMENDATION</b>	Restrict Access and Remove by Licensed Contractor

Thermal insulation to pipework and contamination to floors, and walls

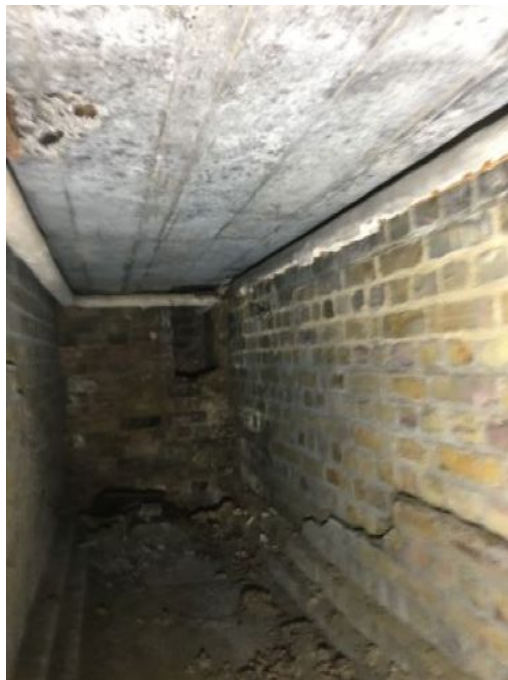
Lead Surveyor	Colin Bliss
Date of Survey	20/09/2017
Date of Next Re-inspection	20/09/2018
Item Description	Tunnel 2
Level of Identification	Sampled
Location Name	000 / Basement tunnels / Basement
Sample No	45
Product Type	Thermal Insulation
Extent of Damage	High Damage
Surface Treatment	Debris & Contamination
Asbestos Type	Amosite / Chrysotile
Amount / Extent	100 LM
Accessibility	Unlikely Disturbance/Usually Inaccessible
Algorithm Score	11
<b>RECOMMENDATION</b>	Restrict Access and Remove by Licensed Contractor

Thermal insulation to pipework and debris contamination to walls, floor and ceiling

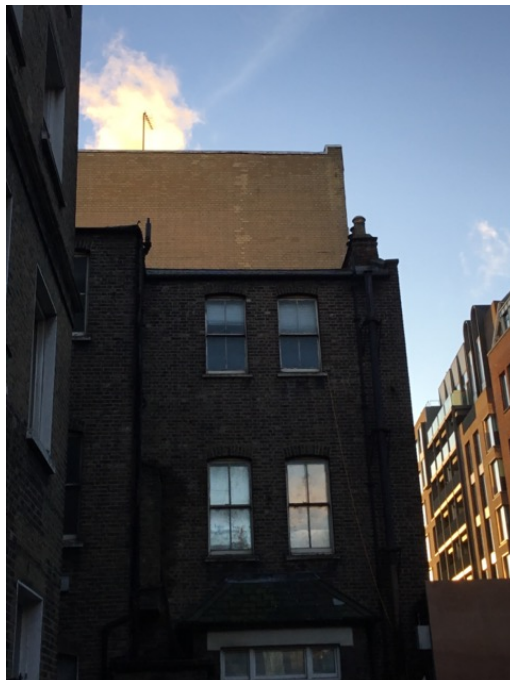
Lead Surveyor	Colin Bliss
Date of Survey	20/09/2017
Date of Next Re-inspection	
Item Description	Cement tiles to roof
Level of Identification	Sampled
Location Name	30 / External south building /
Sample No	50
Product Type	Asbestos Cement
Extent of Damage	
Surface Treatment	
Asbestos Type	NADIS - No Asbestos Detected in Sample
Amount / Extent	
Accessibility	
Algorithm Score	0
<b>RECOMMENDATION</b>	Negative Sample - No Recommendation Required

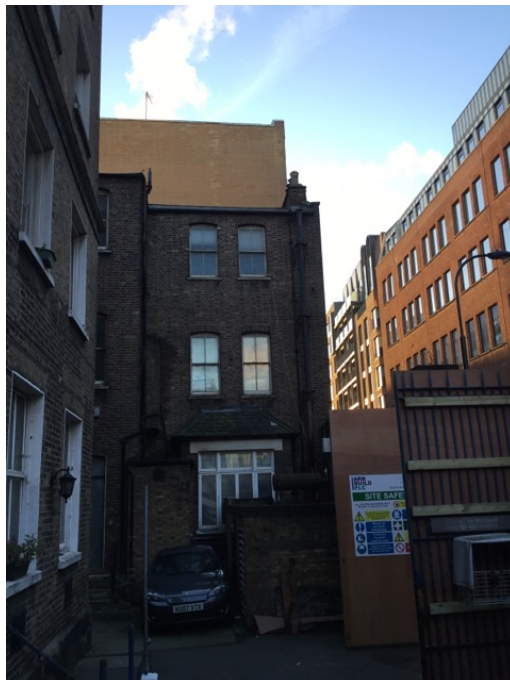
Lead Surveyor	Colin Bliss
Date of Survey	20/09/2017
Date of Next Re-inspection	
Item Description	Gaskets to pipework
Level of Identification	Presumed
Location Name	30 / External south building /
Sample No	
Product Type	Asbestos Reinforced Composite
Extent of Damage	
Surface Treatment	
Asbestos Type	
Amount / Extent	
Accessibility	
Algorithm Score	0
<b>RECOMMENDATION</b>	Negative Sample - No Recommendation Required

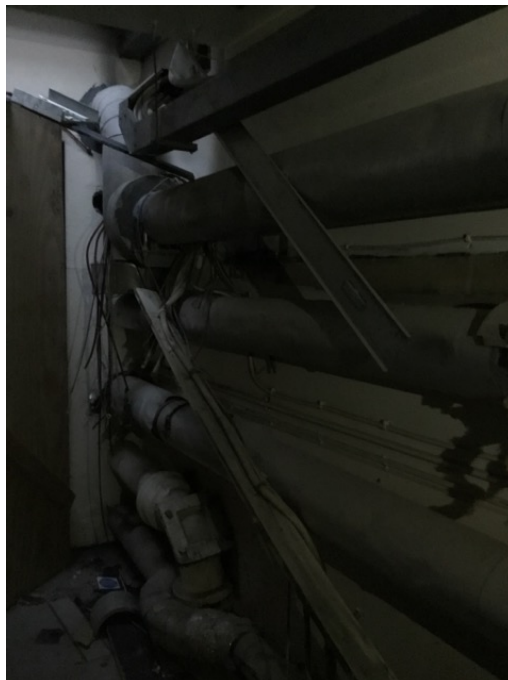
Lead Surveyor	Colin Bliss
Date of Survey	20/09/2017
Date of Next Re-inspection	
Item Description	Fibreglass lagged pipework
Level of Identification	
Location Name	13 / Corridor / Basement
Sample No	
Product Type	
Extent of Damage	
Surface Treatment	
Asbestos Type	
Amount / Extent	
Accessibility	
Algorithm Score	0
<b>RECOMMENDATION</b>	Negative Sample - No Recommendation Required

Lagging from mail corridor continues into this section.

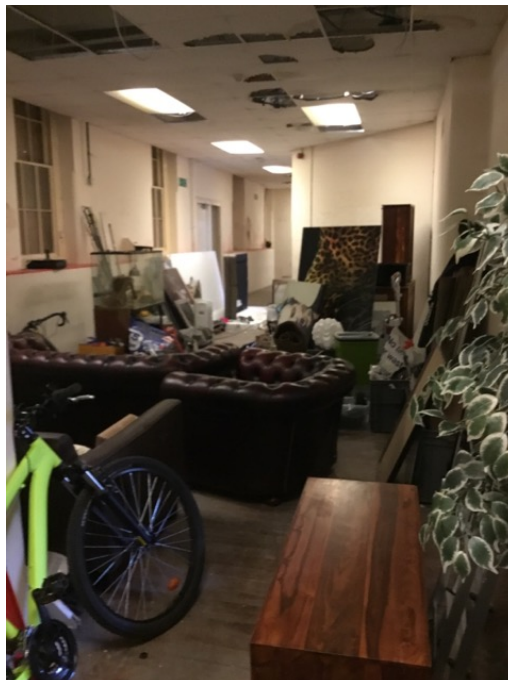
Lead Surveyor	Colin Bliss
Date of Survey	20/09/2017
Date of Next Re-inspection	
Item Description	Limited access due to stored items.
Level of Identification	Presumed
Location Name	31 / Ground floor of Annex (under Reach Section) / Ground
Sample No	
Product Type	
Extent of Damage	
Surface Treatment	
Asbestos Type	
Amount / Extent	
Accessibility	
Algorithm Score	0
<b>RECOMMENDATION</b>	Negative Sample - No Recommendation Required

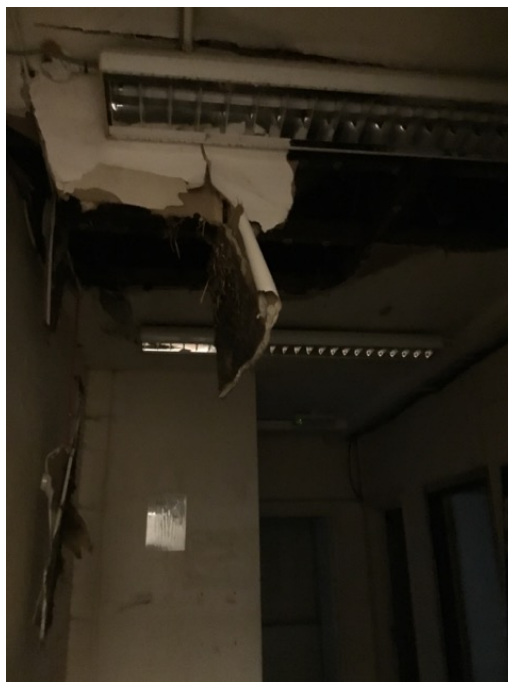
Lead Surveyor	Colin Bliss
Date of Survey	20/09/2017
Date of Next Re-inspection	
Item Description	Limited access to area with severe damages to roof
Level of Identification	
Location Name	31 / Ground floor of Annex (under Reach Section) / Ground
Sample No	
Product Type	
Extent of Damage	
Surface Treatment	
Asbestos Type	
Amount / Extent	
Accessibility	
Algorithm Score	0
<b>RECOMMENDATION</b>	Negative Sample - No Recommendation Required

Further inspection required. Roof is severely damaged and can collapse anytime. Part of the ceiling is already on the floor.

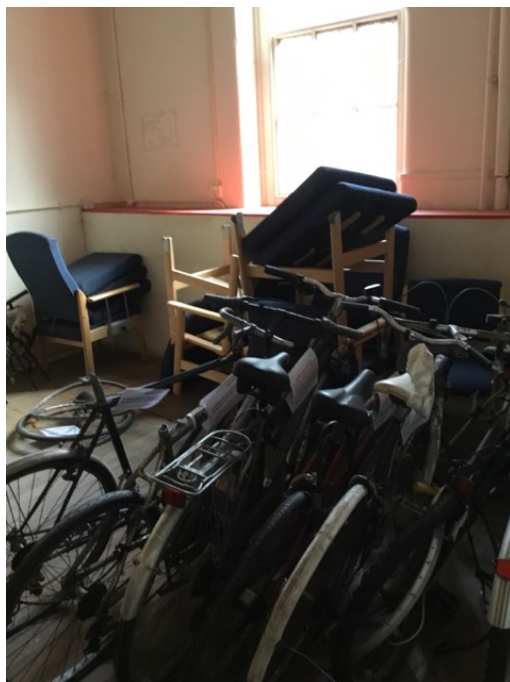
Lead Surveyor	Colin Bliss
Date of Survey	20/09/2017
Date of Next Re-inspection	
Item Description	Visual inspection of area
Level of Identification	
Location Name	31 / Ground floor of Annex (under Reach Section) / Ground
Sample No	
Product Type	
Extent of Damage	
Surface Treatment	
Asbestos Type	
Amount / Extent	
Accessibility	
Algorithm Score	0
<b>RECOMMENDATION</b>	Negative Sample - No Recommendation Required

Limited access into boxings by windows due to this being a listed building.

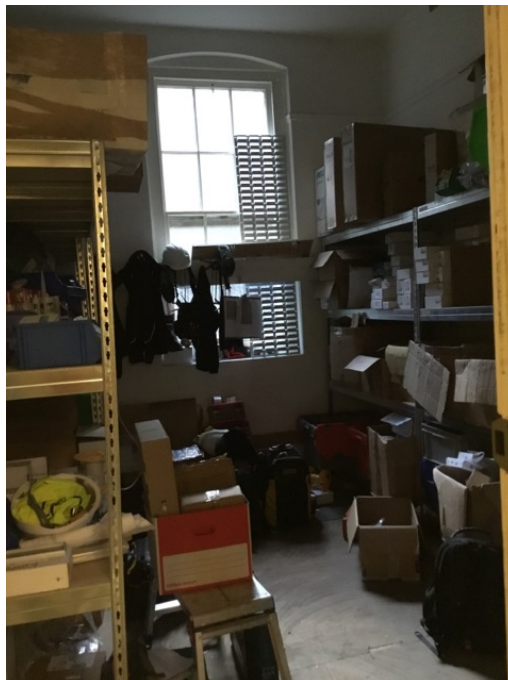
Lead Surveyor	Colin Bliss
Date of Survey	20/09/2017
Date of Next Re-inspection	
Item Description	Visual inspection of rooms
Level of Identification	
Location Name	32 / Ground floor reach active stores / Ground
Sample No	
Product Type	
Extent of Damage	
Surface Treatment	
Asbestos Type	
Amount / Extent	
Accessibility	
Algorithm Score	0
<b>RECOMMENDATION</b>	Negative Sample - No Recommendation Required

Masonry ceiling and walls. Hardwood flooring.

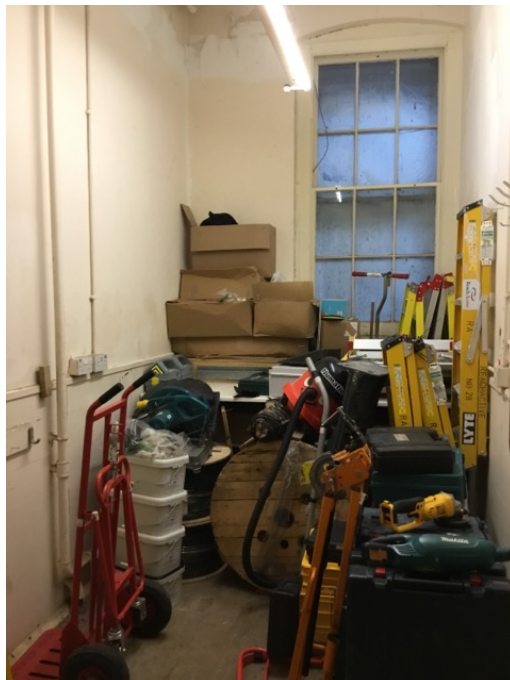
Lead Surveyor	Colin Bliss
Date of Survey	20/09/2017
Date of Next Re-inspection	
Item Description	Visual inspection of store
Level of Identification	
Location Name	32 / Ground floor reach active stores / Ground
Sample No	
Product Type	
Extent of Damage	
Surface Treatment	
Asbestos Type	
Amount / Extent	
Accessibility	
Algorithm Score	0
<b>RECOMMENDATION</b>	Negative Sample - No Recommendation Required

Masonry ceiling and walls. Hardwood flooring.

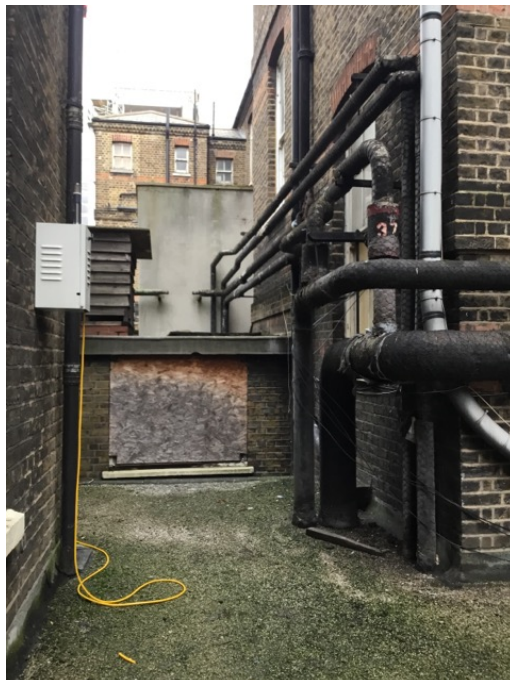
Lead Surveyor	Colin Bliss
Date of Survey	20/09/2017
Date of Next Re-inspection	20/09/2018
Item Description	Thermal insulation
Level of Identification	Sampled
Location Name	/ External /
Sample No	54
Product Type	Thermal Insulation
Extent of Damage	High Damage
Surface Treatment	Unsealed Lagging & Spray
Asbestos Type	Amosite / Chrysotile
Amount / Extent	100 LM
Accessibility	Unlikely Disturbance/Usually Inaccessible
Algorithm Score	11
<b>RECOMMENDATION</b>	Remove by Licensed Asbestos Contractor

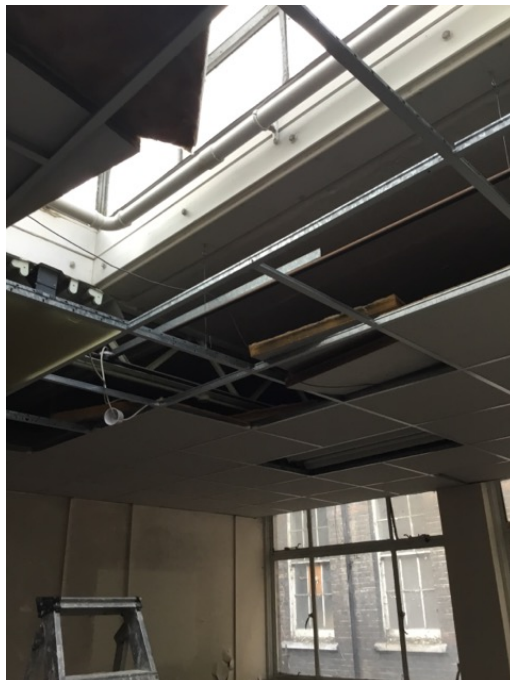
Lead Surveyor	Colin Bliss
Date of Survey	20/09/2017
Date of Next Re-inspection	20/09/2018
Item Description	Sprayed coating to ceiling
Level of Identification	Sampled
Location Name	33 / Room / Ground
Sample No	55
Product Type	Sprayed Asbestos
Extent of Damage	Low Damage
Surface Treatment	Sealed
Asbestos Type	Amosite / Chrysotile
Amount / Extent	50 M2
Accessibility	Occasional Disturbance
Algorithm Score	6
<b>RECOMMENDATION</b>	Remove by Licensed Asbestos Contractor

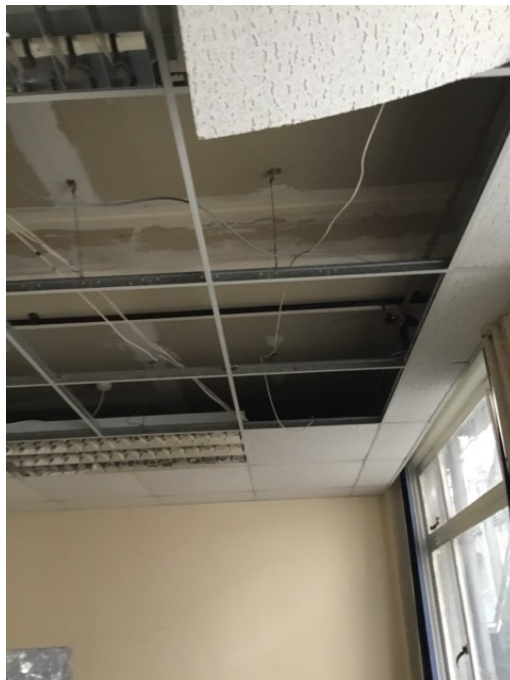
Lead Surveyor	Colin Bliss
Date of Survey	20/09/2017
Date of Next Re-inspection	
Item Description	Ceiling
Level of Identification	
Location Name	33 / Room / Ground
Sample No	
Product Type	
Extent of Damage	
Surface Treatment	
Asbestos Type	
Amount / Extent	
Accessibility	
Algorithm Score	0
<b>RECOMMENDATION</b>	Negative Sample - No Recommendation Required

MMMf suspended ceiling opening to plasterboard ceiling.
